August 18, 2023
Project No. 606752008

Subject: Geotechnical Services
 Valley Vista Subdivision Soil Evaluation
 Oro Valley, Arizona

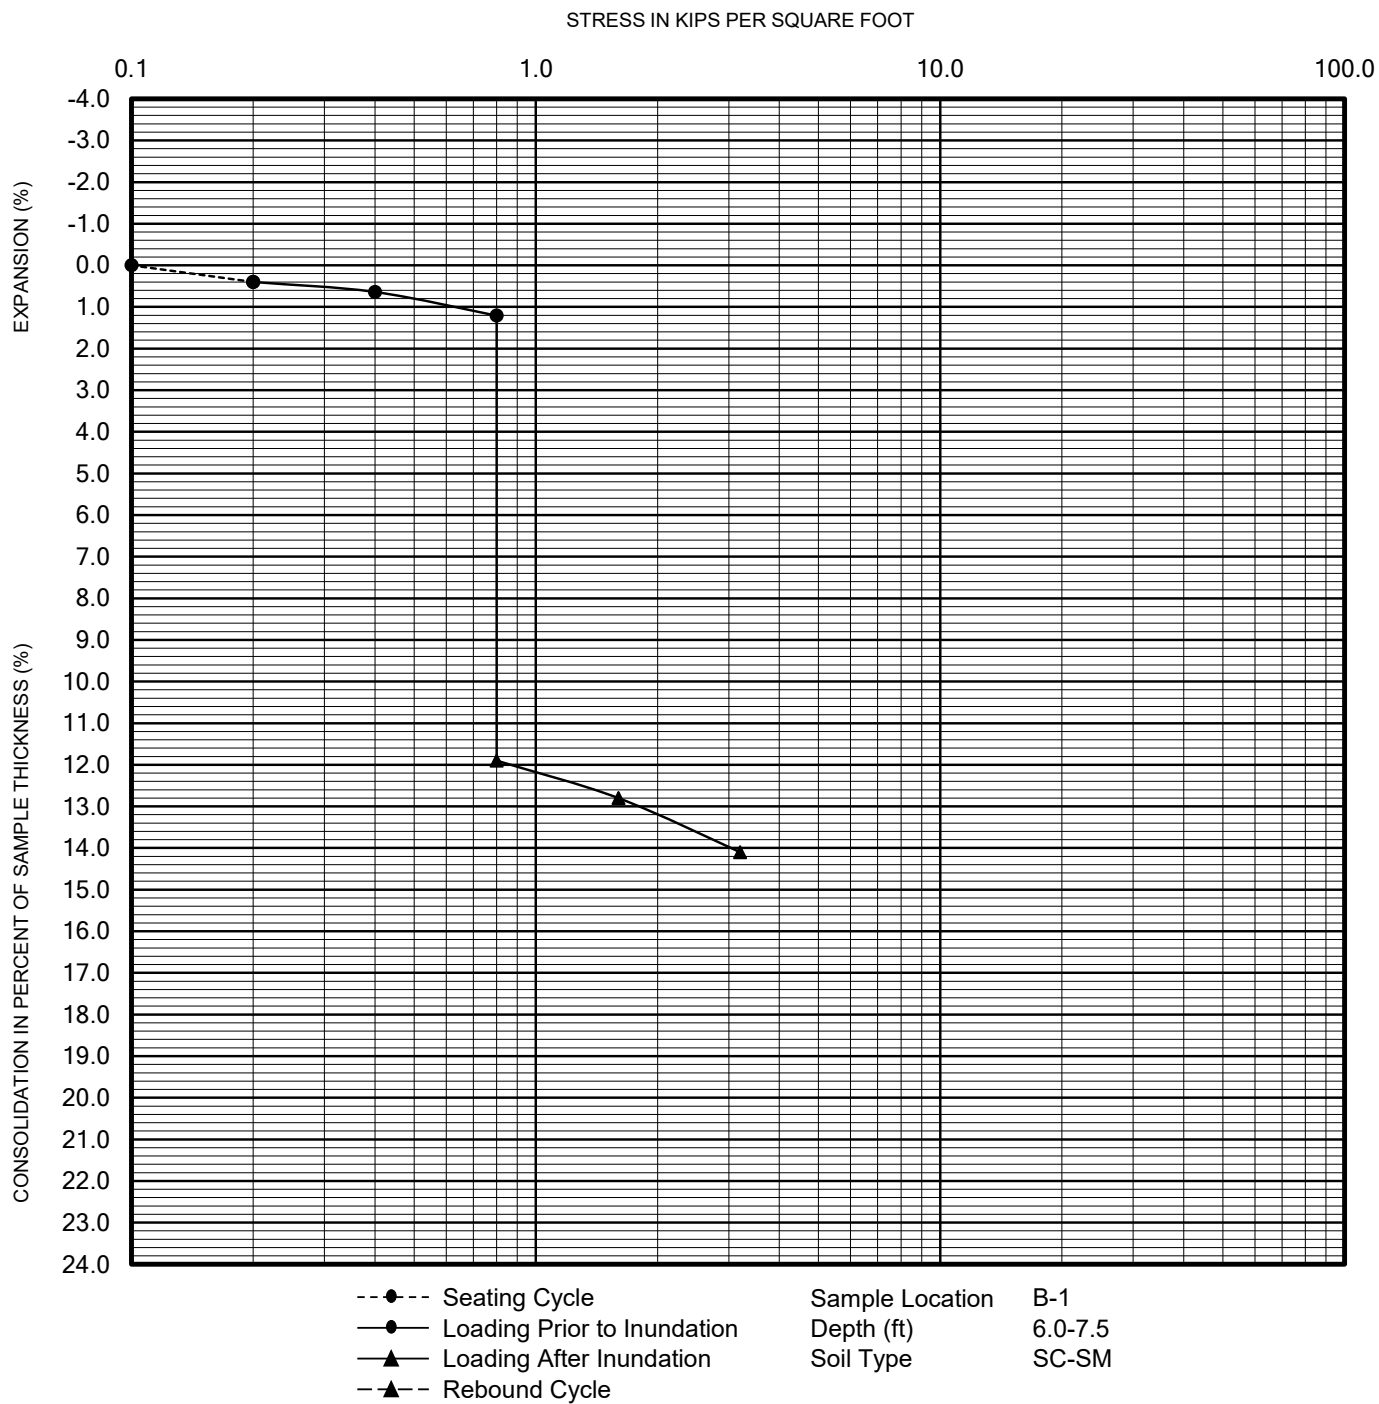
FIGURE B-8

The laboratory test results also show that both fill and native alluvial soils at our exploration locations are relatively consistent and include low plasticity silty sand and silty clayey sand. Based on the collected relatively undisturbed ring samples, the fill soils have generally higher dry densities and moisture content than the alluvial soils. The results of the consolidation tests indicate moderate to very severe collapse potential upon saturation:
