Geotechnical Investigation

Rancho Vistoso Valley Vista – Lot 19 Residence

780 East Kalalau Drive Oro Valley, Arizona ProTeX Job No.: 12804

Re: Geotechnical Investigation - Forensics

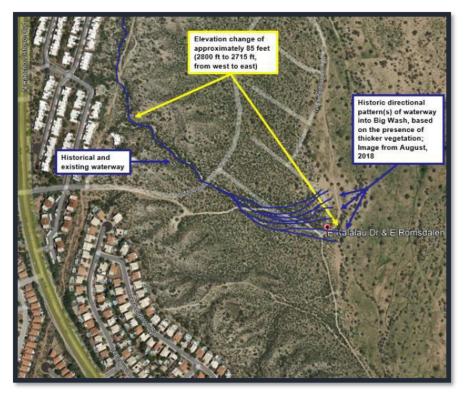
Figure 4: August, 2018, highlighting waterway patterns

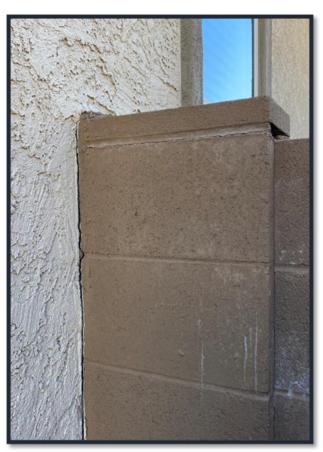
Lot 19 - West Block Wall: The privacy wall system on the west side of the lot consists of a single wall system that borders a neighboring homeowner. Evaluation of the general condition of the privacy wall system was noted to have undergone minimal to mostly zero deflections. However, separation cracks, measuring up to approximately 1/8" were observed in this wall.

Figure 1: Separation of west block wall from residential structure

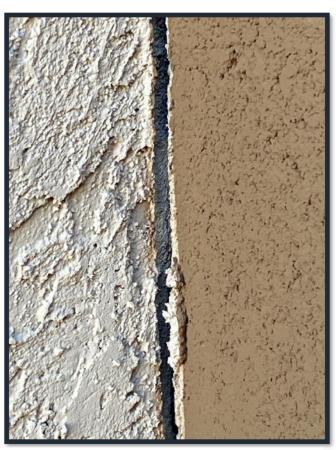
Figure 2: Close-up of separation crack on west side of house

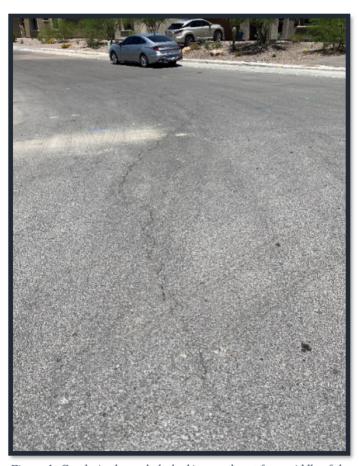
The local residential roadway where Kalalau Drive and Romsdalen Road connect, is currently paved with asphalt. The condition of the asphalt pavement was noted to have developed cracks at various locations. It also appears that this area has had the asphalt pavement replaced.

Figure 1: Cracks in the asphalt, looking northeast from middle of the Figure 2: Cracks in the asphalt, looking southwest from middle of the road

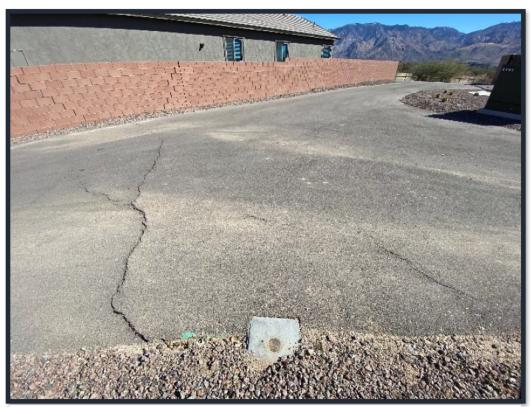
The area is currently paved with asphalt and includes small gravel areas with smaller utility housing. Cracks in the asphalt were observed, trending southwest to northeast. The patterns in both the block wall and the cracks in the asphalt pavement appear to follow similar trends.

Figure 1: Cracking in common area of booster station, in the asphalt pavement, and leading to Lot 20. Similar residual cracking patterns in both wall and asphalt pavement
