DAILY REPORT OF FIELD OBSERVATIONS

Service Date: 07/08/2024

Project Name: Rancho Vistoso Valley Vista Sewer Repair
Project Address: 601 E. Kalalau Dr.
Oro Valley AZ 85755
Client: Pima County
General Contractor: Hunter Contracting
Approved Documents:

Project Number: 608157001
Jurisdiction: Pima County/Oro Valley
Permit:
Plan File No.:

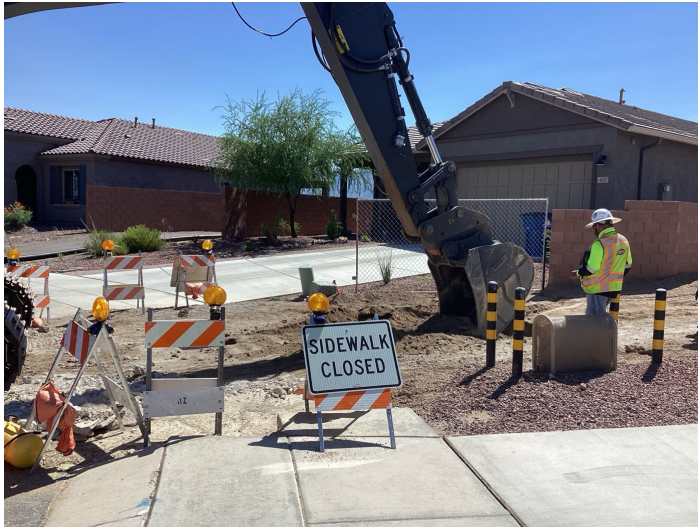
Excavating trench

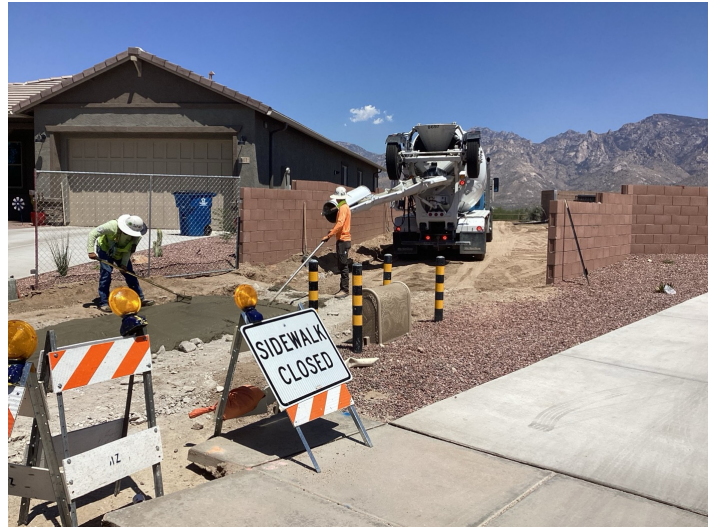
Arrived on site and talked to Eric on what needed testing.
No density tests were necessary for today. Only a slurry test/sample.
Proceeded to test/sample slurry for a 42.5 cy pour. Everything was within specs.
Finished paperwork before leaving site.

Poured slurry
