## DAILY REPORT OF FIELD OBSERVATIONS

Service Date: 07/10/2024

**Project Name:** Rancho Vistoso Valley Vista Sewer Repair  
**Project Address:** 601 E. Kalalau Dr.  
Oro Valley AZ 85755  
**Client:** Pima County  
**General Contractor:** Hunter Contracting  
**Approved Documents:**

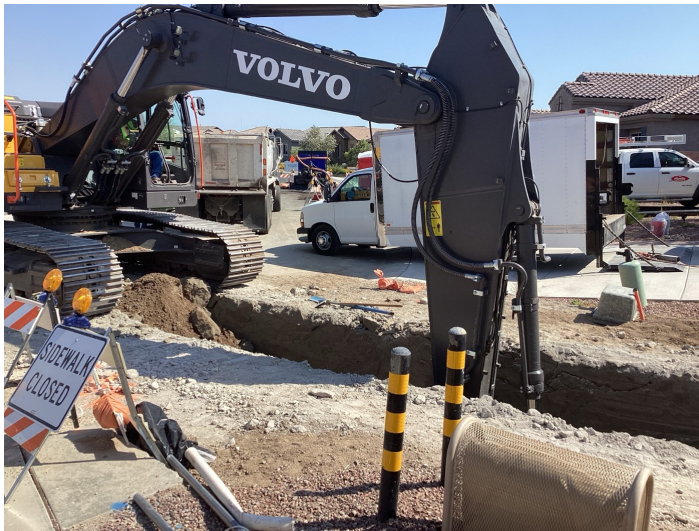
**Excavating trench**
