DAILY REPORT OF FIELD OBSERVATIONS

Service Date: 07/16/2024

Project Name: Rancho Vistoso Valley Vista Sewer Repair
Project Address: 601 E. Kalalau Dr.
Oro Valley AZ 85755
Client: Pima County
General Contractor: Hunter Contracting
Approved Documents:

Project Number: 608157001
Jurisdiction:
Permit:
Plan File No.

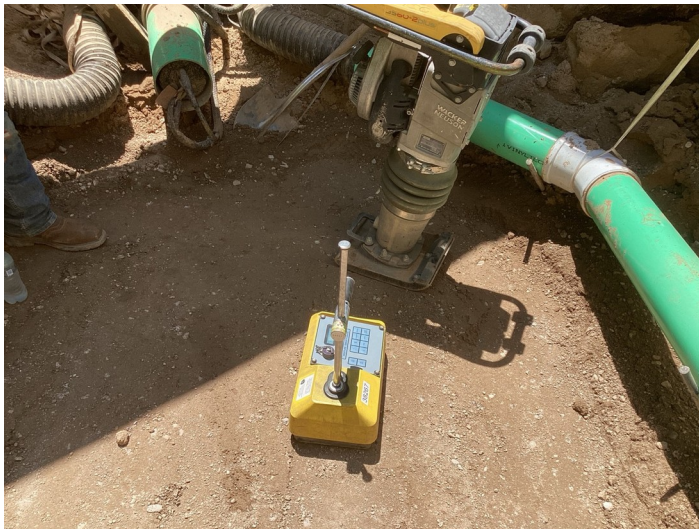
Compaction done with jumping jack.

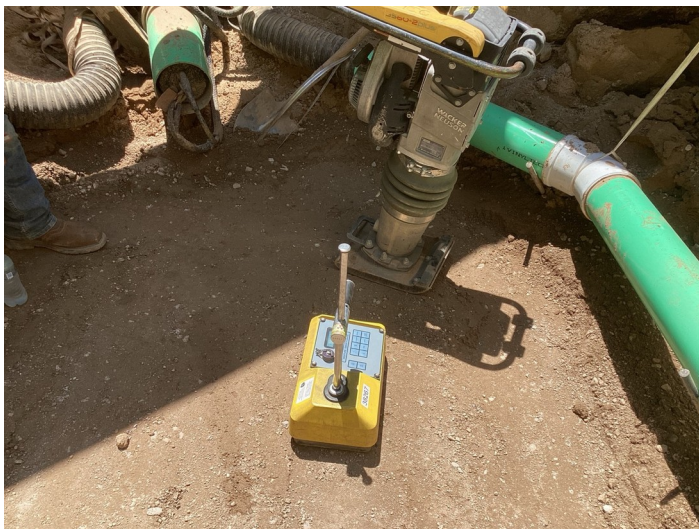
Manhole #2 base

Test No.	Elevation	Location	Material Type	In-Place Moisture (%)	In-Place Dry Density (pcf)	Relative Compaction (%)	Specified Compaction	Pass/Fail
1	Manhole base	Manhole #2	Aggregate Base	8.6	128.1	98	95	Pass
