DAILY REPORT OF FIELD OBSERVATIONS

Service Date: 07/22/2024

Project Name: Rancho Vistoso Valley Vista Sewer Repair
Project Address: 601 E. Kalalau Dr.
Oro Valley AZ 85755
Client: Pima County
General Contractor: Hunter Contracting
Approved Documents:

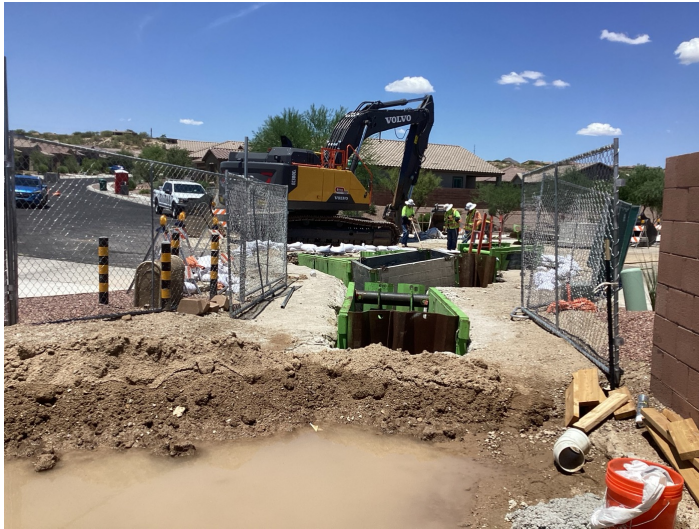
Work area

Arrived on site and talked to Eric about today's plan.
The Contractor is working on cleaning up the manhole area due to rain. The Concrete base done previously was removed.
Proceeded to take density test at manhole #2 base.
Informed Andy of passing test.
Finished paperwork before leaving site.

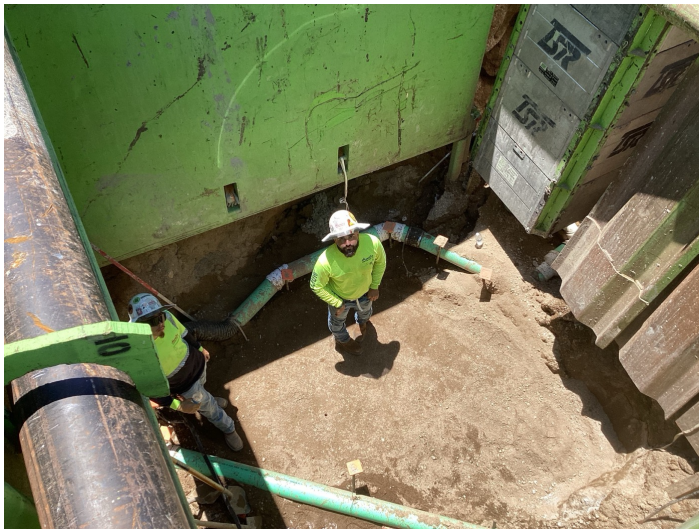
Test No.	Elevation	Location	Material Type	In-Place Moisture (%)	In-Place Dry Density (pcf)	Relative Compaction (%)	Specified Compaction	Pass/Fail
1	Manhole #2 base	Manhole #2	Aggregate Base	6.2	128.4	98	95	Pass
