DAILY REPORT OF FIELD OBSERVATIONS

Service Date: 07/24/2024

Project Name: Rancho Vistoso Valley Vista Sewer Repair
Project Address: 601 E. Kalalau Dr.
Oro Valley AZ 85755
Client: Pima County
General Contractor: Hunter Contracting
Approved Documents:

Project Name: Rancho Vistoso Valley Vista Sewer Repair

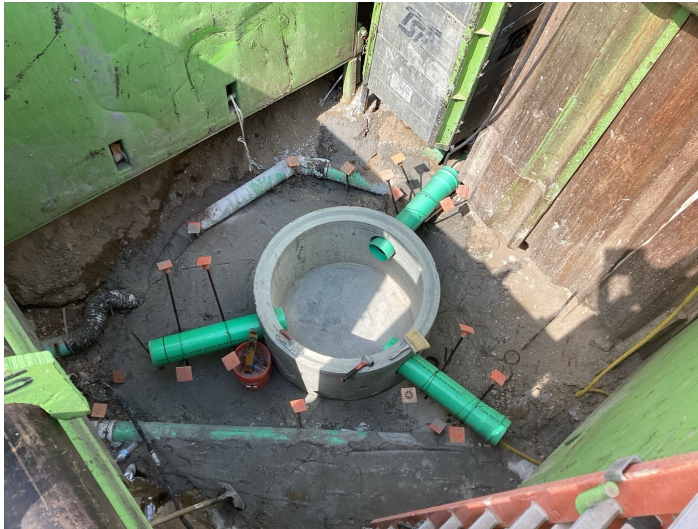
Work area

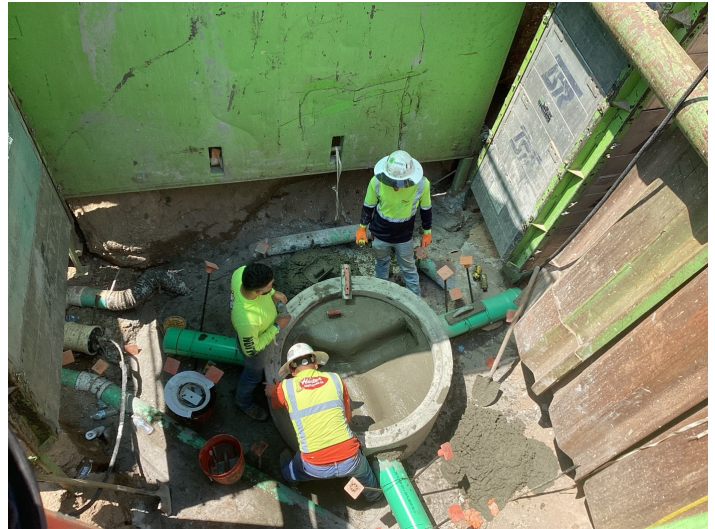
Proceeded to test/sample concrete placed at manhole #2 base. (Previously poured base was removed and replaced with today's concrete pour)

Everything was within specs.

Finished pour manhole #2 base
