# DAILY REPORT OF FIELD OBSERVATIONS

Service Date: 08/01/2024

**Project Name:** Rancho Vistoso Valley Vista Sewer Repair  
**Project Address:** 601 E. Kalalau Dr.  
Oro Valley AZ 85755  
**Client:** Pima County  
**General Contractor:** Hunter  
**Approved Documents:**

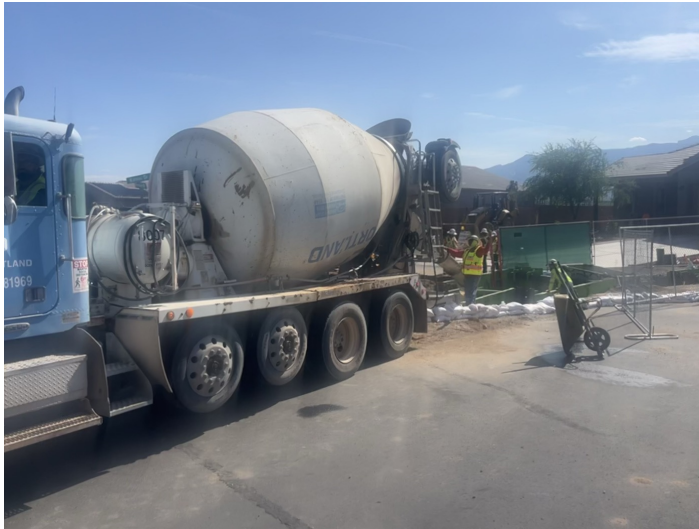
**Concrete Placement Overview**

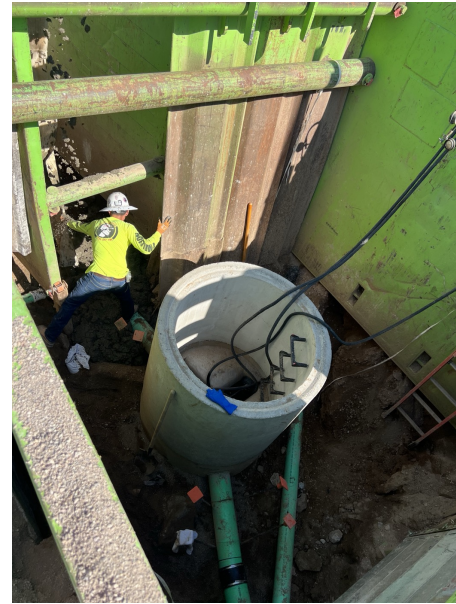
**Concrete Placement**
