DAILY REPORT OF FIELD OBSERVATIONS

Service Date: 08/02/2024

Project Name: Rancho Vistoso Valley Vista Sewer Repair
Project Address: 601 E. Kalalau Dr.
Oro Valley AZ 85755
Client: Pima County
General Contractor: Hunter Contracting
Approved Documents:

Project Name: Rancho Vistoso Valley Vista Sewer Repair

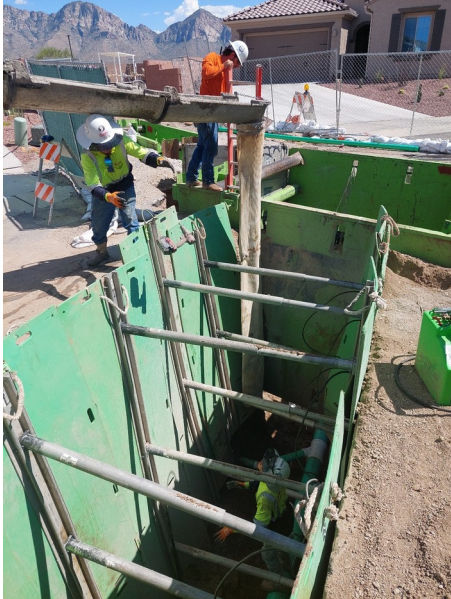
Slurry placement on the sewer line inlet repair
