DAILY REPORT OF FIELD OBSERVATIONS

Service Date: 08/02/2024

Project Name: Rancho Vistoso Valley Vista Sewer Repair
Project Address: 601 E. Kalalau Dr.
Oro Valley AZ 85755
Client: Pima County
General Contractor: Hunter
Approved Documents:

Project Number: 608157001
Jurisdiction: Oro Valley
Permit:
Plan File No.:

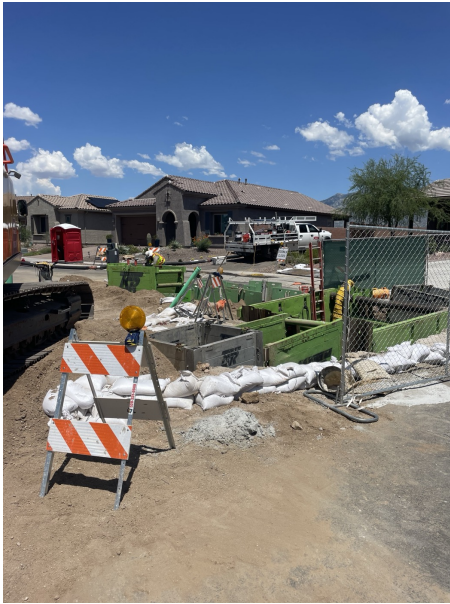
broad view of work area

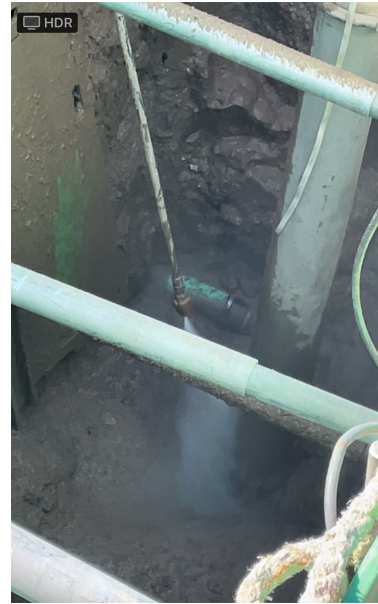
ditch with vacuuming

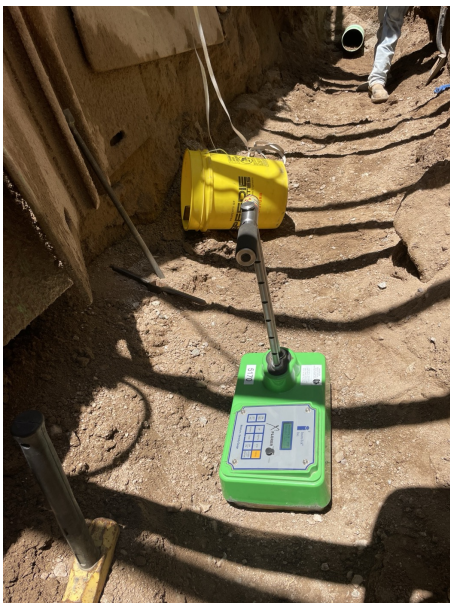
Test No.	Elevation	Location	Material Type	In-Place Moisture (%)	In-Place Dry Density (pcf)	Relative Compaction (%)	Specified Compaction	Pass/Fail
1	- 12' / 1st lift	15' W of 803 Romsdalen Rd	Native Soils	7.7	128.6	96	95	Pass

test location
