NORTHRIDGE ESTATES REZONING SITE ANALYSIS

(ORO VALLEY #2302611)

NOVEMBER 2024

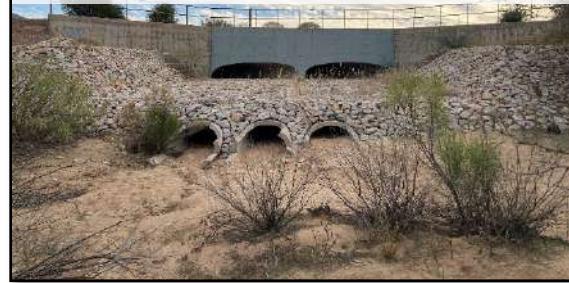
Existing Drainage Structure Under Moore Road Flowing into the Property

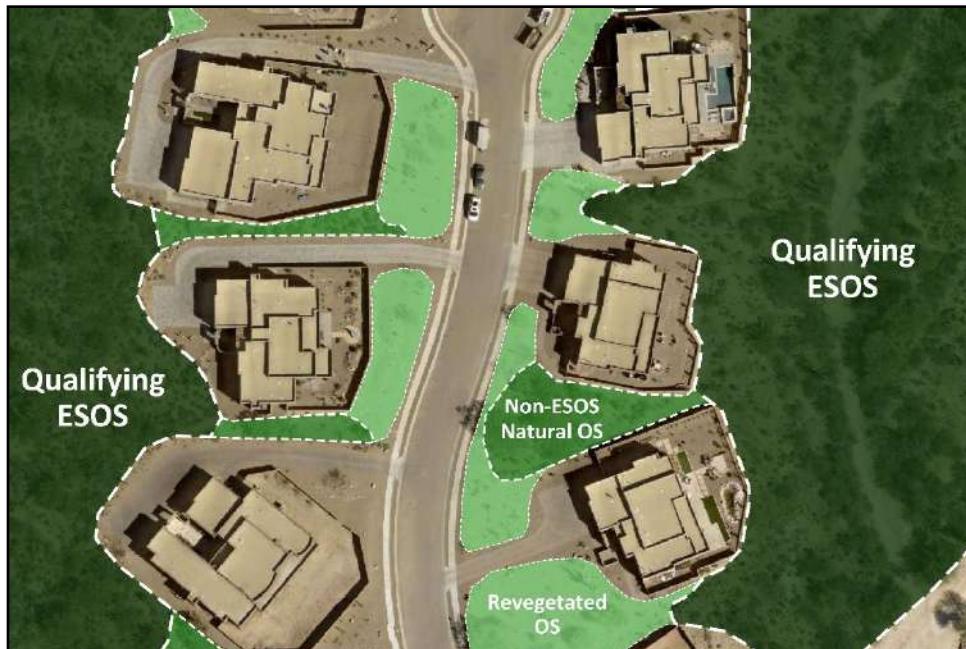
The onsite wash forms a strand of Critical Resource Area running through the central portion of the Property from the north to the south. A minimum of 93.6% of this Critical Resource Area will be preserved. The remainder of the Property will be composed of Resource Management Area Tiers 1 & 2 upon approval of the minor General Plan Amendment accompanying this rezoning. The overall project will provide 47.7% ESOS. Additional open space will be provided onsite between some of the house pads, although some of those areas will not qualify due to their geometry, even if they're left in their natural, undisturbed state. Additionally, revegetated open space areas, which are visually significant, also don't count as ESOS. Any vegetation that is disturbed will of course meet mitigation requirements as set forth in the Town of Oro Valley Zoning Code. In the example graphic to the right, the darkest green area is the only open space that qualifies as ESOS, whereas the areas colored as two lighter shades of green don't count toward ESOS despite the fact that they're important and functional open space within the development. See Exhibit III-C-1: Proposed ESOS.

Conservation Category	Area	Allowed Disturbance	Additional Requested Disturbance	Total Proposed Disturbance
Major Wildlife Linkage	0	0	0	0
Critical Resource Area	3.84± Ac.	5% (0.192± Ac.)	1.4% (0.053± Ac.)	6.4% (0.244± Ac.)
Core Resource Area	0	0	0	0
Resource Management Area Tier 1	13.00± Ac.	34% (4.420± Ac.)	24.1% (3.089± Ac.)	57.8% (7.509± Ac.)
Resource Management Area Tier 2	18.53± Ac.	75% (13.900± Ac.)	-17.0% (-3.142± Ac.)	58.0% (10.758± Ac.)
Resource Management Area Tier 3	0	0	0	0
Total Site	35.37± Ac.	52.3% (18.512± Ac.)	0% (0 Ac.)	52.3% (18.512± Ac.)

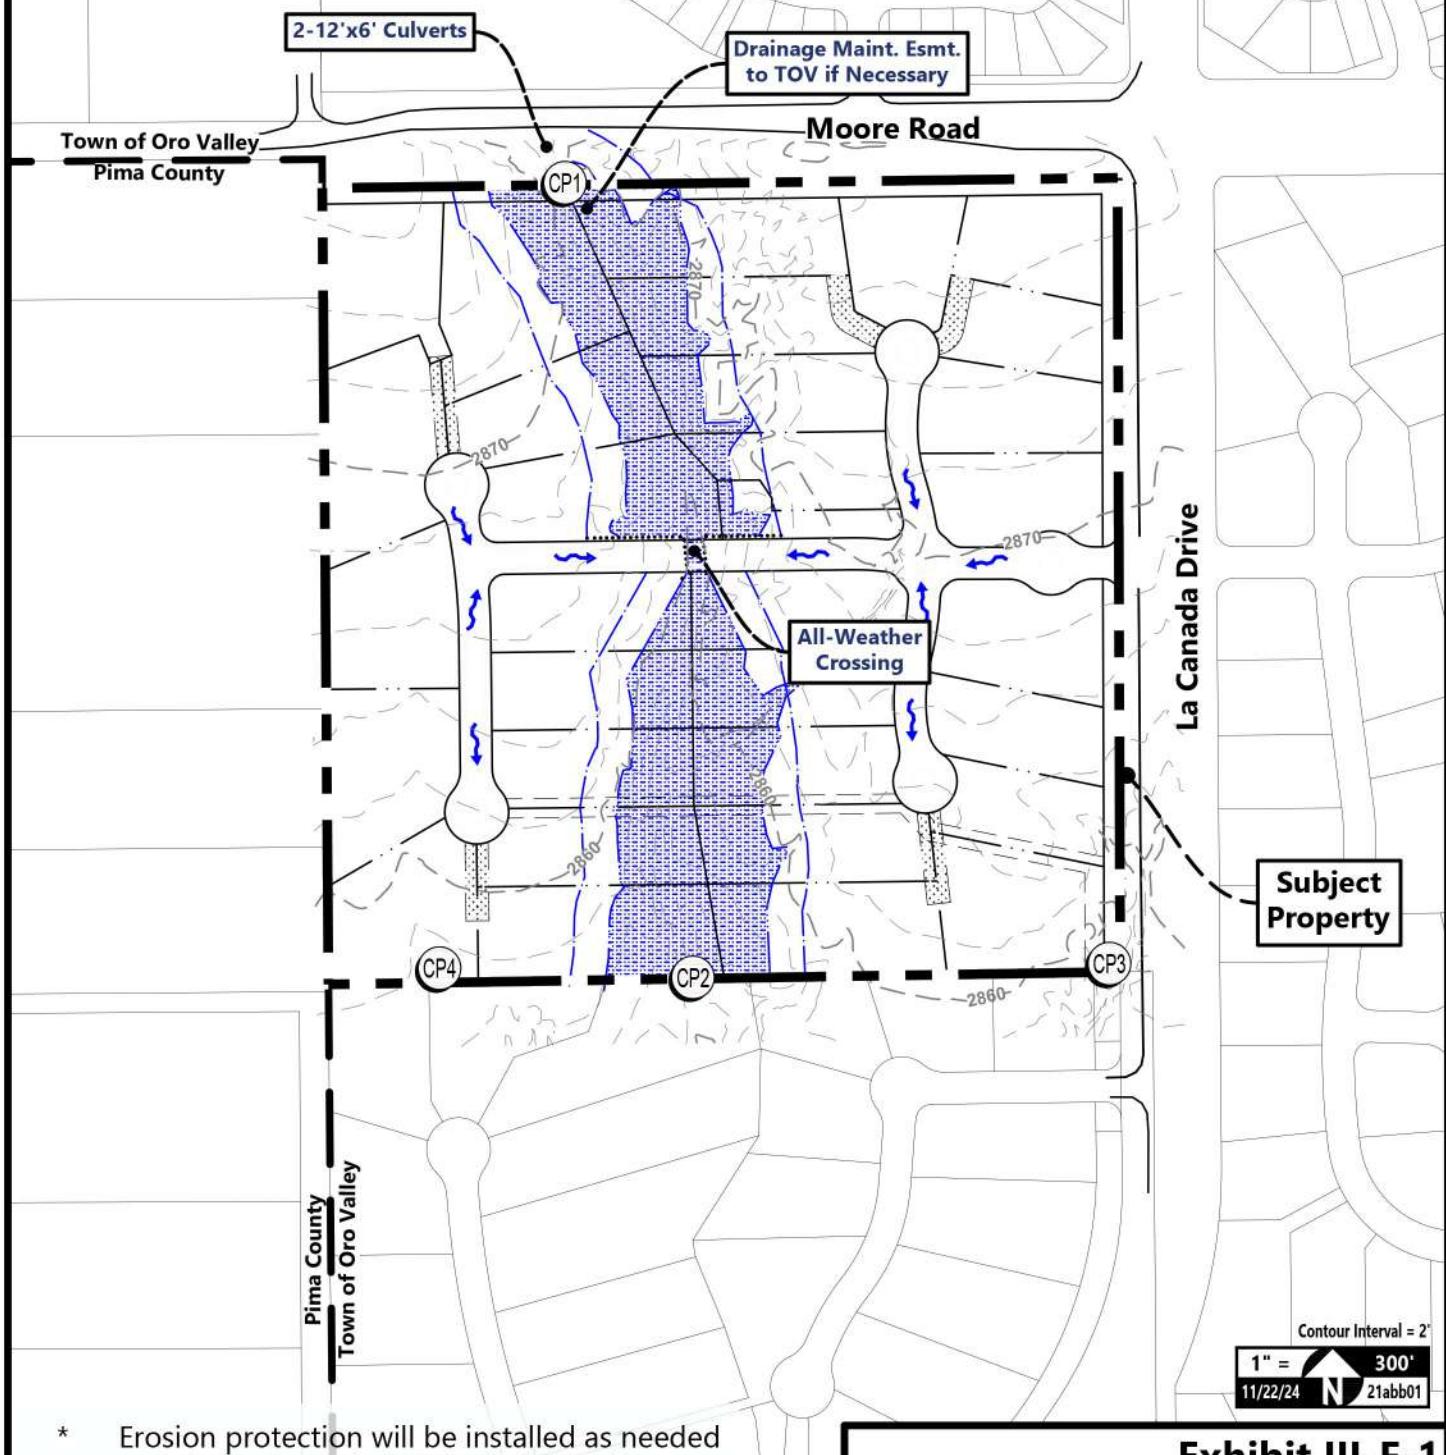
Exhibit III-F-1
Post-Development Hydrology

Basins will be Located within the Property as Needed to Meet OV Drainage Guidelines

* Erosion protection will be installed as needed and determined during the individual lot grading permit design and approval phase.

Onsite stormwater flows will generally continue to follow their existing patterns. The central onsite wash, which is the only regulated floodplain, will remain in its natural condition except for encroachments for the central roadway crossing, drainage infrastructure, utilities, and house pads. Stormwater that falls on individual lots will sheet flow around the house pads so that it generally continues to mimic existing conditions along the Property's downstream boundary. During platting the builder will determine if EHS encroachment is necessary for building pad construction. If it is necessary, the minimum 15' EHS will apply per Town Ordinance.

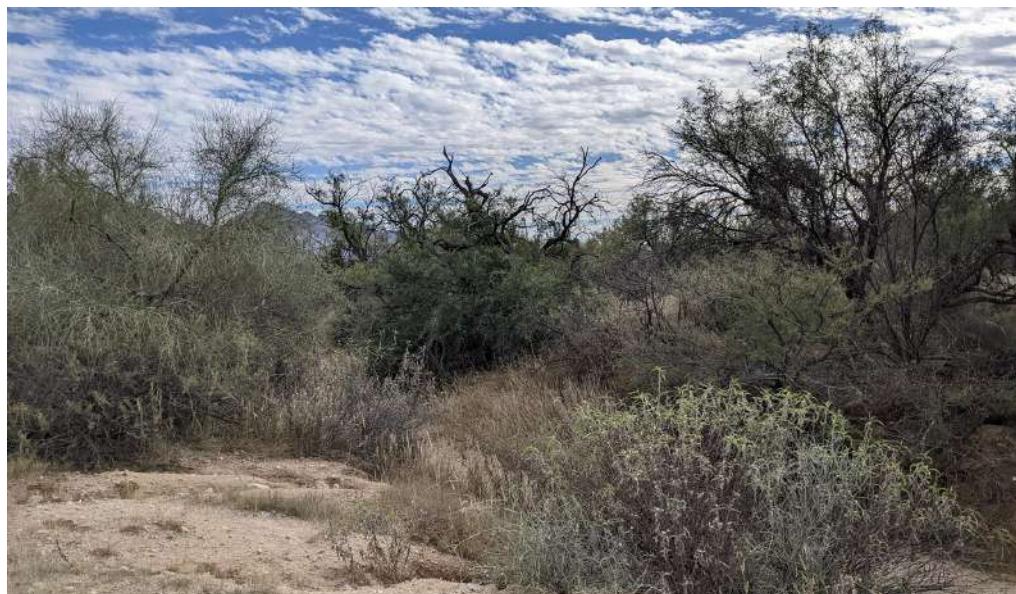
Mesquite and thornscrub species (hackberry, wolfberry, and greythorn) are relatively dense along the watercourse.

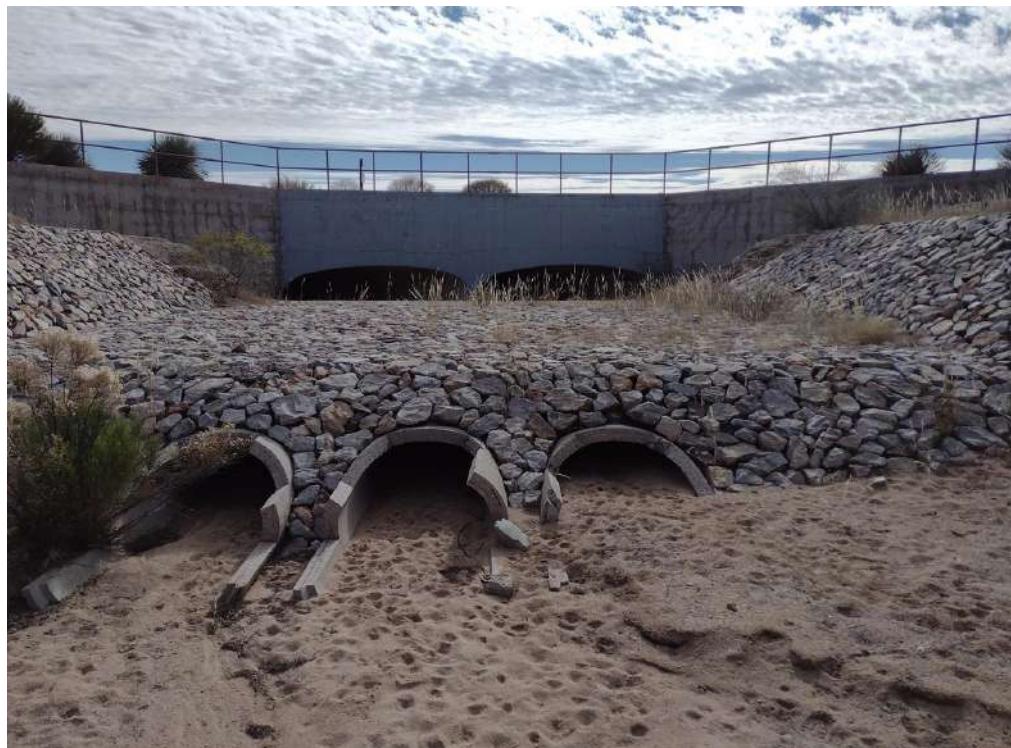
View looking south from the north side of Moore Rd. The watercourse flows under Moore and enters the project site. Wildlife tracks heading under Moore Rd. are abundant.

Rilling: There is significant rilling within the site (deep channels flowing into the watercourse) which is unusual. In review of Pima County aerial imagery, W. Moore Road was a dirt road in 2002. In 2005, Moore Road was widened and paved. The right of way north of the project site was entirely graded, except for a few trees at the NW end. Stabilization of this area (a slope from the roadway edge to the northern project boundary) was not successfully achieved. Over the years since the Moore Road construction, it appears that this area has been used as a construction staging area. In 2011 it appears to have been re-cleared. With no established vegetation on this slope to slow the flow of water and encourage infiltration, the flow of water into the project site has increased. It appears that the additional water flow has been a factor in the deep (several feet) rilling that flows into the site's central drainage course.

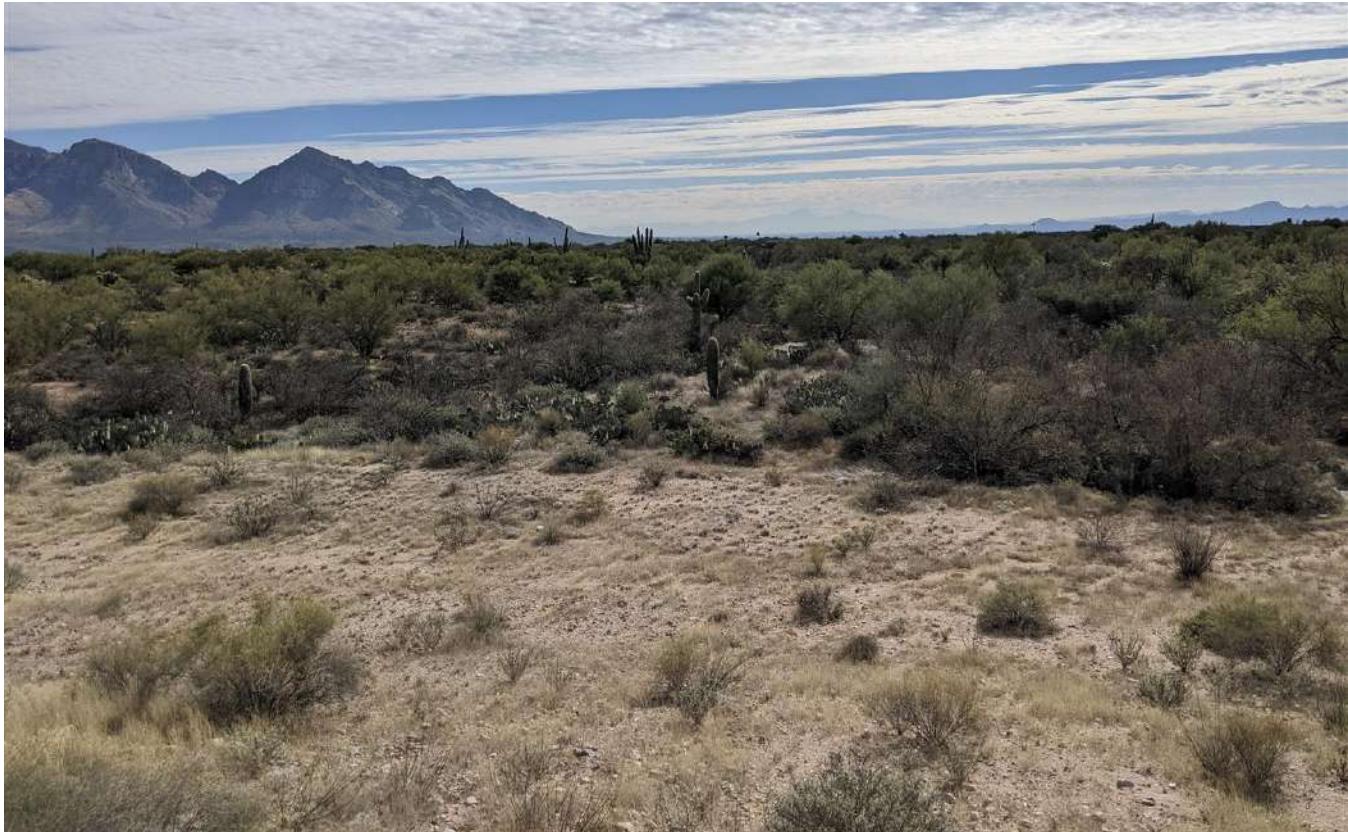
View looking south from Moore Rd, east of drainage culverts. Classic palo verde saguaro forest is on the left, xeroriparian vegetation (denser trees, heavy with mesquite and acacia) is evident in the background on the right.

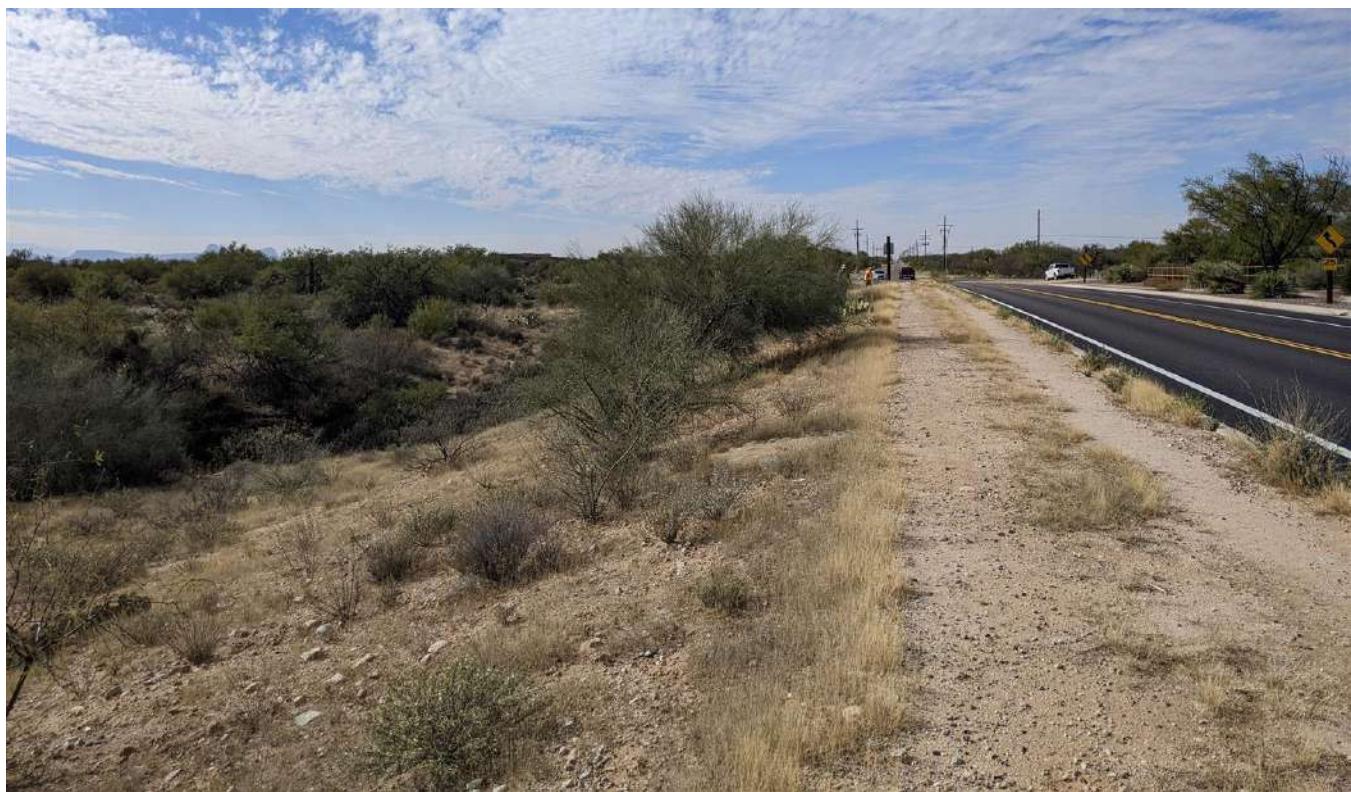
View looking west along Moore Rd. The project site is to the left, at the base of the slope.

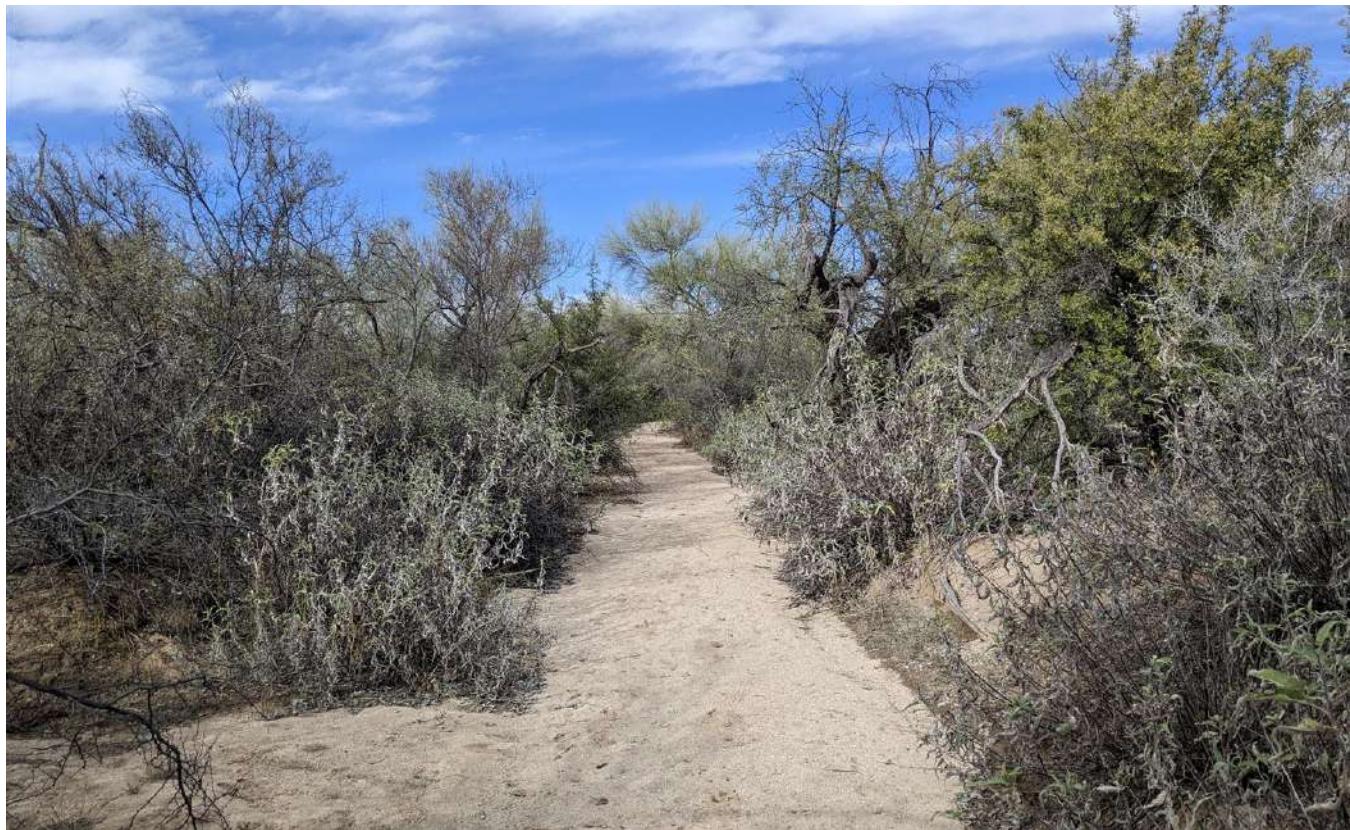
View looking north up the watercourse from the southern project site boundary.

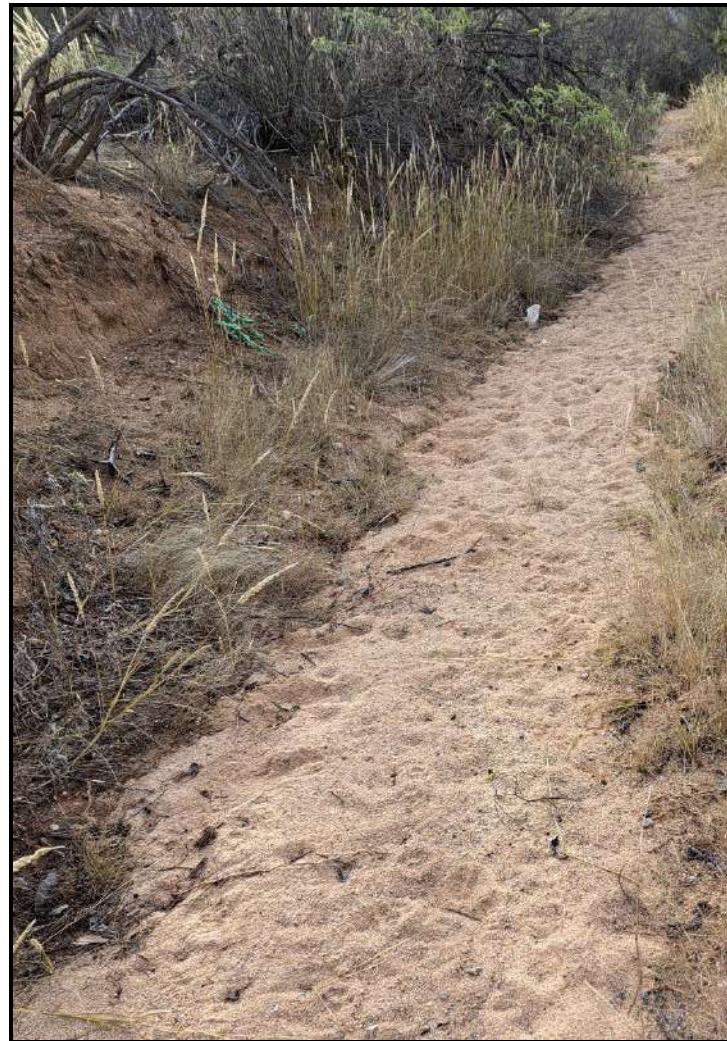
PHOTOGRAPH 6
Riparian Area/Wash Wildlife Tracks Found within
the Study Area

(Attachment 1: Photo 6) indicating extensive use of the area for wildlife movement between habitats. Wildlife tracks (primarily coyote and javelina) were also found throughout the study area.

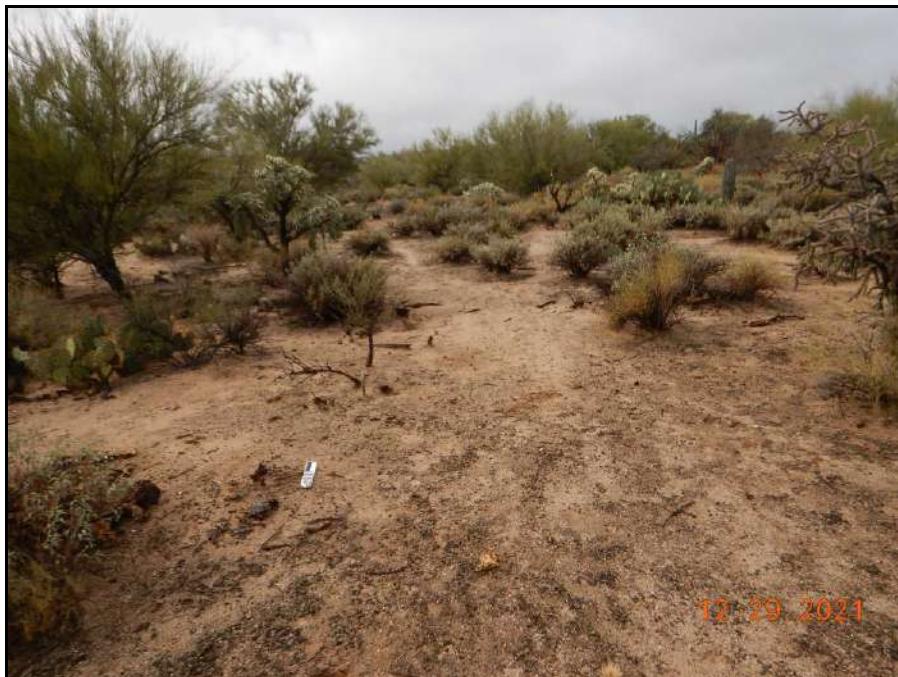
Photo 1. Project Area overview; view to north.

10. BUILT ENVIRONMENT: Modern, paved roads (West Moore Road and La Canada Drive) run along the north and east Project Area boundaries. Barbed wire fencing runs along the western edge of the Project Area. An informal walking trail trends approximately north-south along the west side of a large drainage near the center of the Project Area. Modern residential houses are south of the Project Area.

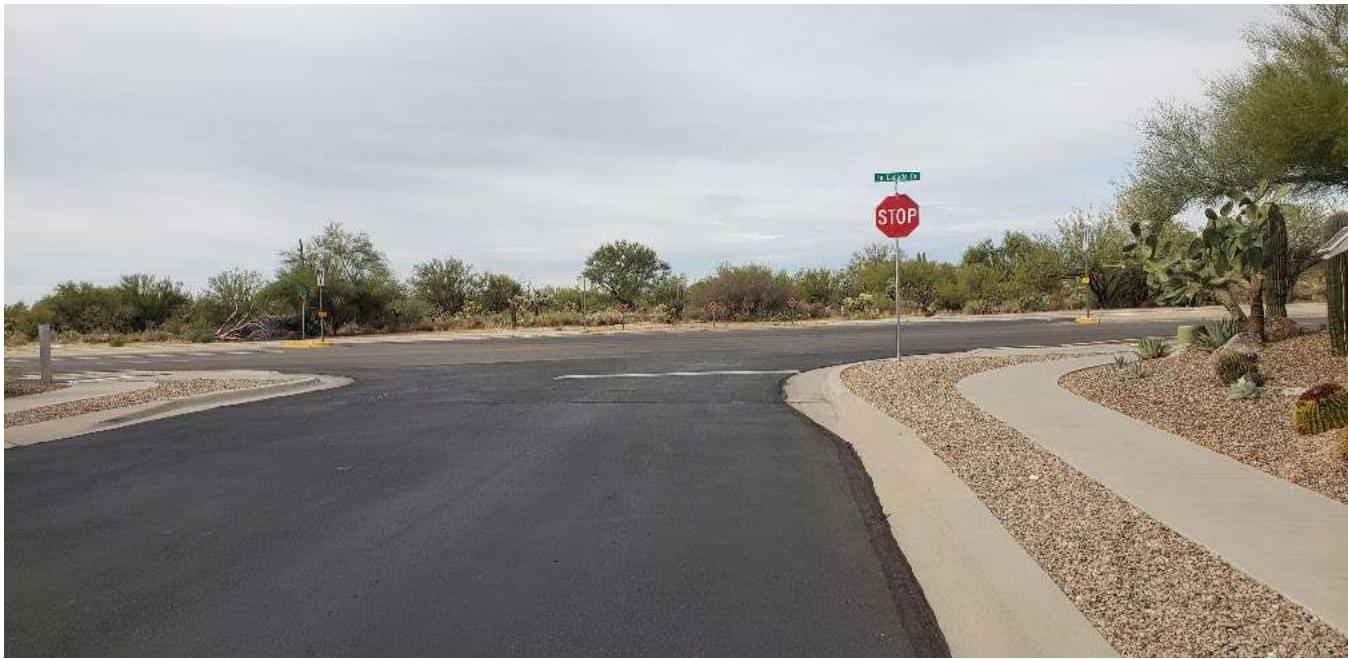
Looking West toward La Canada Drive from White Diamond Place. The project access will be opposite White Diamond Place.

Ground photos of the project area are provided in Exhibit 4.

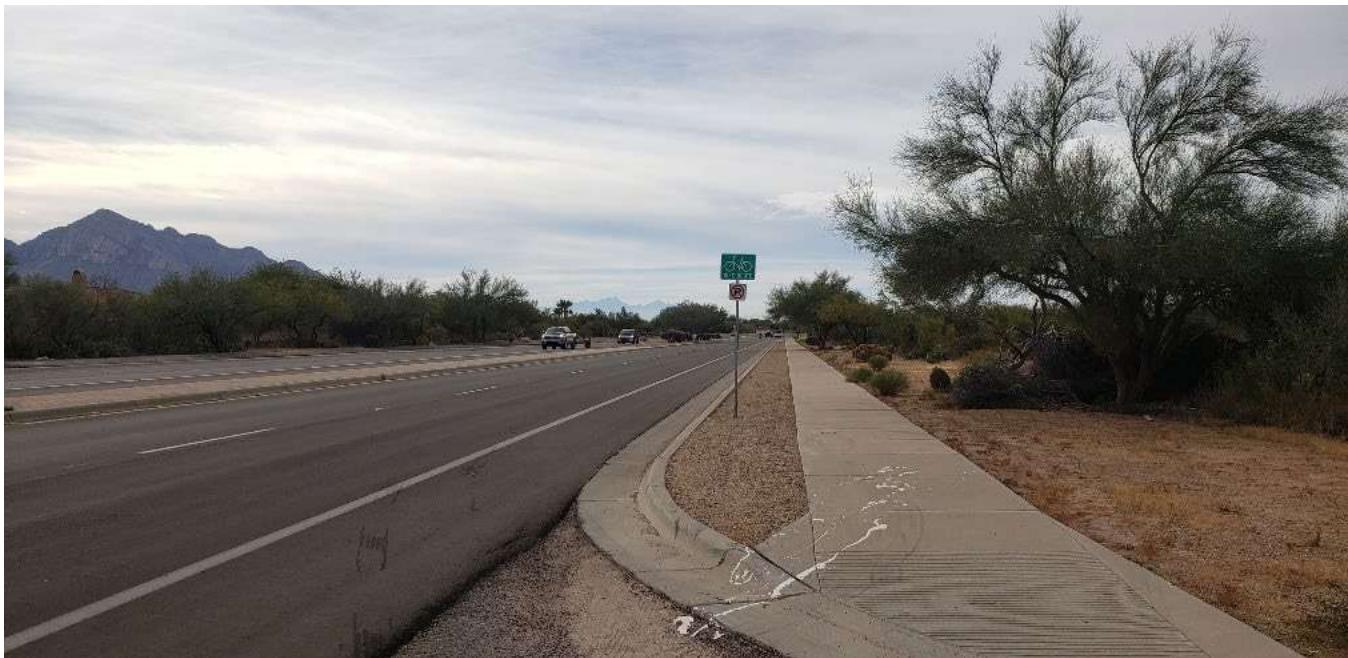
Looking South on La Canada Drive from the Project Access.

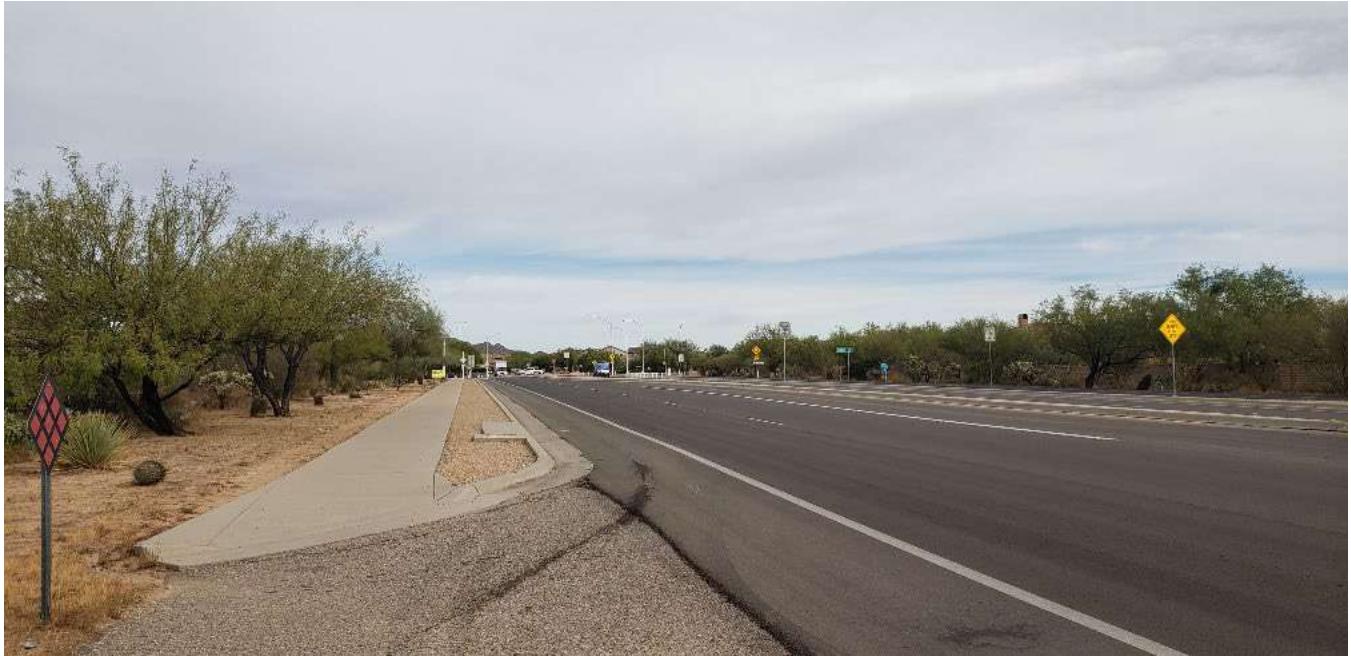
Looking North on La Canada Drive toward Moore Road from the Project Access.

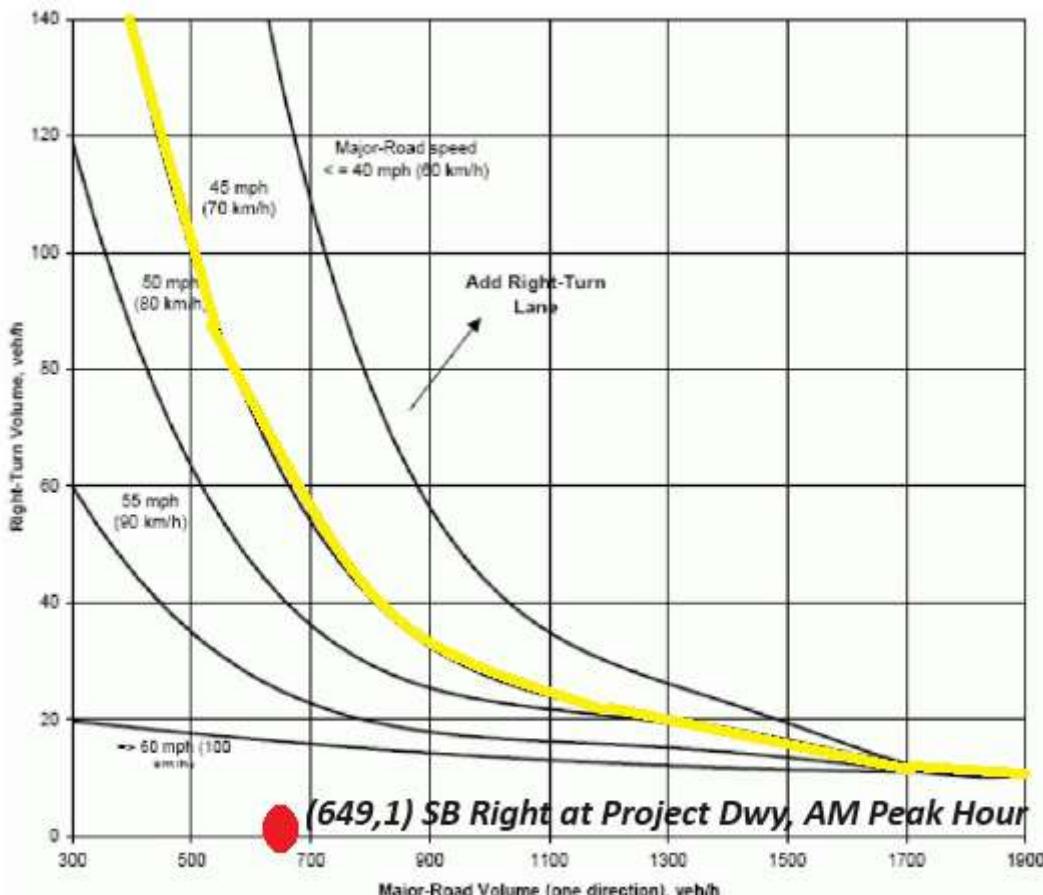
A-3 RIGHT TURN LANE GUIDELINES FOR FOUR-LANE ROADS⁹

Note: Existing roadway constraints may restrict the ability or need to install turning lanes. Traffic Engineering may require a traffic engineering analysis to support alternative recommendations for the installation of turning lanes.
