AVILLA RANCHO VISTOSO (WEST)

REZONING SITE ANALYSIS

(2200222)

DECEMBER 2022

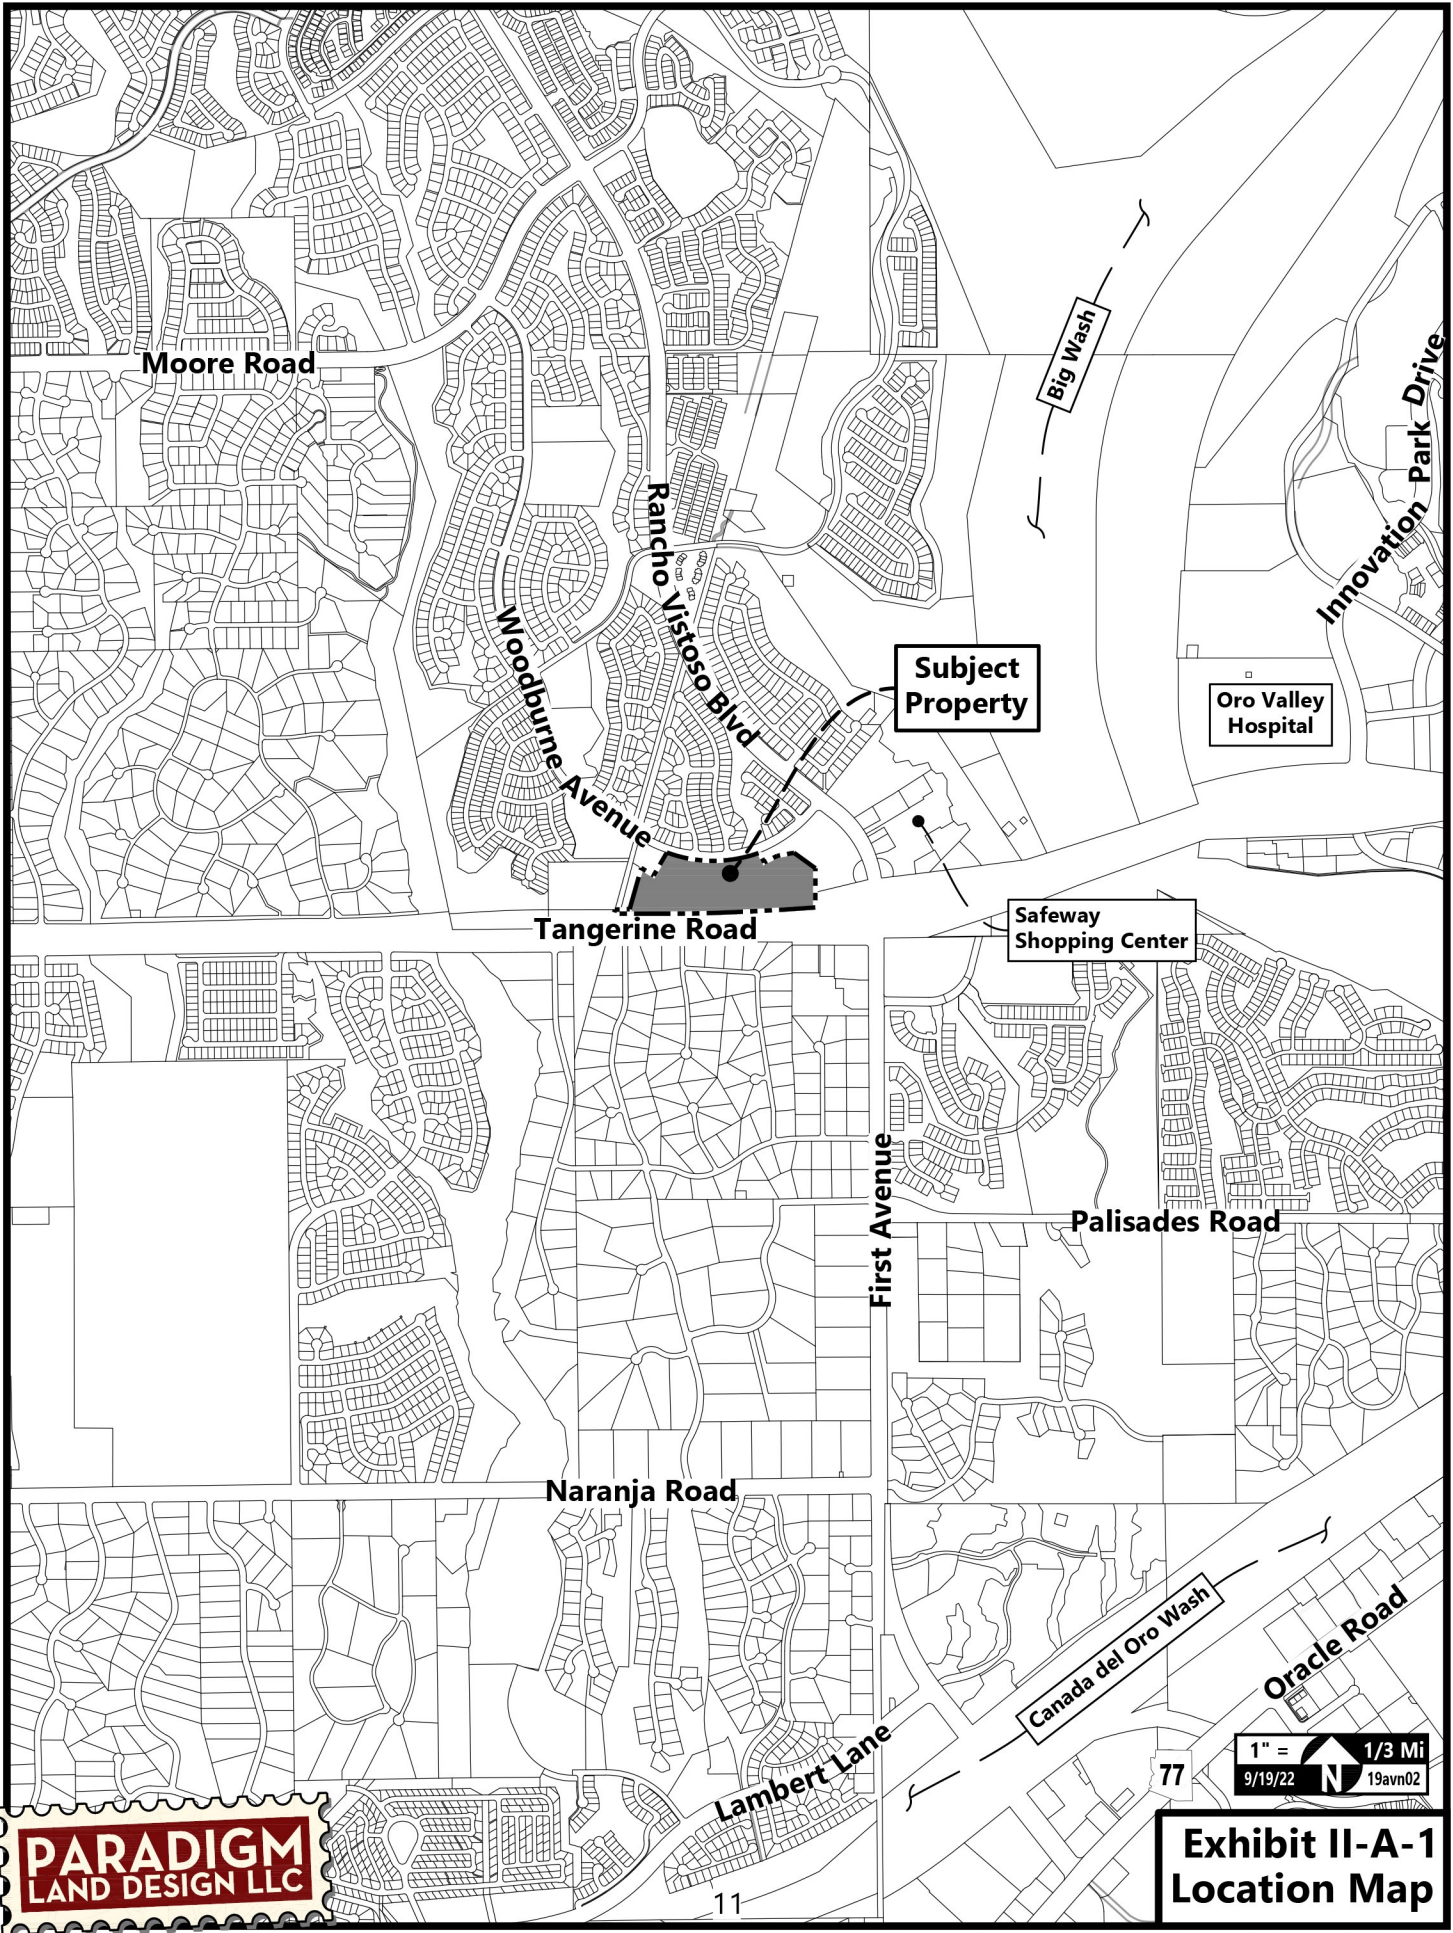
Exhibit II-A-1
Location Map

- Surrounding buildings are a mixture of one & two story, with residential structures up to approximately 24 feet and commercial structures up to 34 feet in height.

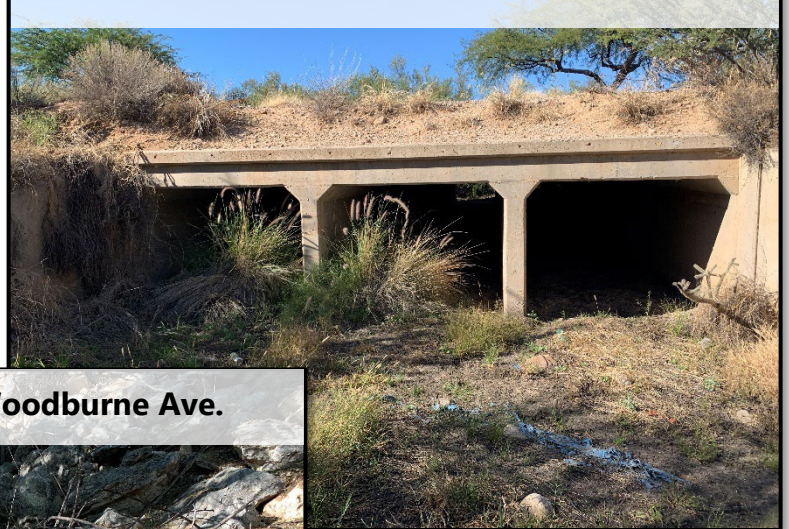
Eastern Culvert Under Woodburne Ave.

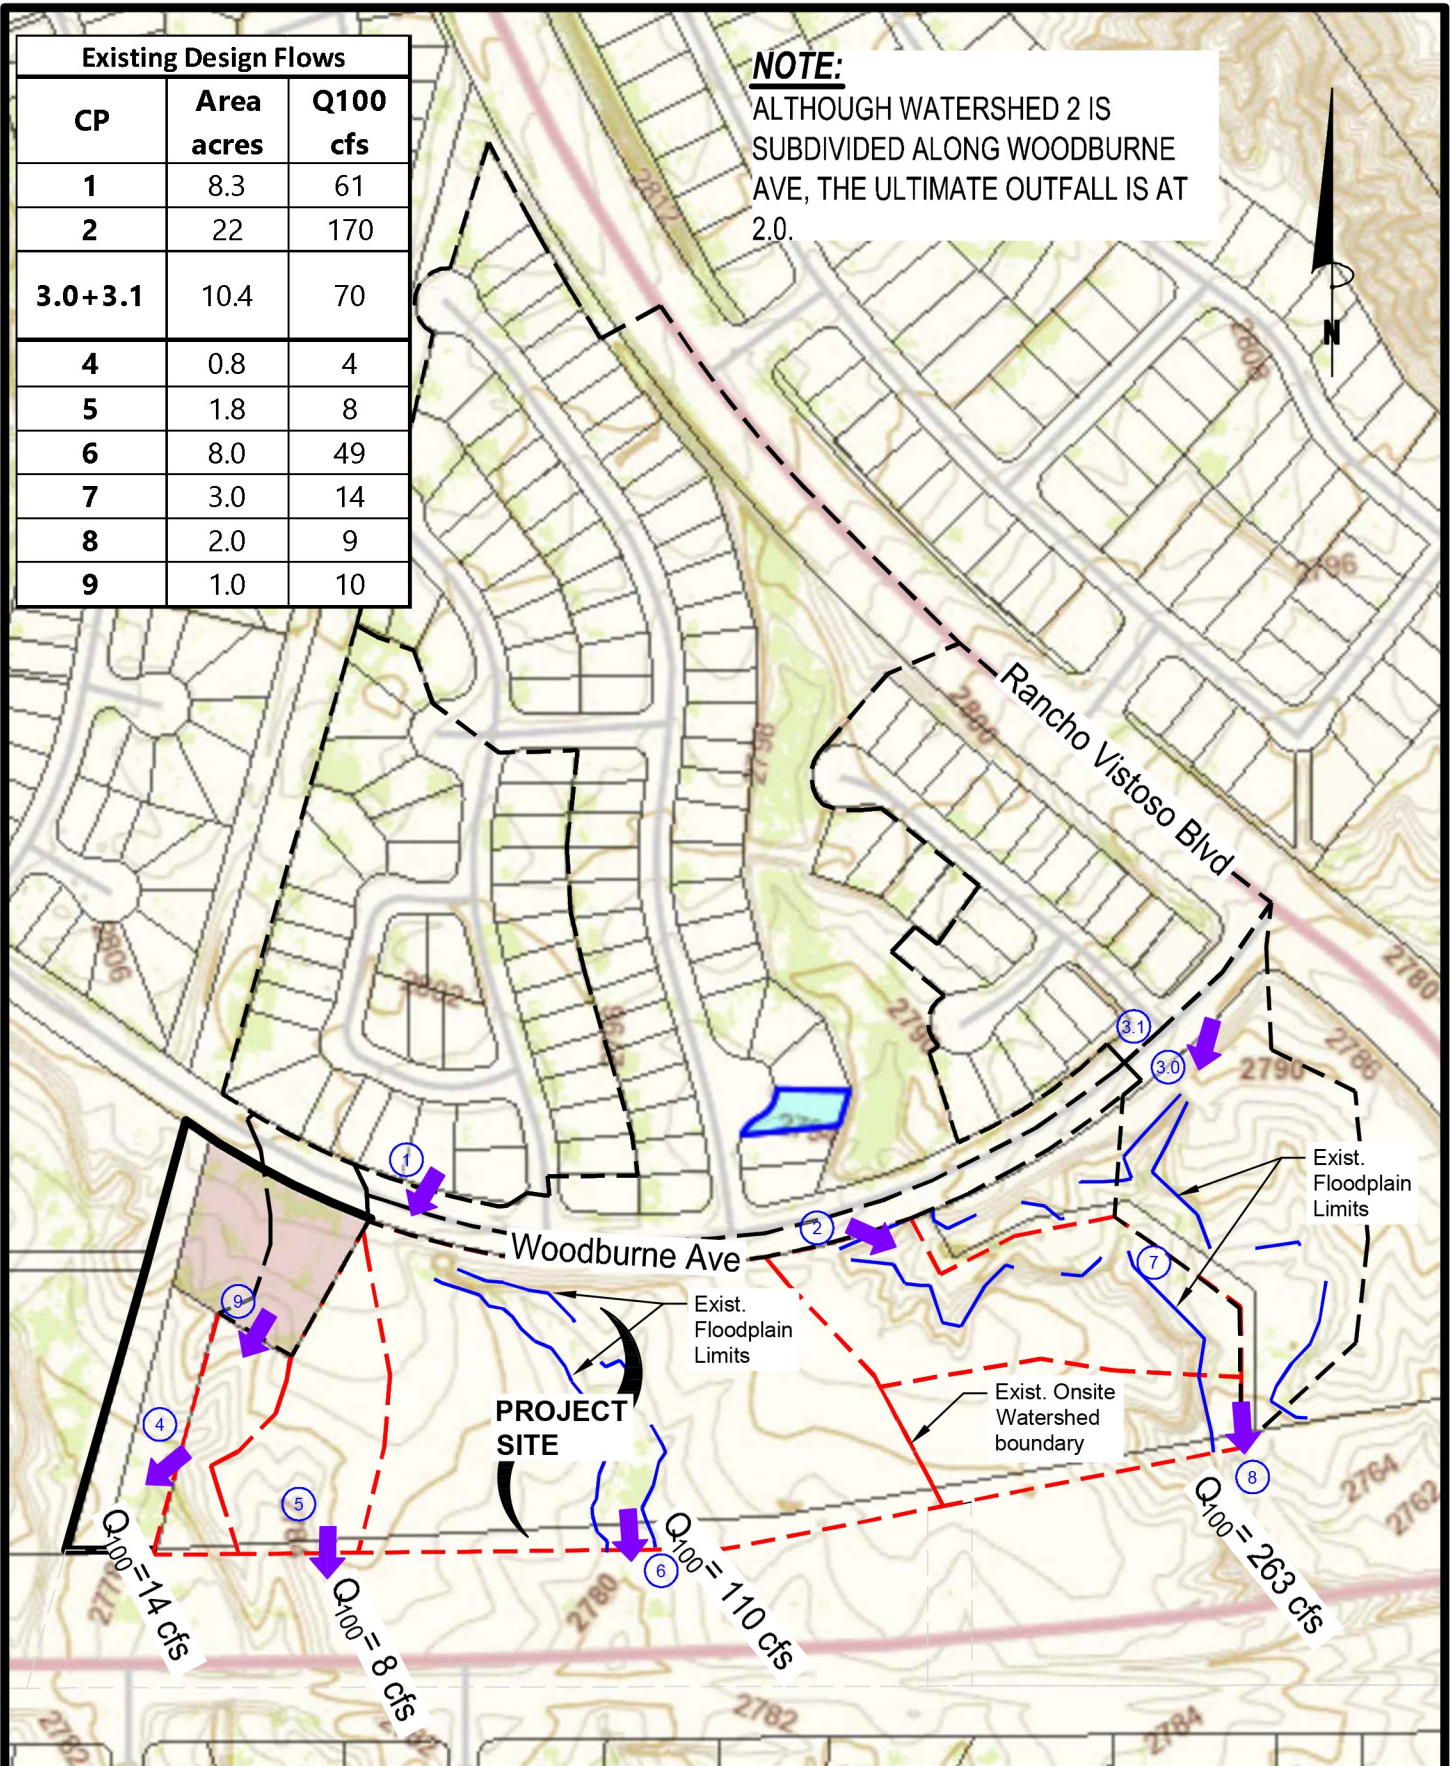
ALTHOUGH WATERSHED 2 IS
SUBDIVIDED ALONG WOODBURNE
AVE, THE ULTIMATE OUTFALL IS AT
2.0.

This section of the site analysis describes onsite and offsite hydrologic and hydraulic characteristics and is based on information provided by Bowman Consulting. Please refer to Exhibit II-E-1.

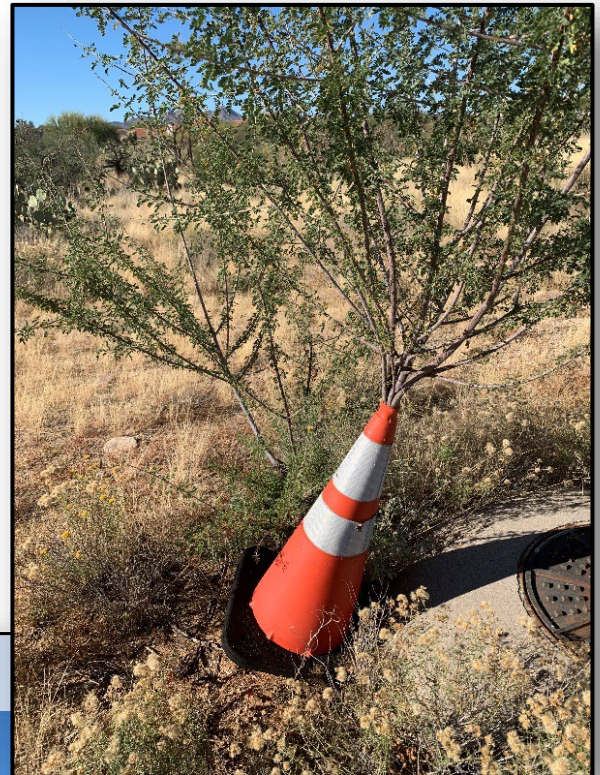
Typical Vegetation Onsite

Vegetative density of the Property is approximately 35% plant cover. See Exhibit II-F-1: Vegetation.

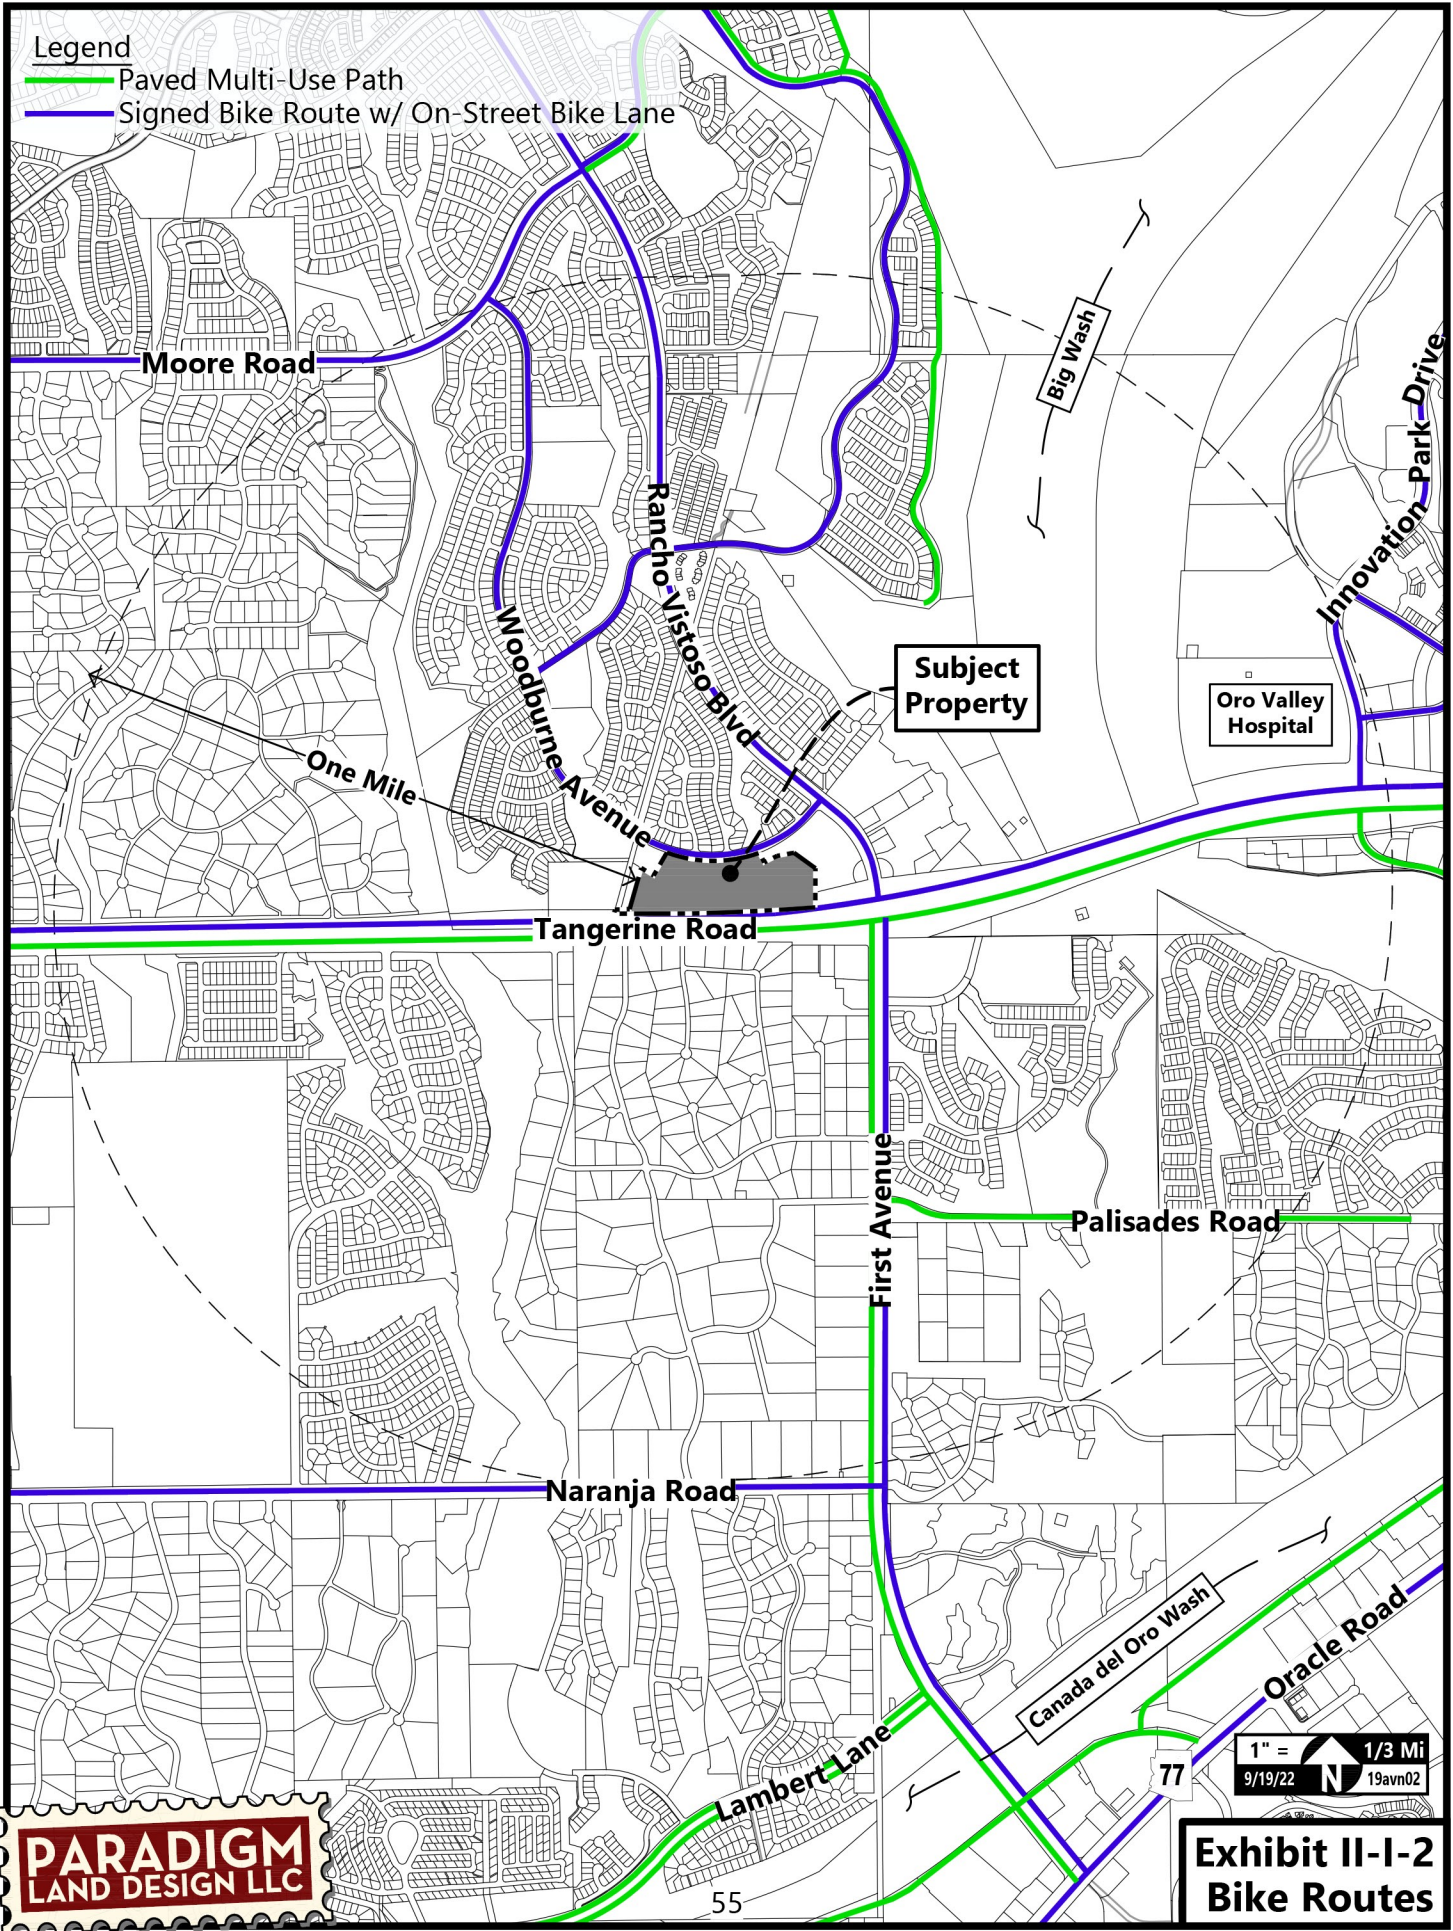
**Exhibit II-I-2
Bike Routes**

- Paved Multi-Use Path
- Signed Bike Route w/ On-Street Bike Lane

There is a signed bike route with on-street bike line that extends the entire length of Rancho Vistoso Boulevard from Tangerine Road to Oracle Road. On-street bike lanes and paved multi-use paths also exist the entire length of Tangerine Road and First Avenue. These routes provide connectivity to Painted Sky Elementary School, Copper Creek Elementary School, Honey Bee Park, the Woodshade Linear Park, Sunset Park, Hohokam Park and the greater Oro Valley / Pima County bicycle-pedestrian path system. See Exhibit II-I-2: Bike Routes.

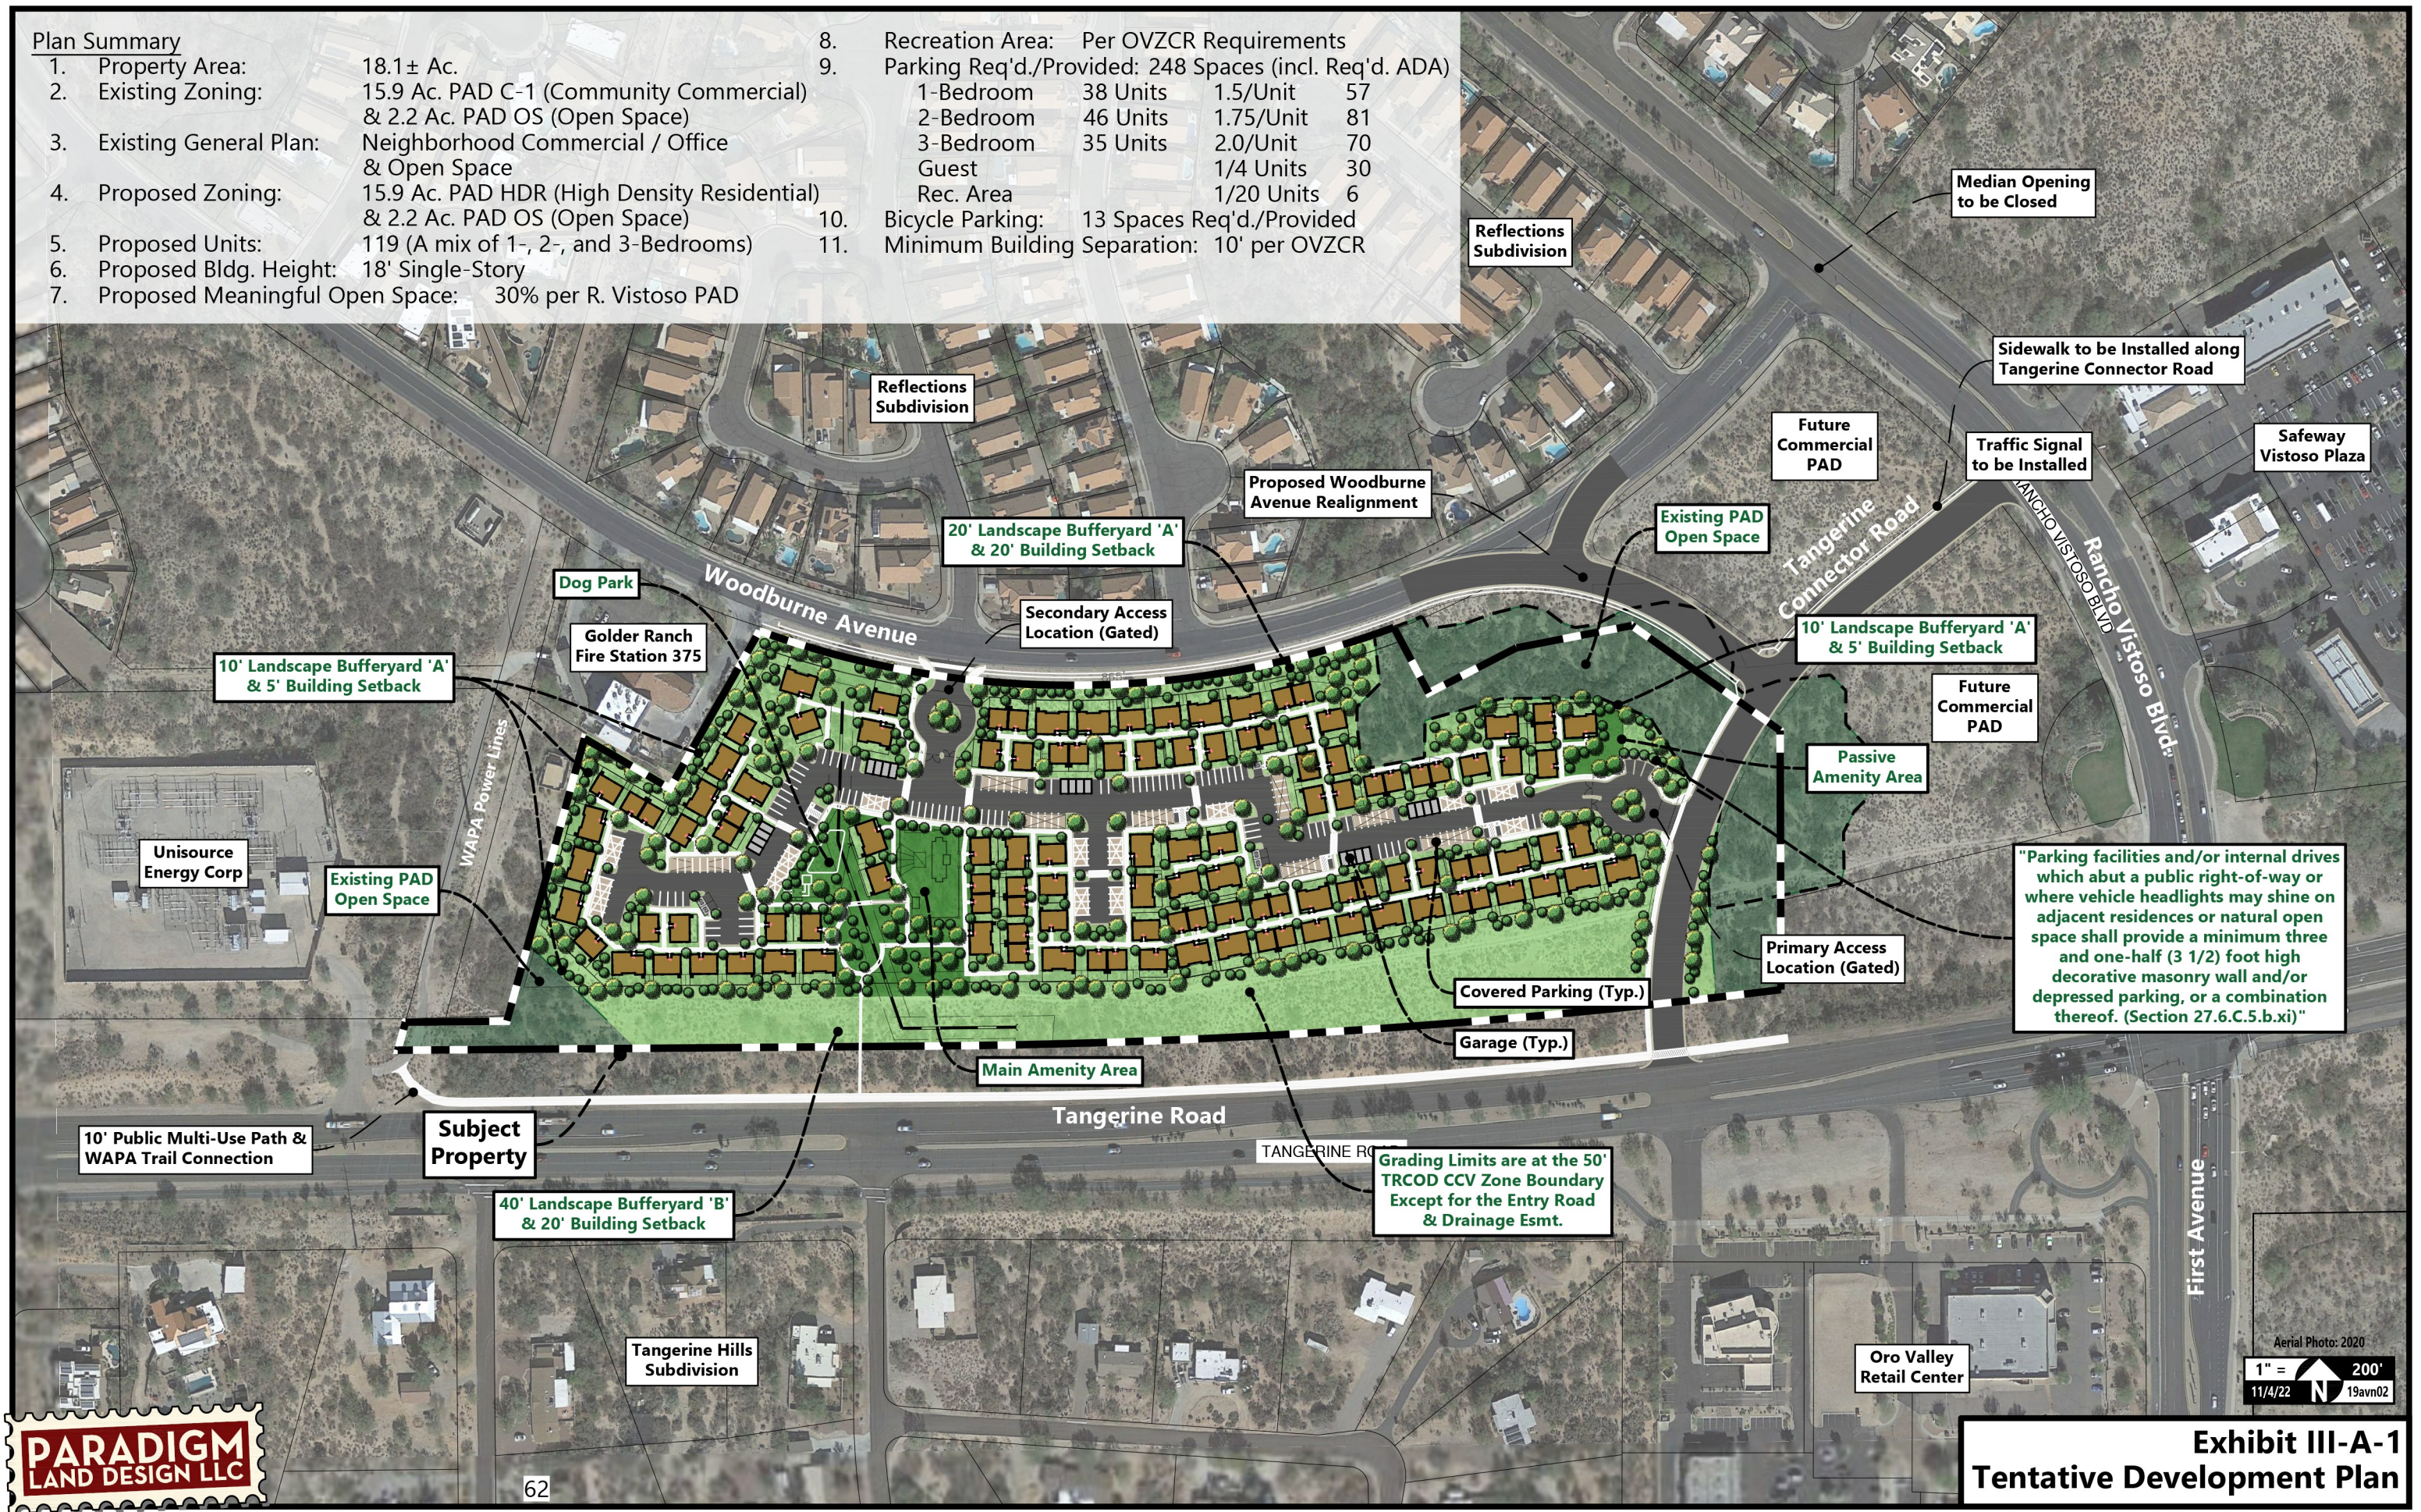
Exhibit III-A-1
Tentative Development Plan

1-Bedroom	38 Units	1.5/Unit	57
2-Bedroom	46 Units	1.75/Unit	81
3-Bedroom	35 Units	2.0/Unit	70
Guest		1/4 Units	30
Rec. Area		1/20 Units	6
10. Bicycle Parking: 13 Spaces Req'd./Provided
11. Minimum Building Separation: 10' per OVZCR

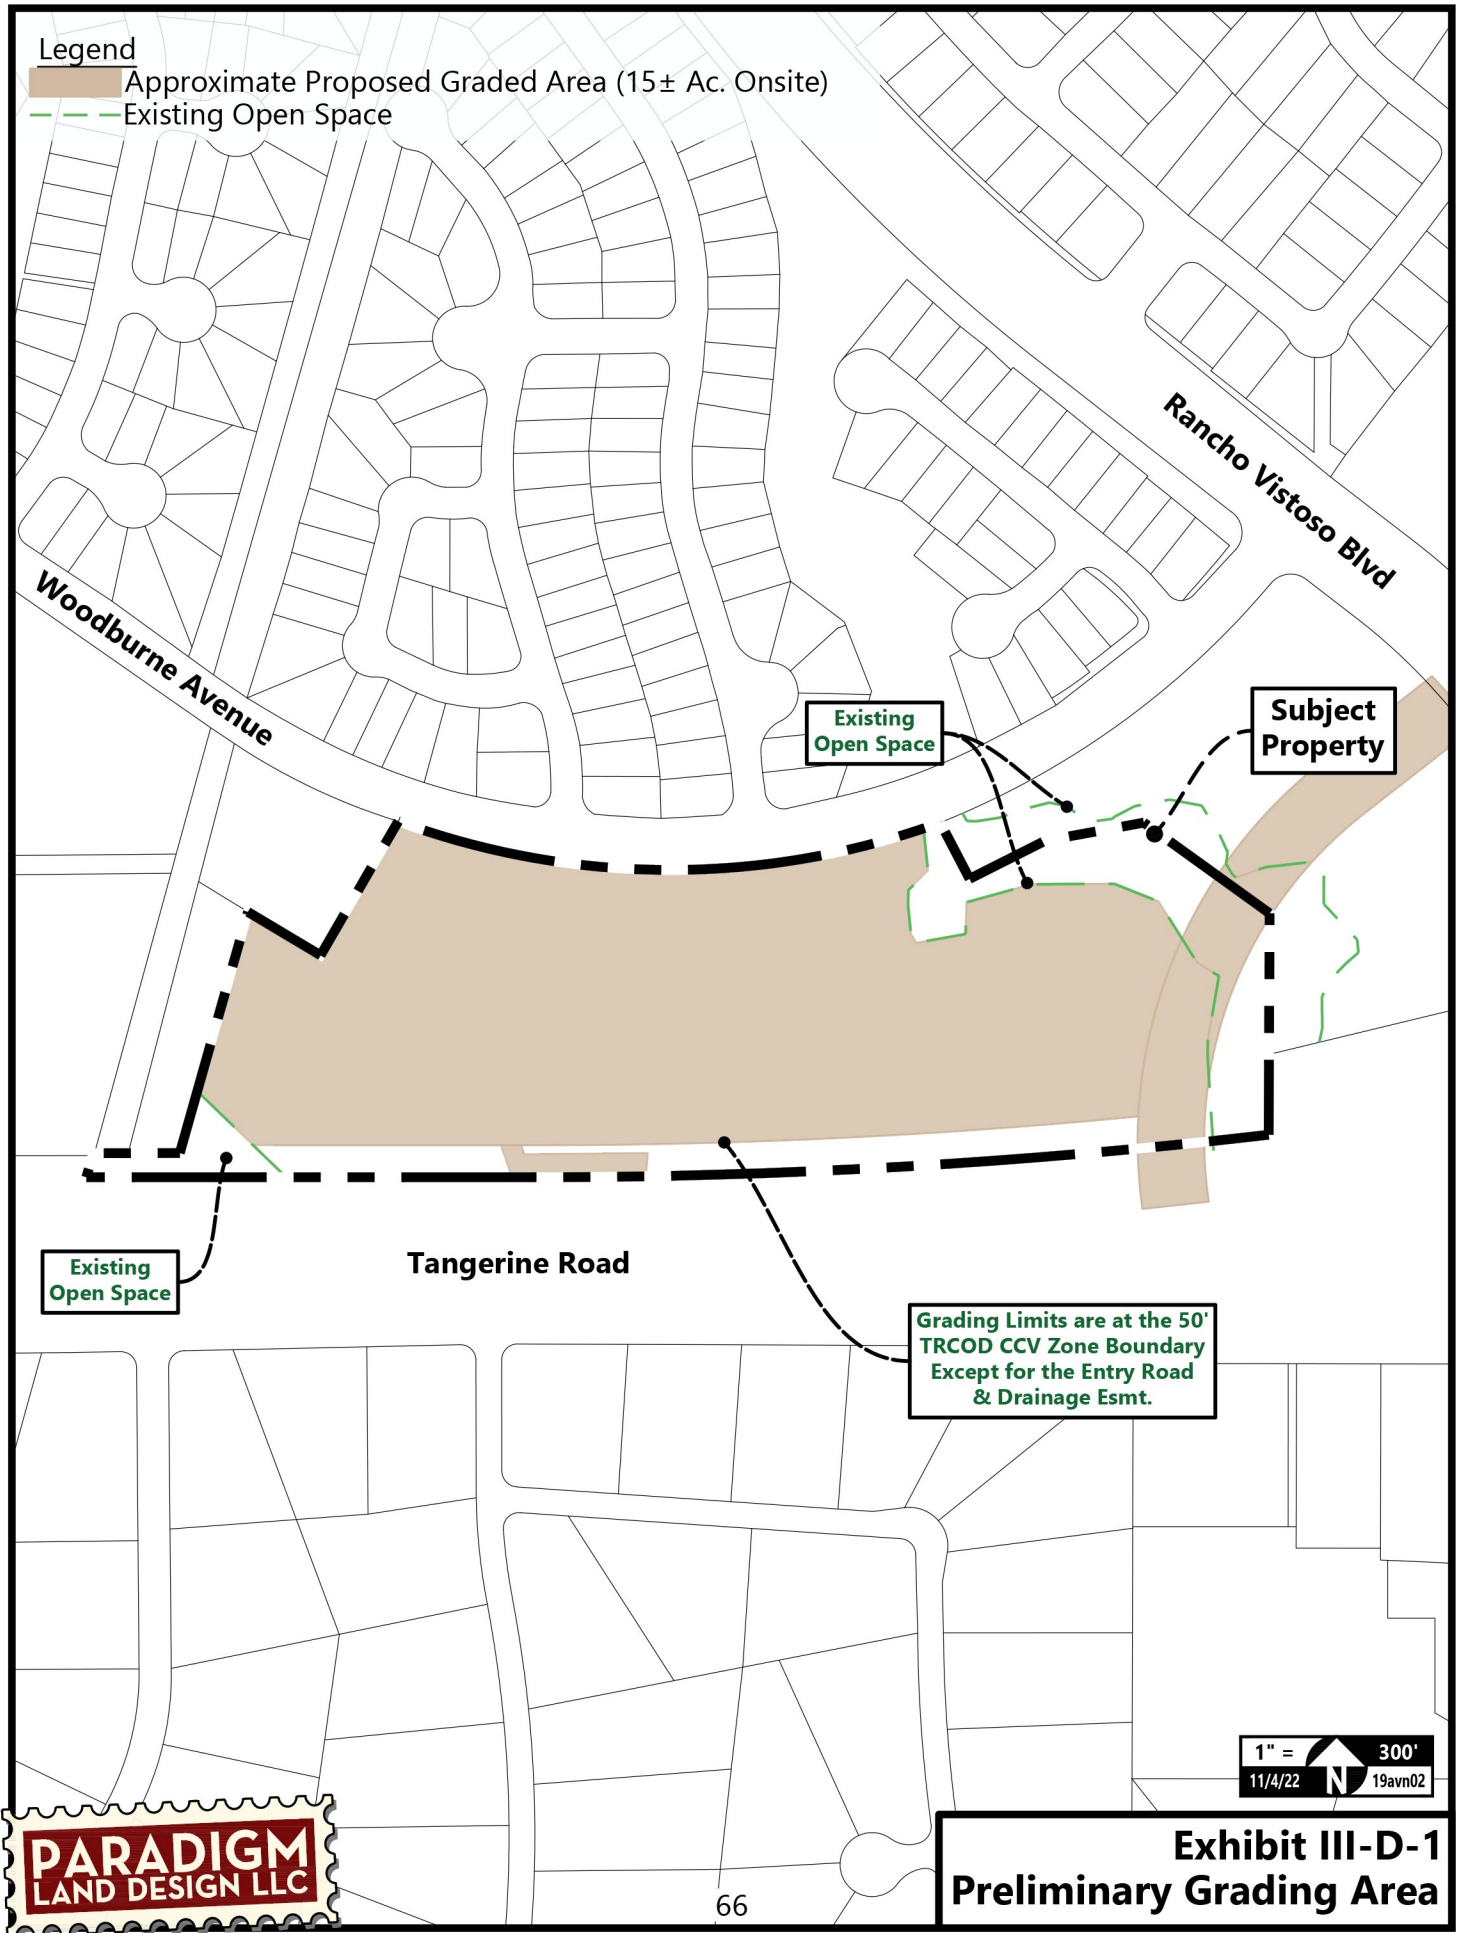
Exhibit III-D-1
Preliminary Grading Area

- Approximate Proposed Graded Area (15± Ac. Onsite)
- Existing Open Space

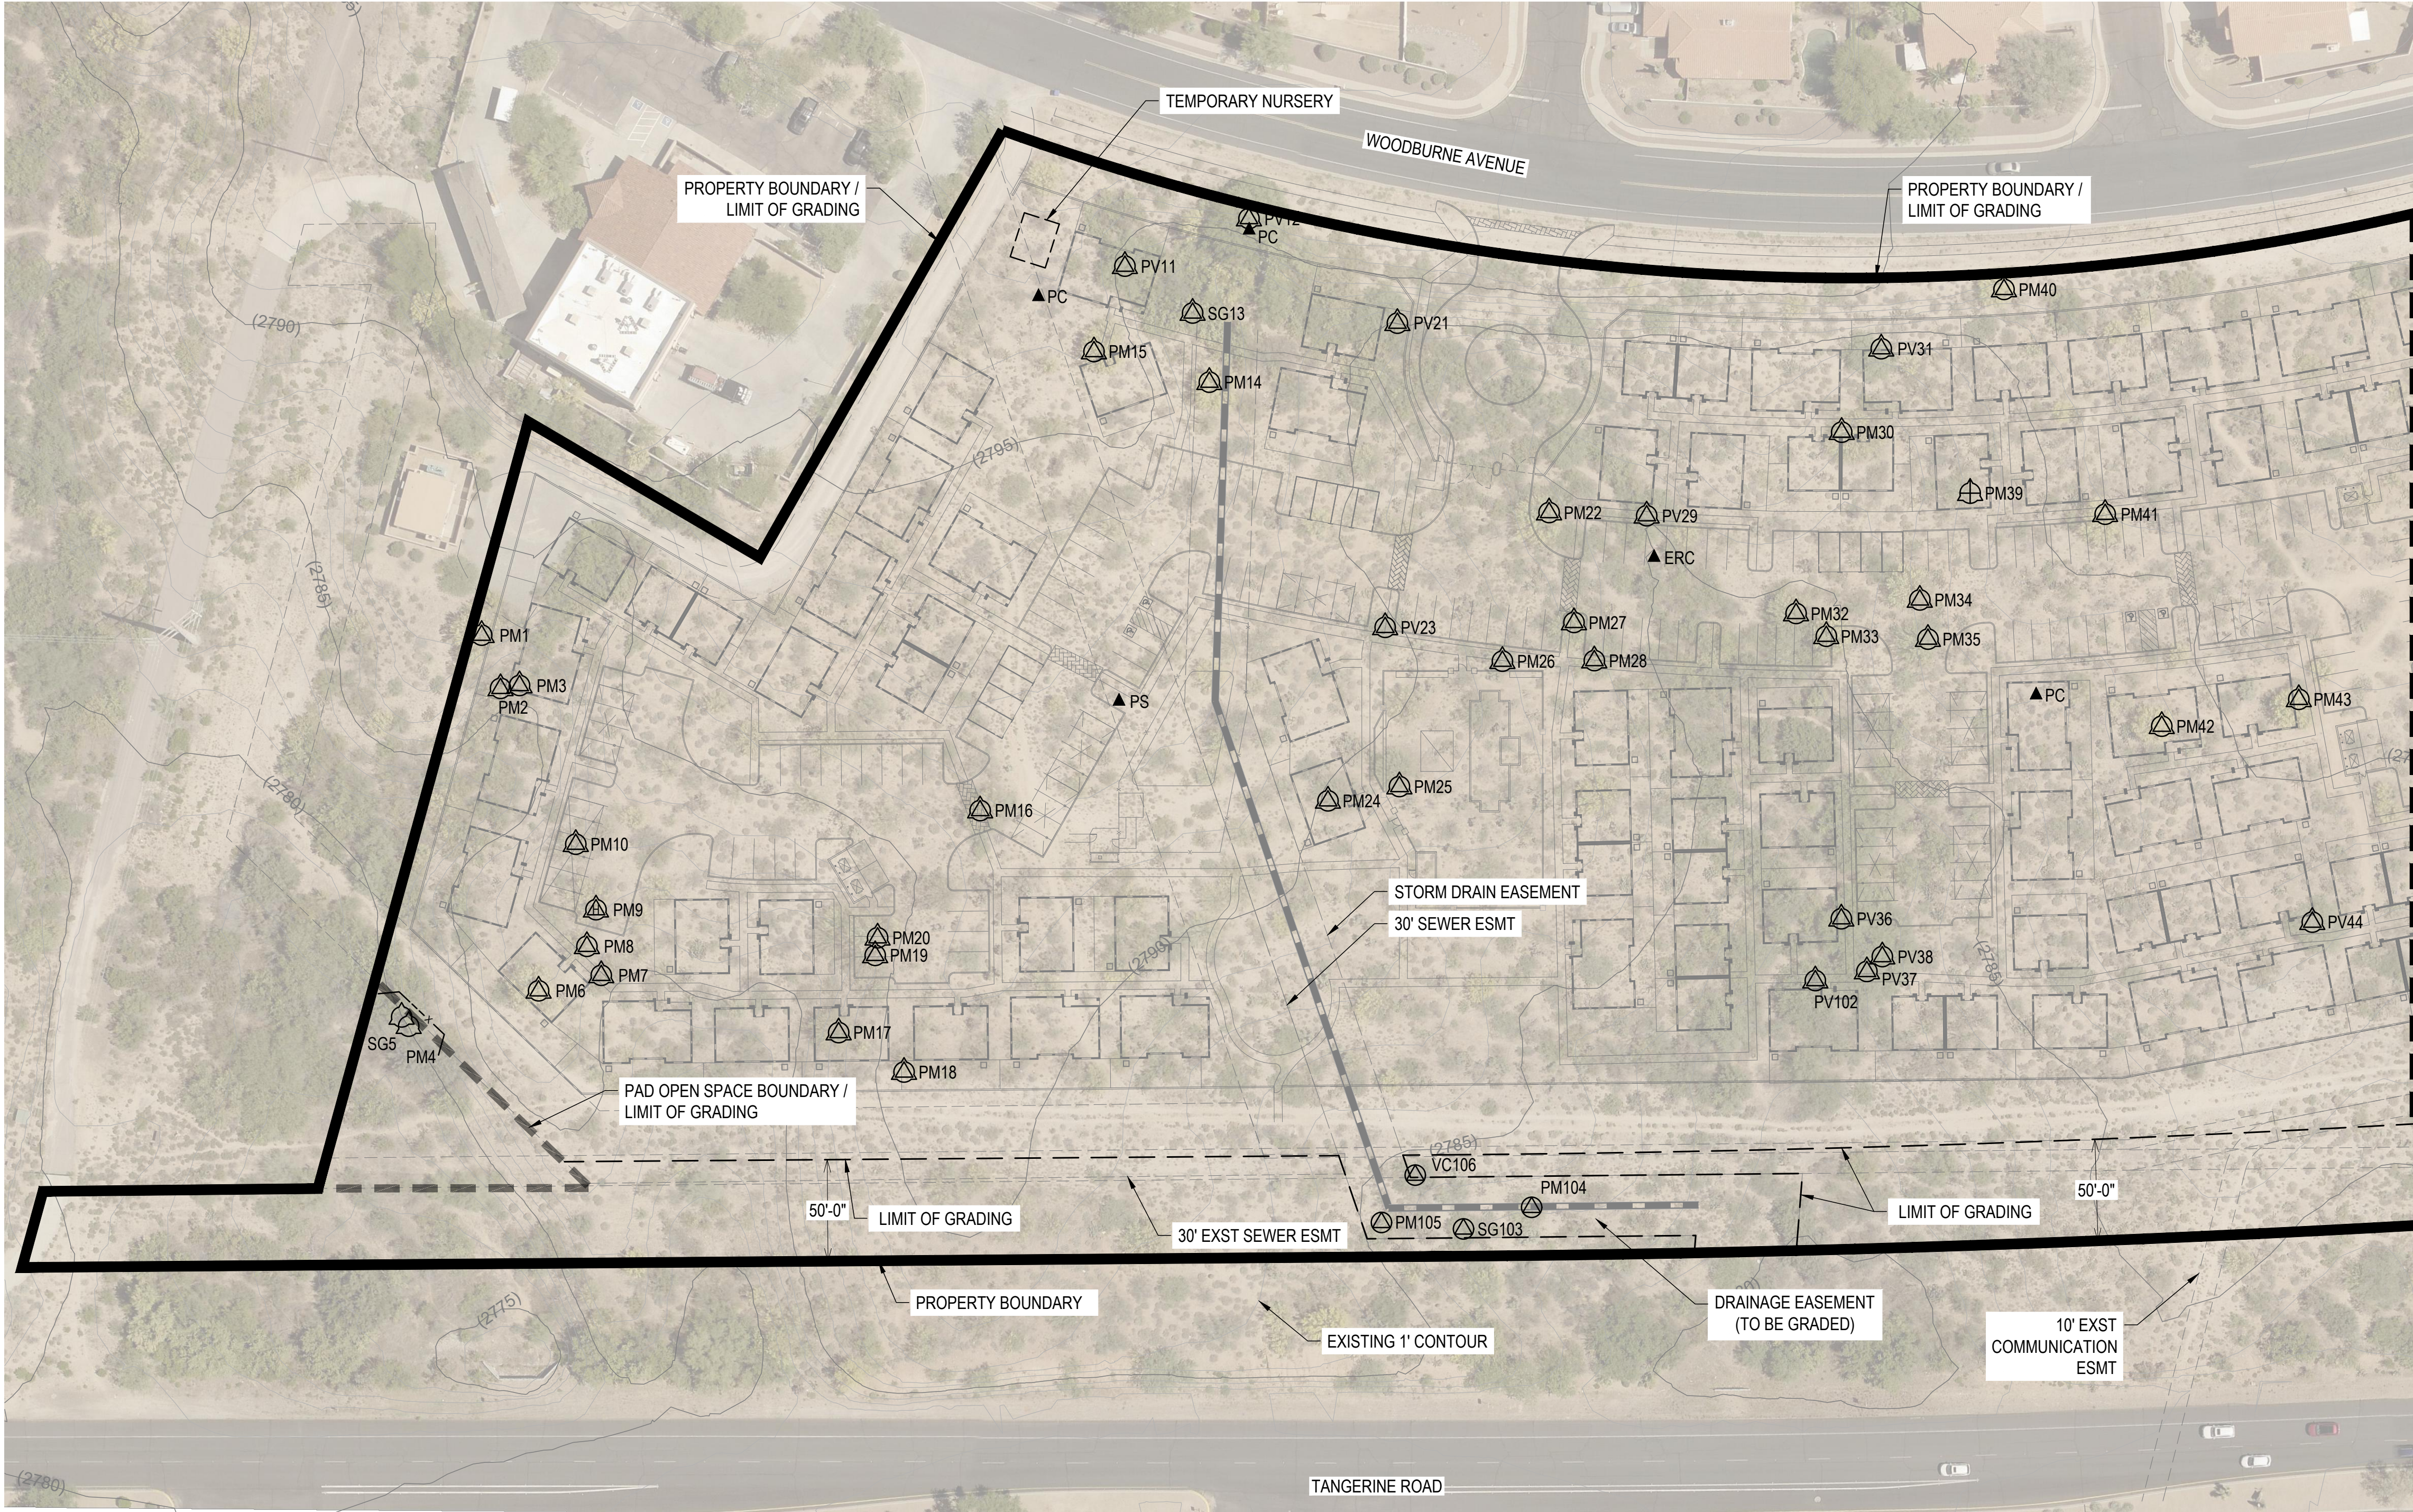
SITE RESOURCE INVENTORY PLAN

1. The Site Resource Inventory (SRI) was conducted in compliance with Town of Oro Valley (TOV) code requirements (TOV Zoning Code Section 27.6.B.3). Plants meeting the criteria for Significant Vegetation are shown on the SRI.
2. No stands of Significant Vegetation were noted.
3. Mitigation of Significant Vegetation shall be in accordance with TOV Zoning Code Section 27.6.B.4.j.
4. Significant Vegetation Information:
- a. Amount present within Grading Limits (canopy diameter assessed as two times the height of tree): 67,519 SF
- b. Amount being disturbed: 43,640 SF
- c. Total percentage disturbed: 65%
- d. Mitigation Ratio: 2:1
5. Required mitigation plants shall be reflected in the Landscape Plans for this project.

Required mitigation is per Table 27-1 and % Significant Vegetation disturbance. 102 Significant Trees were inventoried; 68 are designated for removal. One of the 102 trees is noted as untransplantable due to health. Percentage of viable Significant Vegetation to be removed from site (measured as the square footage of the ground cover area) is 65%.
