# Oro Valley Village Center

## Environmentally Sensitive Lands Ordinance Amendment

WLB Job No. 185050-WT-03  
July 5, 2020

Reference: Oro Valley Village Center (formerly known as the Oro Valley Marketplace) – Environmentally Sensitive Lands Critical Resource Area Site Assessment (RECON Number 9666)

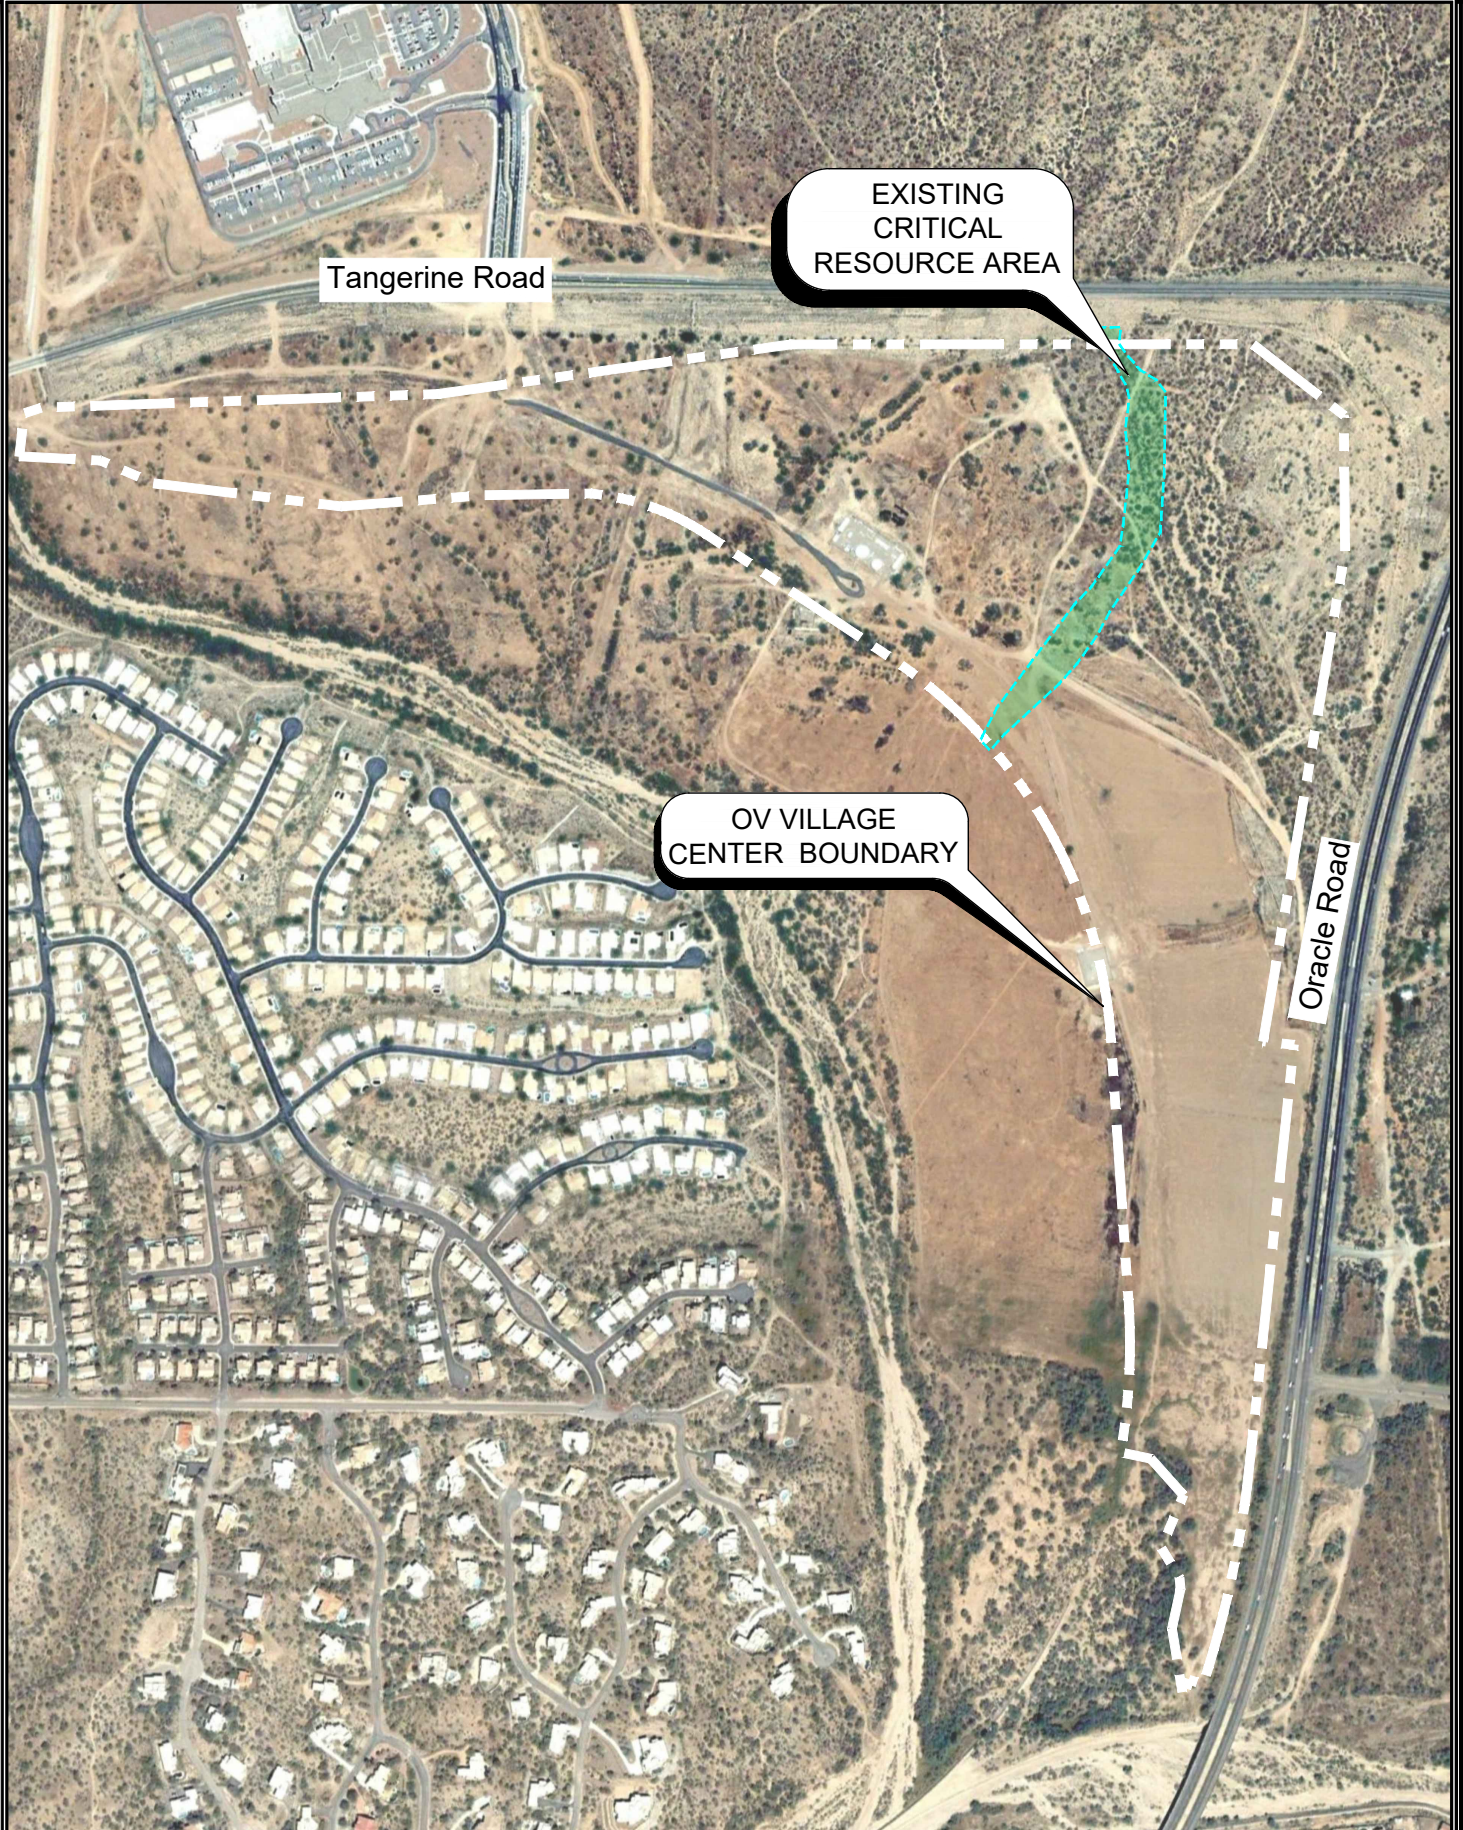
Tangerine Road

EXISTING  
CRITICAL  
RESOURCE AREA

OV VILLAGE  
CENTER BOUNDARY

Oracle Road

Please refer to *Exhibits A and B* which show aerial photographs from 2006 and 2018 and demonstrate how the site looked prior to development and how it looks in a more recent condition.

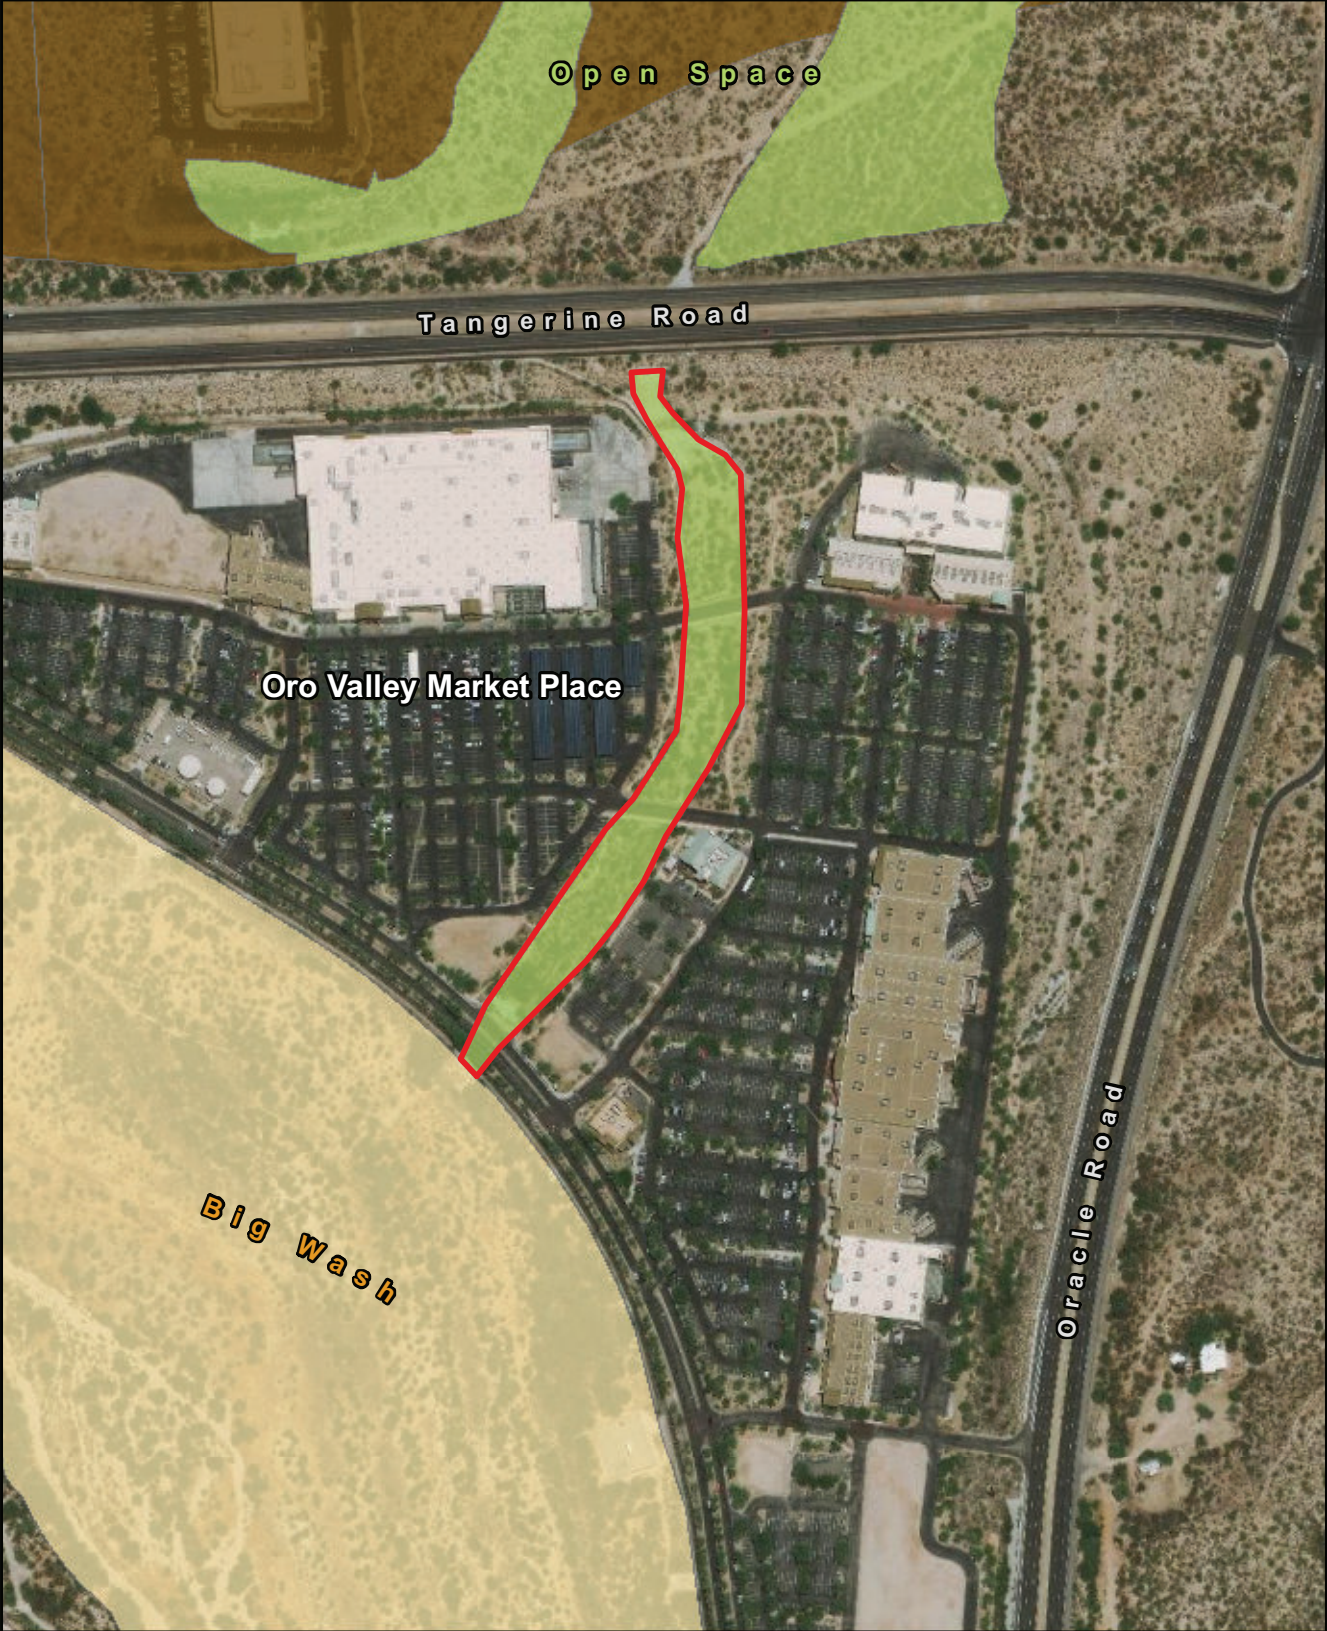
FIGURE 2  
Study Area

Study Area
-

Critical Resource Area
-

Major Wildlife Linkage
-

Resource Management Area Tier 3

Within the Oro Valley Village Center, the study area is currently located between developed and paved areas to the east and west, Tangerine Road to the north, and the internal Village Center access road to the south (see Figure 1). The study area is bisected by two access roads connecting the Village Center businesses. There is a large concrete drainage feature (concrete culverts, terraced concrete channels, and rock rip-rap channels) in the northern portion of the study area (Figure 2).

Big Wash, designated as a Major Wildlife Linkage under the ESL, is located south of the Village Center access road. An area zoned as Open Space and four areas designated as Critical Resource Areas are located north of the study area and north of Tangerine Road (see Figure 1).

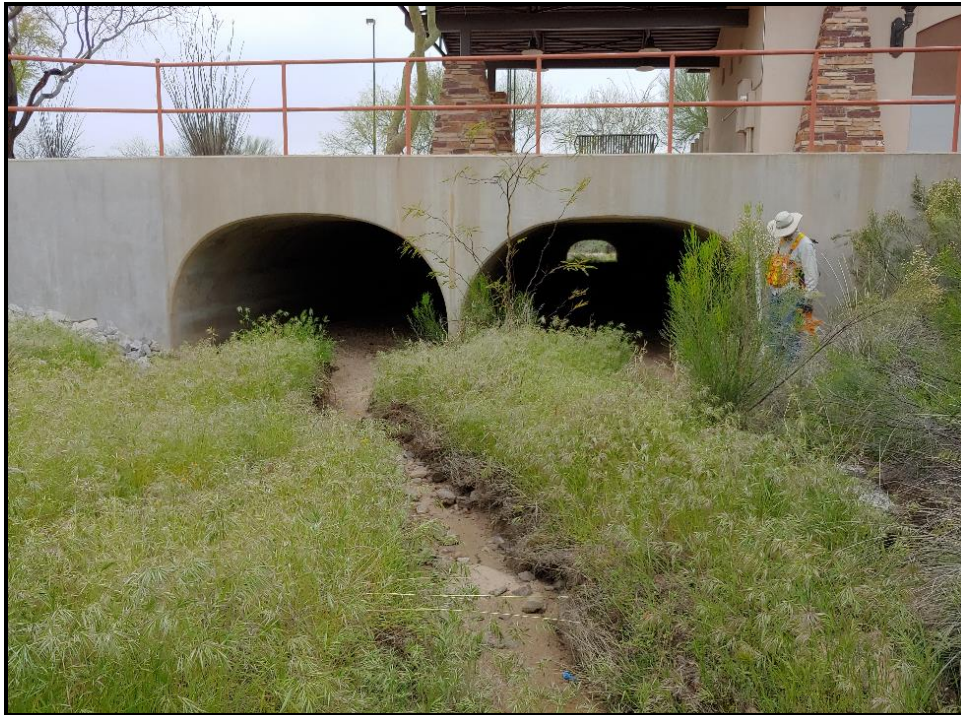
**PHOTOGRAPH 19**

Southern Culvert over Marketplace Access Road that Leads to  
Open Space and Big Wash

Wildlife tracks (primarily coyote and javelina) were found throughout the study area. In addition, wildlife tracks were found outside and within culverts located at the north end, central portion, and south end of the study area. Wildlife tracks were also found within the culvert leading to the study area that passes under Tangerine Road as well as at the exit of the culvert located at the southern end of the study area leading to Big Wash.

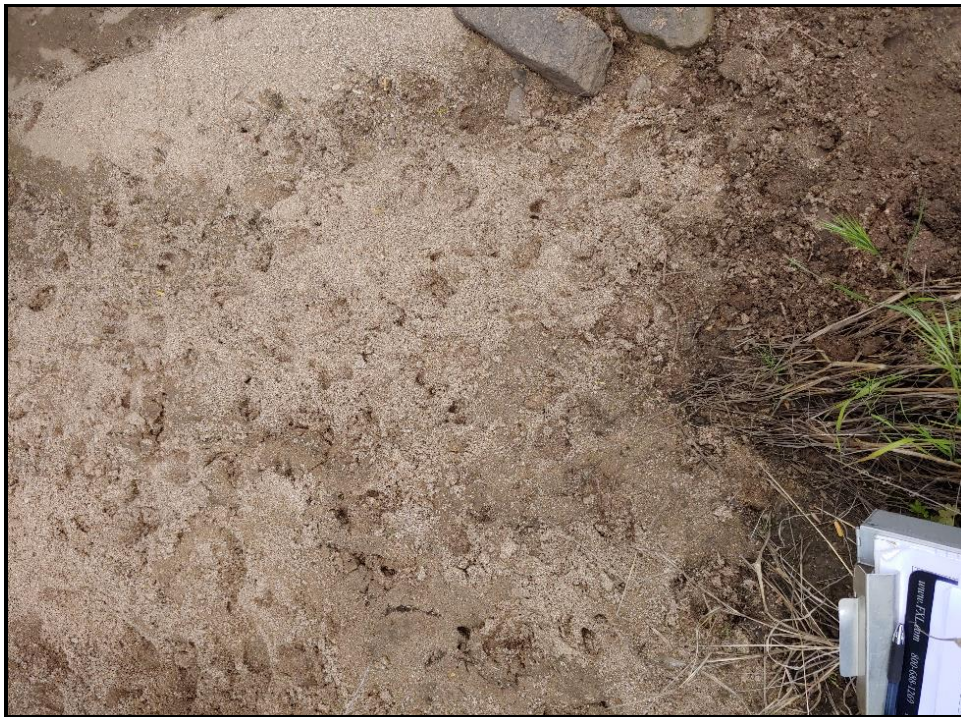
**PHOTOGRAPH 20**

Javelina Tracks at Southern Culvert to Open Space and Big  
Wash

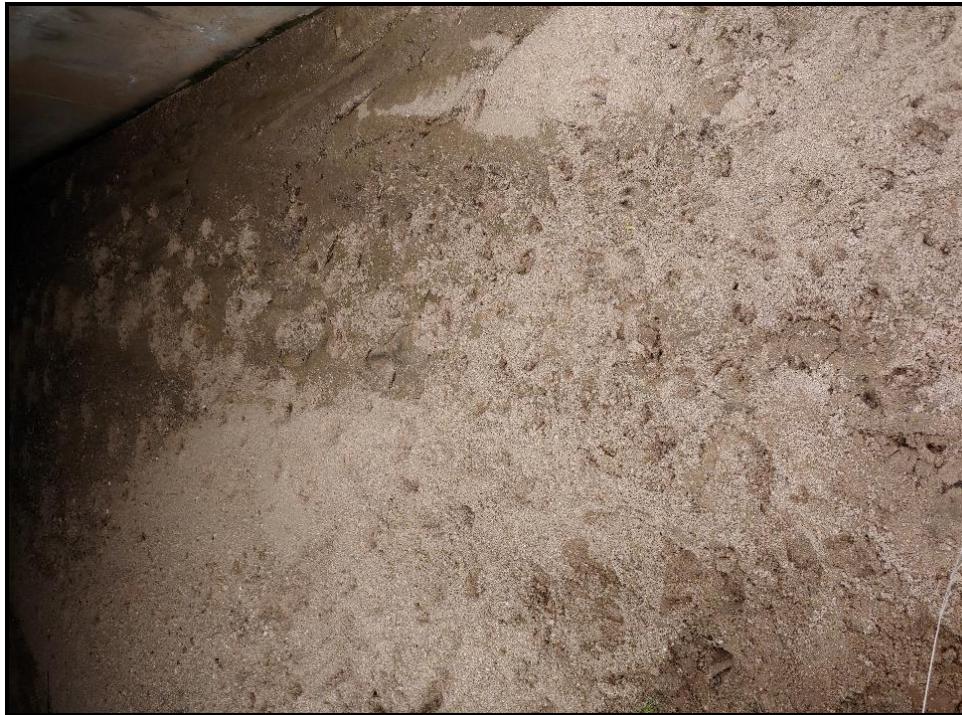
PHOTOGRAPH 21  
Javelina Tracks Inside Southern Culvert to Open Space and Big Wash

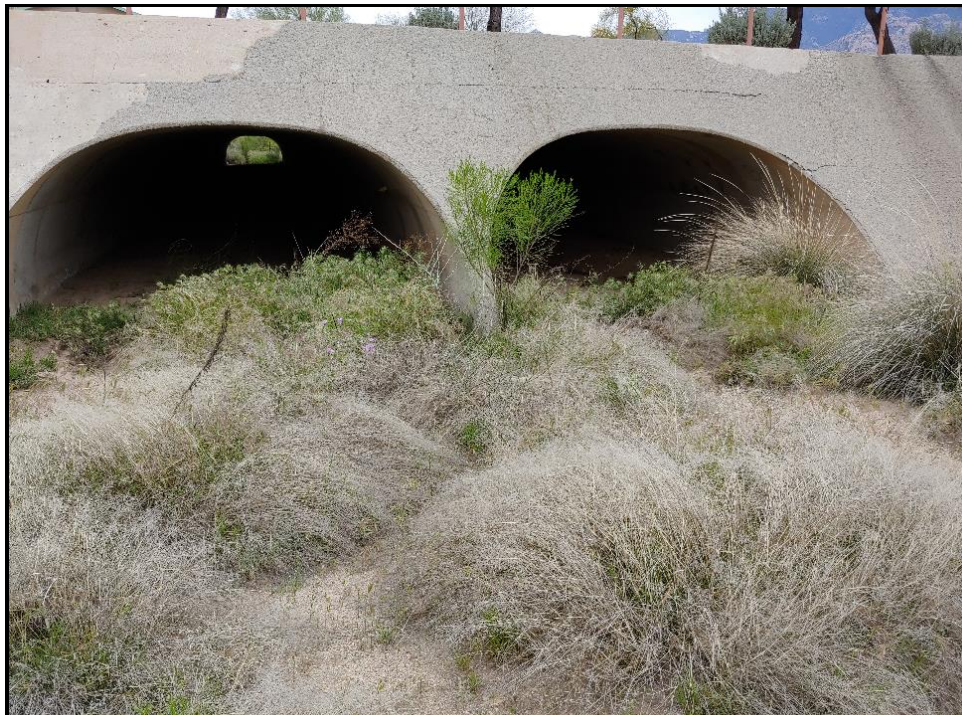
PHOTOGRAPH 22  
Southern Culvert Facing North from Mitigation Area  
Towards Study Area

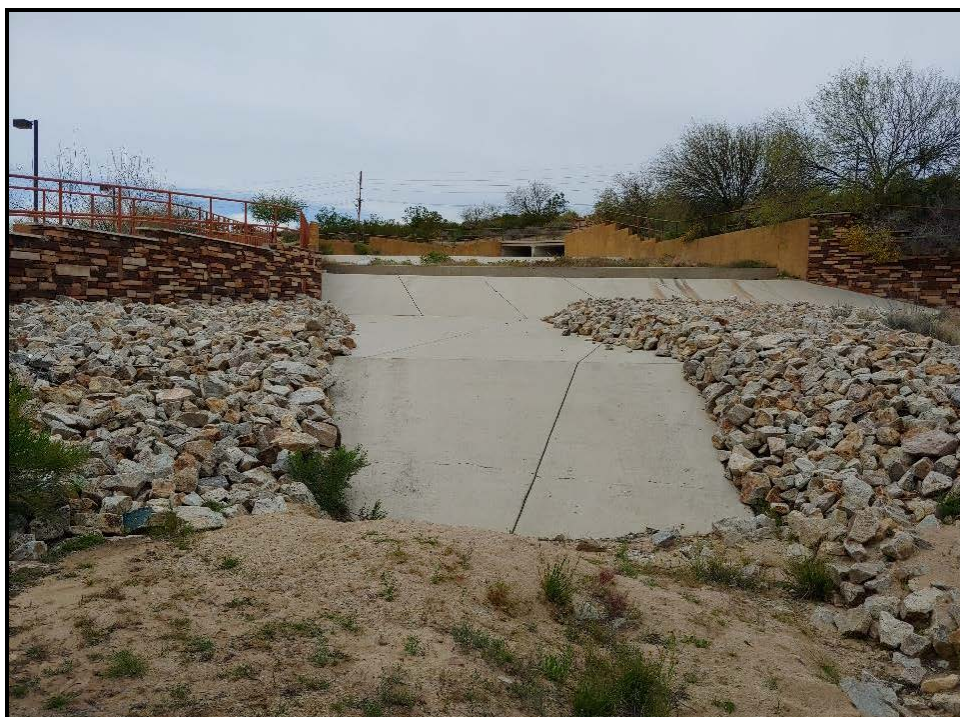
**PHOTOGRAPH 23**

Northern Terraced Drainage Feature, South of Tangerine Road

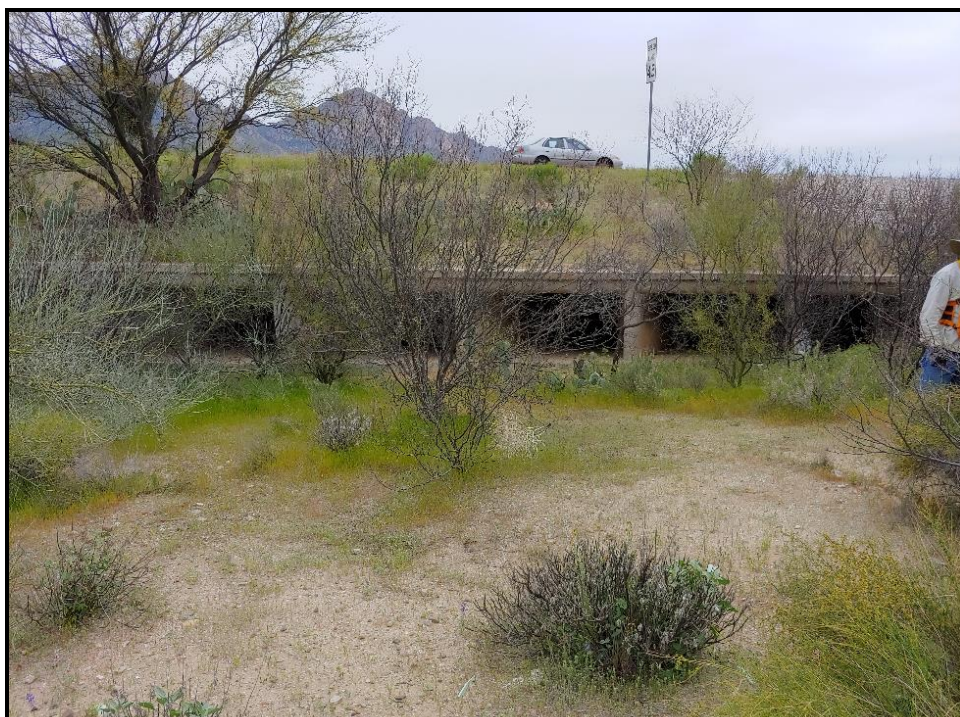
**PHOTOGRAPH 24**

Drainage Area from Open Space to North of Tangerine Road  
Connecting to Marketplace and Study Area. Javelina Tracks  
Found in Sandy Bottom and at Culvert Entrances.
