# The Stone Canyon Reserve Rancho Vistoso PAD Amendment

December 22, 2022

**Prepared By:**  
The WLB Group, Inc.  
4444 E Broadway Blvd  
Tucson, AZ 85711  
Robert G. Longaker III, PLA, AICP  
Liz Madsen  
520.881.7480  
rlongaker@wlbgroup.com  
lmadsen@wlbgroup.com

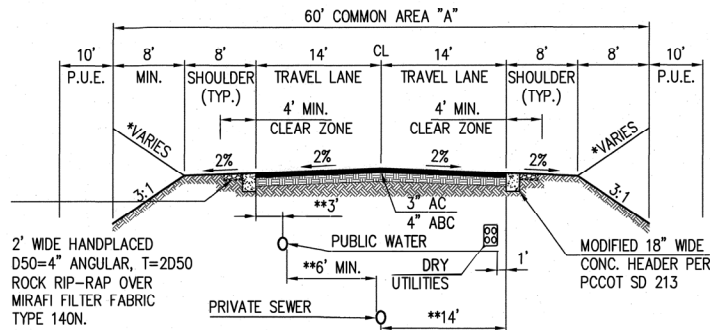
**(A) TYPICAL CROSS SECTION**  
CROWN SECTION AT TORTOLITA MOUNTAIN CIRCLE  
SCALE: NTS

\* IN CONSIDERATION OF MINIMIZING DISTURBANCE OF ROCK OUTCROPS, NATIVE BOULDERS, AND SIGNIFICANT VEGETATION, THE SHOULDER MAY BE REDUCED TO 4'. A 4' MINIMUM CLEAR ZONE FROM FACE OF CURB MAY BE UTILIZED ALONG WITH APPROPRIATE BARRIER TREATMENTS WHEN WARRANTED DEPENDING ON FIELD CONDITIONS. THESE AREAS SHALL BE EVALUATED BY THE ENGINEER OF RECORD AND SUBJECT TO APPROVAL BY T.O.V. TOWN ENGINEER PRIOR TO CONSTRUCTION OF REDUCED SHOULDER (TYP).

\*\* UTILITIES LOCATION VARIES, SEE PLAN

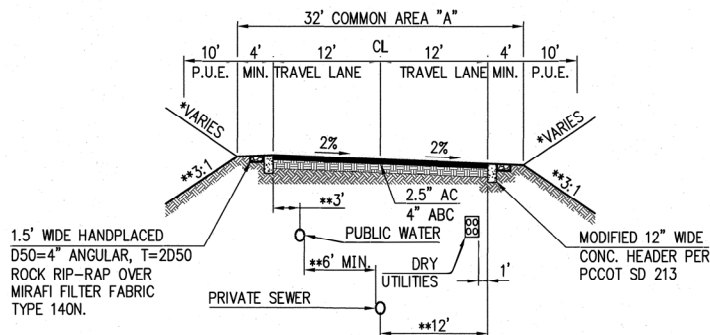
**(B) PRIVATE STREET SECTION**  
SUPERELEVATED SECTION AT PRIVATE STREETS  
SCALE: NTS

\* IN CONSIDERATION OF MINIMIZING DISTURBANCE OF ROCK OUTCROPS, NATIVE BOULDERS, AND SIGNIFICANT VEGETATION, THE SHOULDER MAY BE REDUCED TO 4'. A 4' MINIMUM CLEAR ZONE FROM FACE OF CURB MAY BE UTILIZED ALONG WITH APPROPRIATE BARRIER TREATMENTS WHEN WARRANTED DEPENDING ON FIELD CONDITIONS. THESE AREAS SHALL BE EVALUATED BY THE ENGINEER OF RECORD AND SUBJECT TO APPROVAL BY T.O.V. TOWN ENGINEER PRIOR TO CONSTRUCTION OF REDUCED SHOULDER (TYP).

\*\* UTILITIES LOCATION VARIES, SEE PLAN

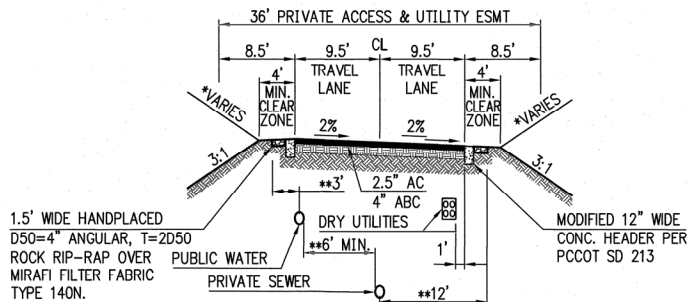
**(C) PRIVATE DRIVE SECTION**  
SUPERELEVATED SECTION AT PRIVATE DRIVE  
SCALE: NTS

\* IN CONSIDERATION OF MINIMIZING DISTURBANCE OF ROCK OUTCROPS, NATIVE BOULDERS, AND SIGNIFICANT VEGETATION, THE SHOULDER MAY BE REDUCED TO 4'. A 4' MINIMUM CLEAR ZONE FROM FACE OF CURB MAY BE UTILIZED ALONG WITH APPROPRIATE BARRIER TREATMENTS WHEN WARRANTED DEPENDING ON FIELD CONDITIONS. THESE AREAS SHALL BE EVALUATED BY THE ENGINEER OF RECORD AND SUBJECT TO APPROVAL BY T.O.V. TOWN ENGINEER PRIOR TO CONSTRUCTION OF REDUCED SHOULDER (TYP).

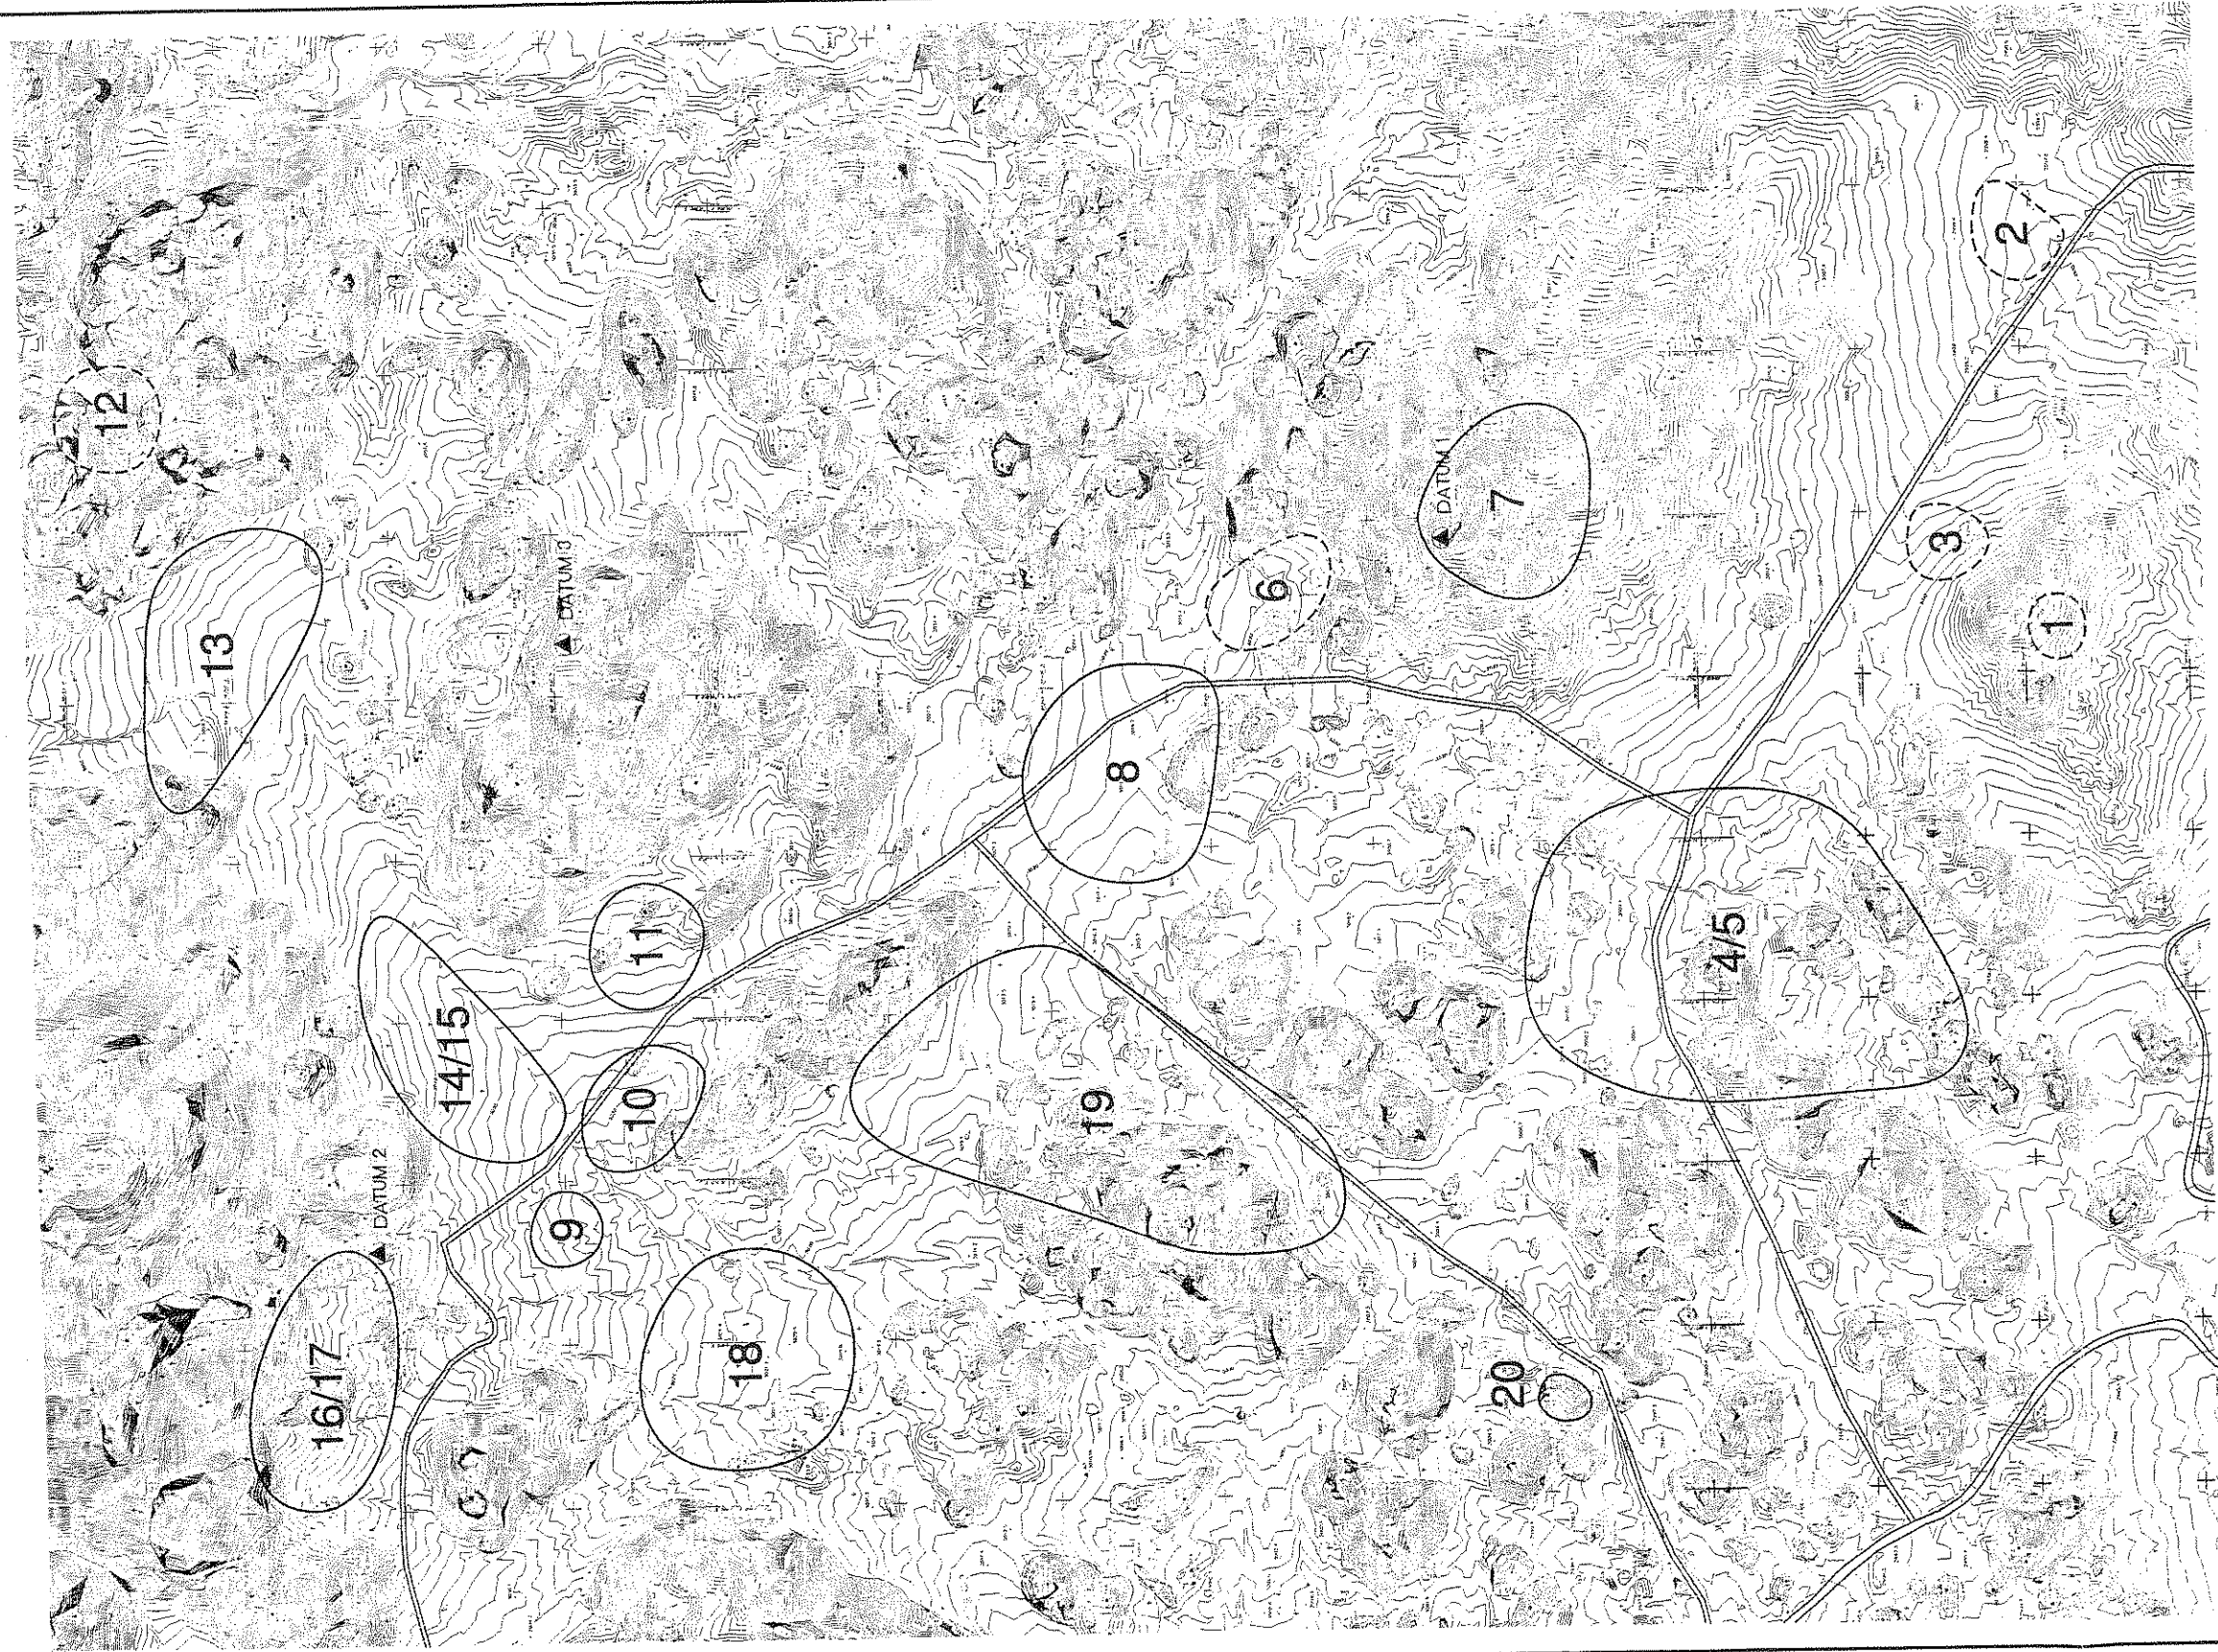
Once detailed surface reconnaissance had been conducted and subsurface investigations of the site began, the need to combine loci to reflect 1999 observations became apparent. Locus 4 and 5, both on the southern end of the site, were found to connect subsurface and were combined. Locus 16 and 17 in the far northwest corner were also combined, as a low density of surface artifacts was present between the two loci. No distinct artifact scatters were observed in the north-central portion of the site. Instead, a low density of artifacts were found scattered throughout this area necessitating the combination of Locus 14 and 15. Figure 3.1 shows the site as it was defined in 1999.

- LOCUS INCLUDED IN THE NEIGHBORHOOD 12 DATA RECOVERY PROJECT
- LOCUS NOT RELOCATED OR WHERE NO FURTHER WORK WAS PERFORMED
- DIRT ROAD

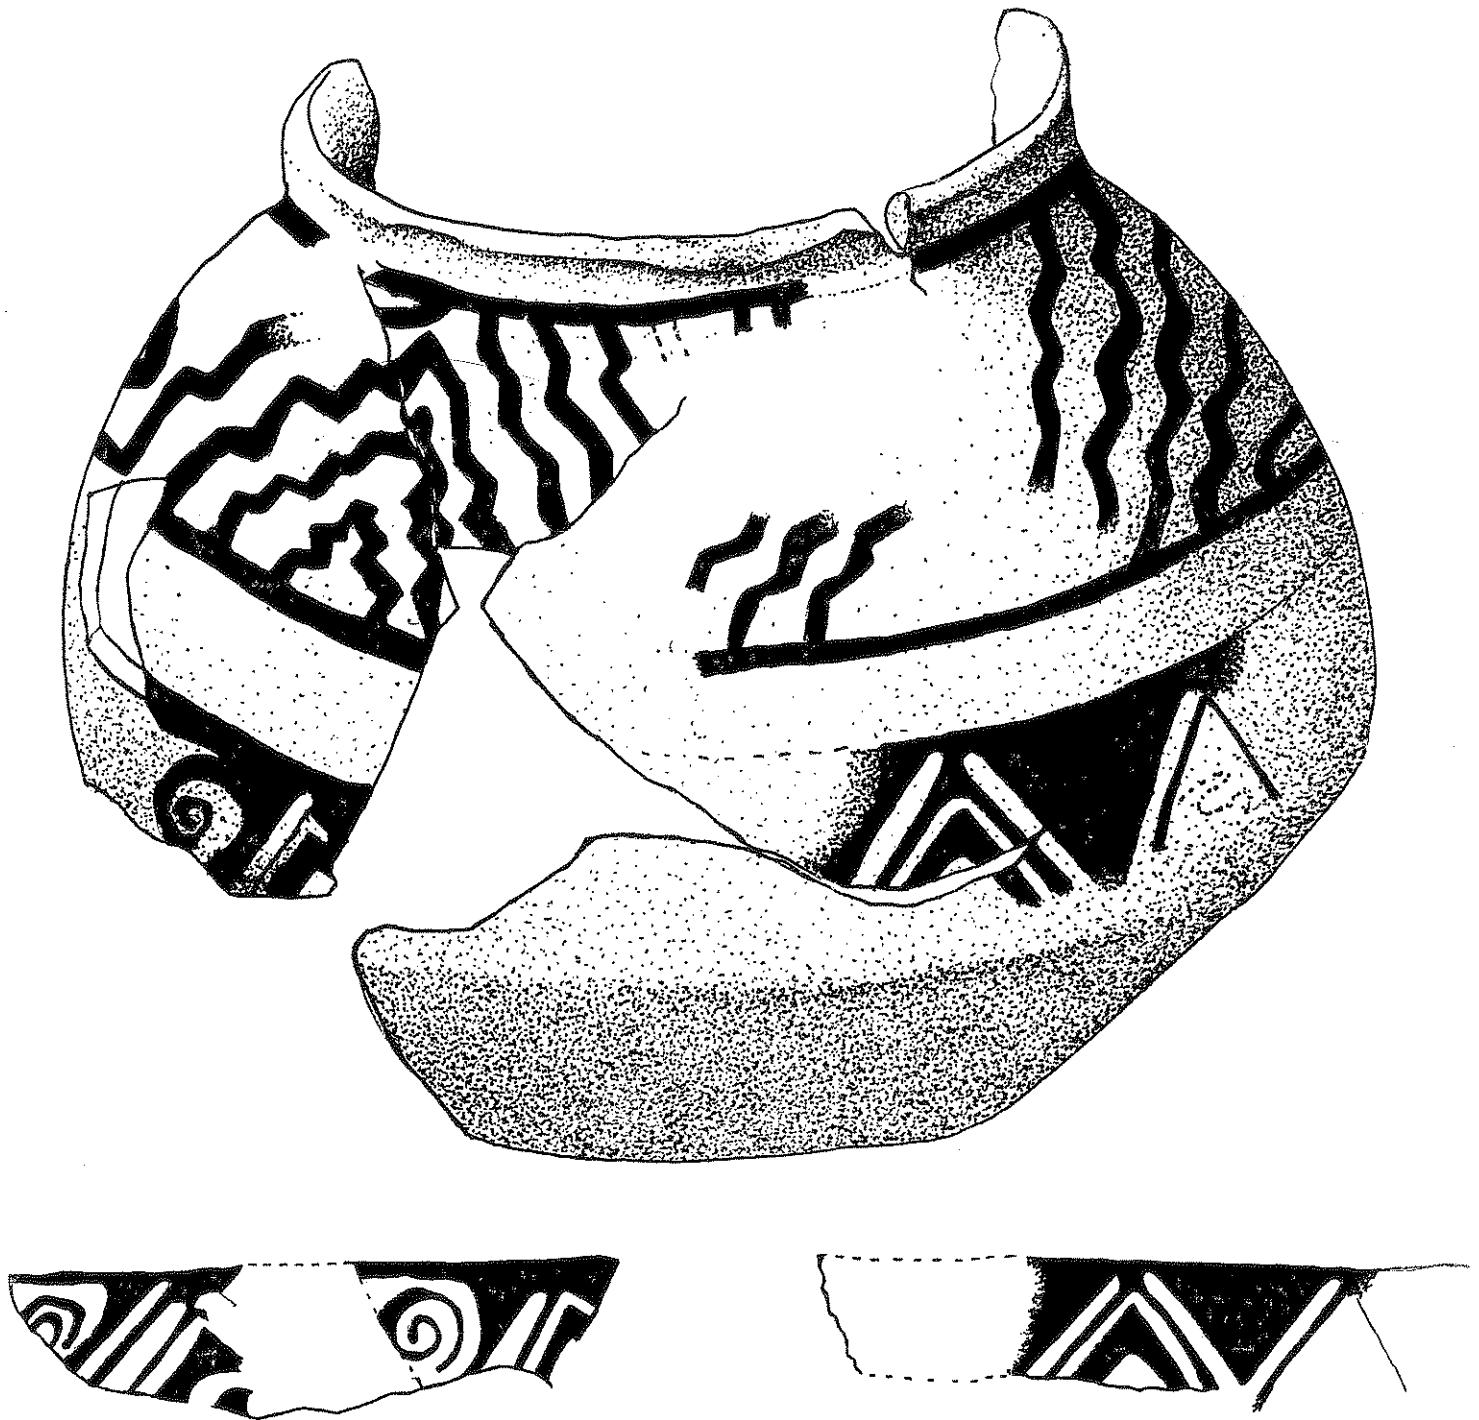
Figure 5.1. Rincon Red-on-brown jar from pit structure Feature 41, AZ BB:9:148 (ASM) (actual size), with a detail of the lower design band.

As shown in Table 5.4, most of the excavated features appear to have had *de facto* depositional contexts. Such depositional interpretations are also supported by the presence in several features of partially or completely reconstructable vessels (see Table 5.5 for descriptions). The sizes of sherds found and the presence of reconstructable vessels indicate that once abandoned, the features were not reused to any great extent. In this regard, the depositional sequence for Feature 4 is fairly clear—partially reconstructable or reconstructable vessels and large sherds were found in the roof fall and floor levels of the feature. The sherds found in Feature 41 may tell a different story. There, large sherds were common, and many were found, but the vessels seemed more fragmentary—as if only portions of the pots were originally deposited in the house. It is possible that the house was used as a primary dumping spot for nearly whole vessels, but I suspect that the fragmented nature of the vessels is illusory. A house fire or sudden collapse might have smashed pots and spread the sherds in such a way that it appears that none of the pots had been whole. Most of the vessel fragments found in Feature 41 were thin-walled vessels that could have been made by one individual. The remnants of one, small Rincon Red-on-brown jar, found at two loci on the house's floor indicates that the event leading to abandonment scattered at least some of the vessels (see Figure 5.1).

Locus 18, Feature 41 floor Point Location 3	Gila Plain	Ca. 1/3 of a large, hemispherical bowl; 7-mm-thick vessel walls; micaceous granitic temper; round rim finish; surface has micaceous sheen; may have had organic material in it when house burned as part of interior is oxidized and part blackened; ca. 32 cm diameter, 12.3 cm high; base is worn (FN 310).	3
Locus 18, Feature 41, floor Point Locations 14 and 15	Rincon Red-on-brown	Ca. 3/4 of a small (ca. 1 quart-sized) jar with a rounded, Sedentary phase shoulder; slightly everted neck is 1.5 cm high and has a round finish; paneled design descends at 45 degree angle from just below base of neck to about 1 inch above shoulder, consists of panels of parallel squiggles and interlocking curvilinear scrolls or triangles; vessel has granitic temper and polished surface, is 15 to 16 cm high with 6 to 8-mm-thick walls; base is slightly worn (FNs 311 and 338) Figure 5.1.	21

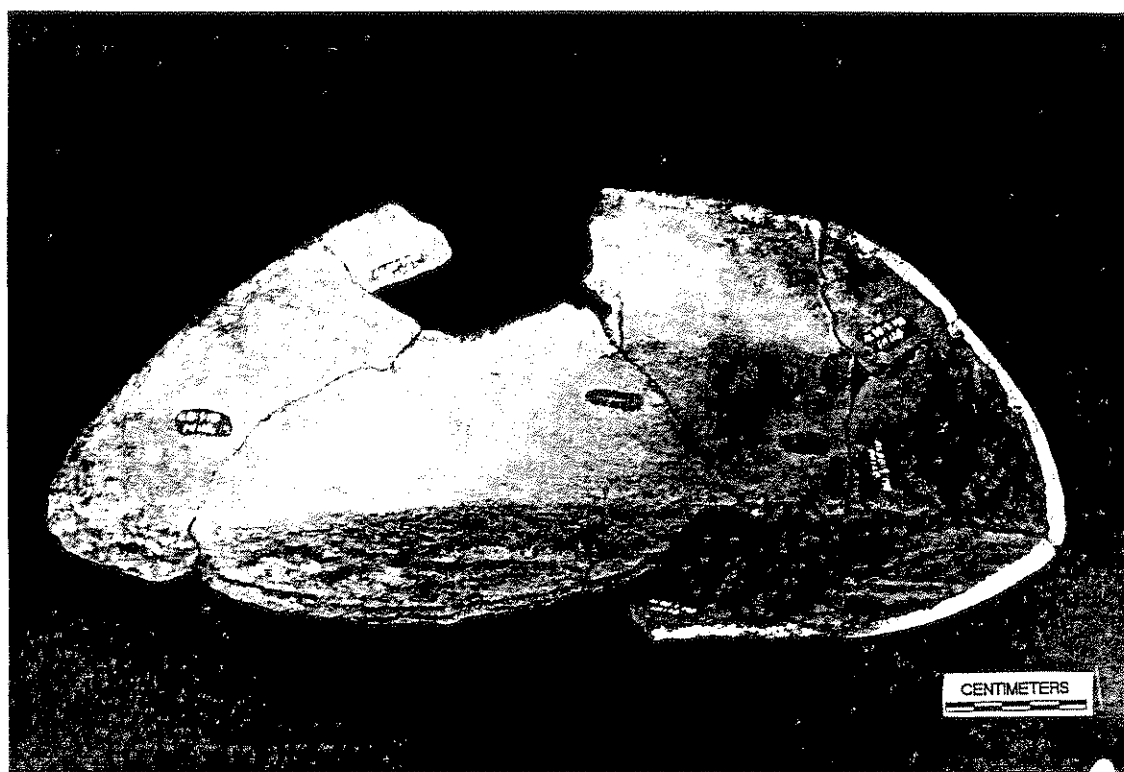
Figure 5.2. Scoop or reworked shallow bowl recovered from pit structure Feature 4, AZ BB:9:148 (ASM).

One vessel found in the floor fill of Feature 4 is a scoop or shallow bowl reworked from either a cauldron-like shape or a Gila shouldered Rincon Red-on-brown jar (Figure 5.2). This scoop may have been part of the pottery making kit found in the house. Also recovered from Feature 4 was a plain ware scoop with an human effigy head attached to it (Figure 5.3). It was found in the roof fall of the feature. Table 5.5 provides a more complete description of these vessels and others found in Feature 4 and elsewhere on the site.

Locus 4/5 Feature 4 northeast quarter	Plain ware	One-eighth to 1/4 of a medium to large suprahemispherical bowl with slightly constricted mouth; quartz, feldspar, mica temper; polished exterior surface; interior weathered; has beveled round rim; resembles early Classic period style (FN 220)	5
Locus 4/5 Feature 4, roof fall northwest quarter	Plain ware	Less than 1/4 of a large, heavy-walled (8-12-mm thick) jar; 2.5 cm high straight neck with a round rim finish; vessel opening is relatively small; vessel is low-shouldered; quartz, feldspar temper; polished surface (FN 219).	1
Locus 4/5 Feature 4, floor fill, northwest quarter	Rincon Red-on-brown	About ½ to 3/4 of a large Rincon Red-on-brown jar or cauldron with Gila shoulder; vessel has been reworked into a scoop-like shape; base, shoulder, and "rim" represented; if cauldron, vessel had round rim finish; if not, then new "rim" has been reworked into a round shape; most edges are clearly ground; remnant of design includes curvilinear scrolls and squiggle or zig-zag line; granitic temper; polished surface has been blackened (FN 128). (Figure 5.2).	7

Feature 4, which contained pottery making tools, also included an odd, cauldron-shaped vessel remade into a scoop. This might have been part of the pottery making kit.

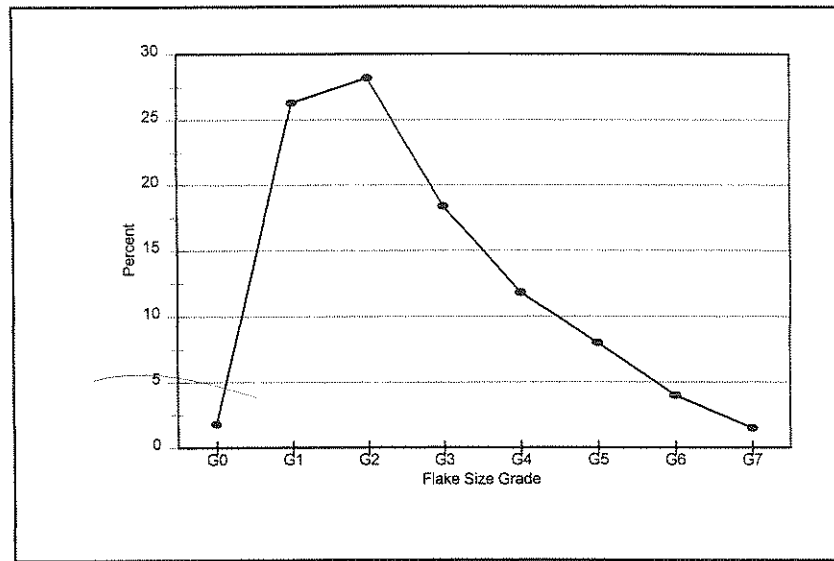
Figure 6.1. Flake size distribution by size grade.

Sixty-seven percent of the flakes ( $n=365$ ) were platform-remnant-bearing. The remaining 33% ( $n=183$ ) of the flakes did not retain a platform. Only three flakes indicating possible bifacial reduction were present in the assemblage, representing three different raw materials: quartzite, rhyolite and chert. The remaining flakes retained platforms indicative of expedient core reduction and flake production. Forty-eight percent ( $n=256$ ) of the flakes have either cortical or flat platforms. Only 7% of thedebitage ( $n=38$ ) have prepared—either reduced or faceted—platforms. The high quantity of flakes with no platforms, cortical platforms, and featureless platforms indicates that hard-hammer and soft-hammer percussion were the dominant methods of reduction on site, and that cores were reduced without preparation of striking platforms.

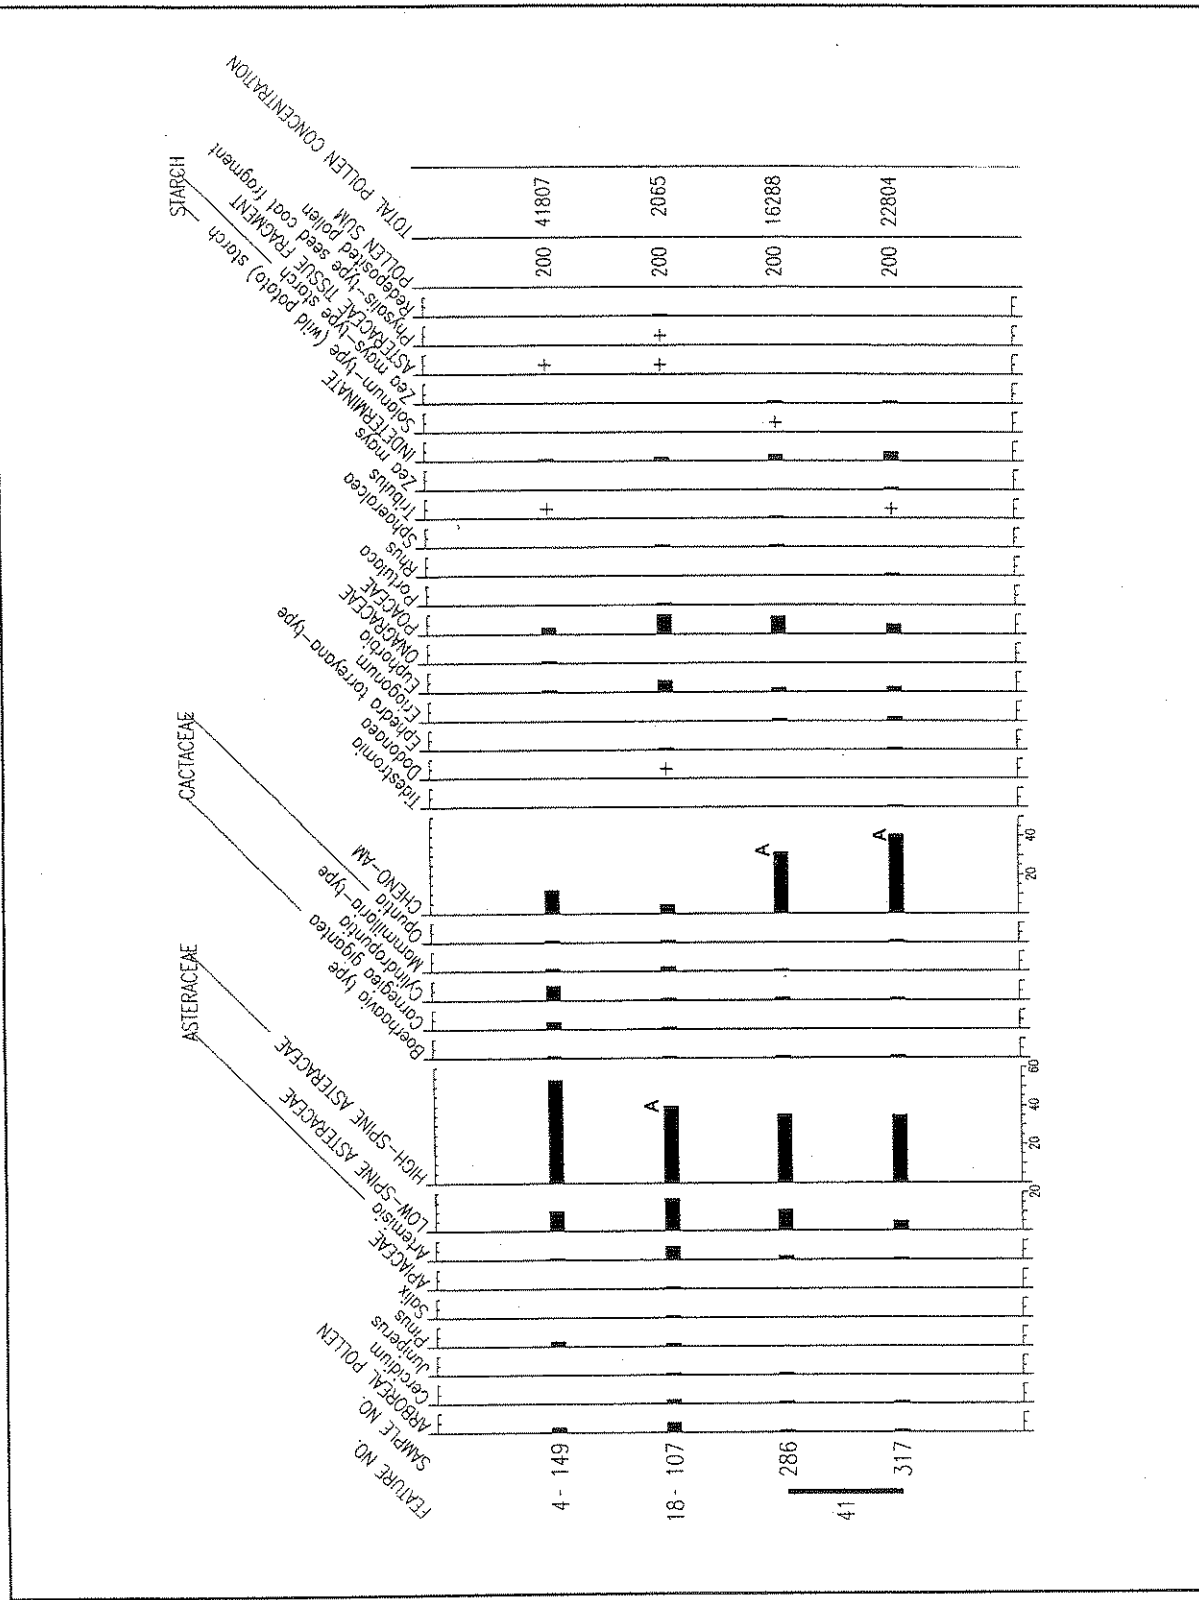
Figure 7.1. Pollen diagram for AZ BB:9:148 (ASM).

quantity of Low-spine Asteraceae pollen probably reflects local bursage at the time of occupation. Recovery of small quantities of *Pinus* and *Artemisia* pollen probably reflect long-distance transport from pine and sagebrush growing in the mountains. Four types of cactus are represented in this sample, including *Mammillaria*-type (*Echinocereus*, *Ferocactus*, and perhaps others), *Carnegiea gigantea* (saguaro), *Opuntia* (prickly pear cactus), and *Cylindropuntia* (cholla). Quantities of both cholla and saguaro cactus pollen were elevated, suggesting that these cacti were processed. It is also possible that other cacti, including *Echinocereus*/*Ferocactus*/*Mammillaria* and prickly pear cactus were processed in this area, possibly with this mano. No other pollen types recovered in this sample suggest economic activity. Recovery of a small quantity of Asteraceae tissue fragments during the scan of this sample represent deteriorated plant tissue from a member of the sunflower family. Collection of the sample from the floor beneath a mano incorporates pollen from activities in this portion of the structure and possibly using this mano. Pollen concentration was high, at over 40,000 pollen per cc of sediment, suggesting that either this
