# Geotechnical Investigation

## Rancho Vistoso Valley Vista – Lot 20 [REDACTED] Residence

803 East Romsdalen Road  
Oro Valley, Arizona  
ProTeX Job No.: 12804

Re: **Geotechnical Investigation - Forensics**

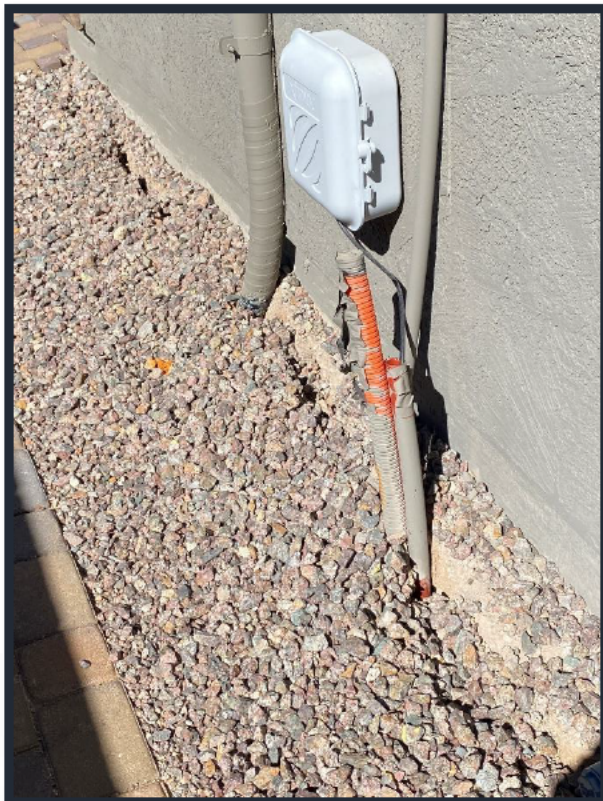
*Figure 4: Lot 20 cracking observed in block wall and pavers at base of the privacy wall*

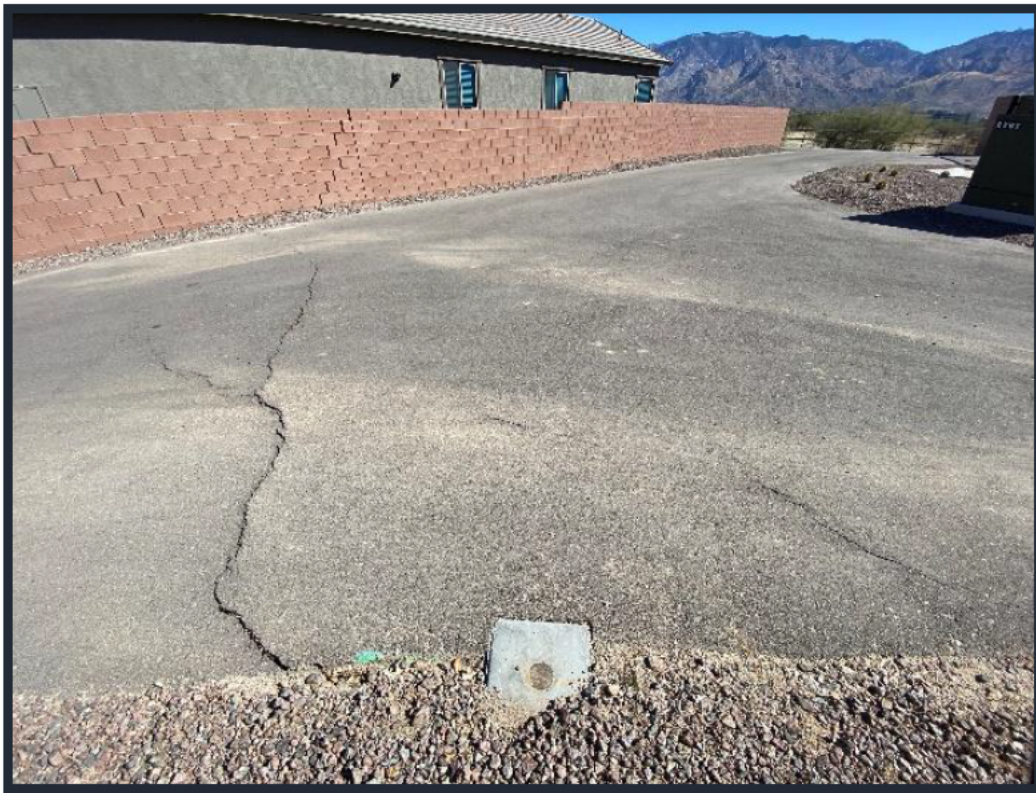
This area is currently paved with asphalt and includes small gravel areas with smaller utility housing. Cracks in the asphalt were observed, trending southwest to northeast. The patterns in both the block wall and the cracks in the asphalt pavement appear to follow similar trends.

*Figure 1: Cracking in common area of booster station, in the asphalt pavement, and leading to Lot 20. Similar residual cracking patterns in both wall and asphalt pavement*
