| NOTES AND DATA | SR-2 |

SITE RESOURCE INVENTORY
RULNEY VISTOSO
RESIDENTIAL

A PORTION OF THE S.E. 1/4 OF SECTION
23, TOWNSHIP 11 SOUTH, RANGE 13 EAST,
G.&S.R.M., TOWN OF ORO VALLEY, PIMA
COUNTY, ARIZONA

CASE NO:
CASE
#2301236
REFERENCE:
2203155,
2301138,
2301232
SR-1
1 OF 2

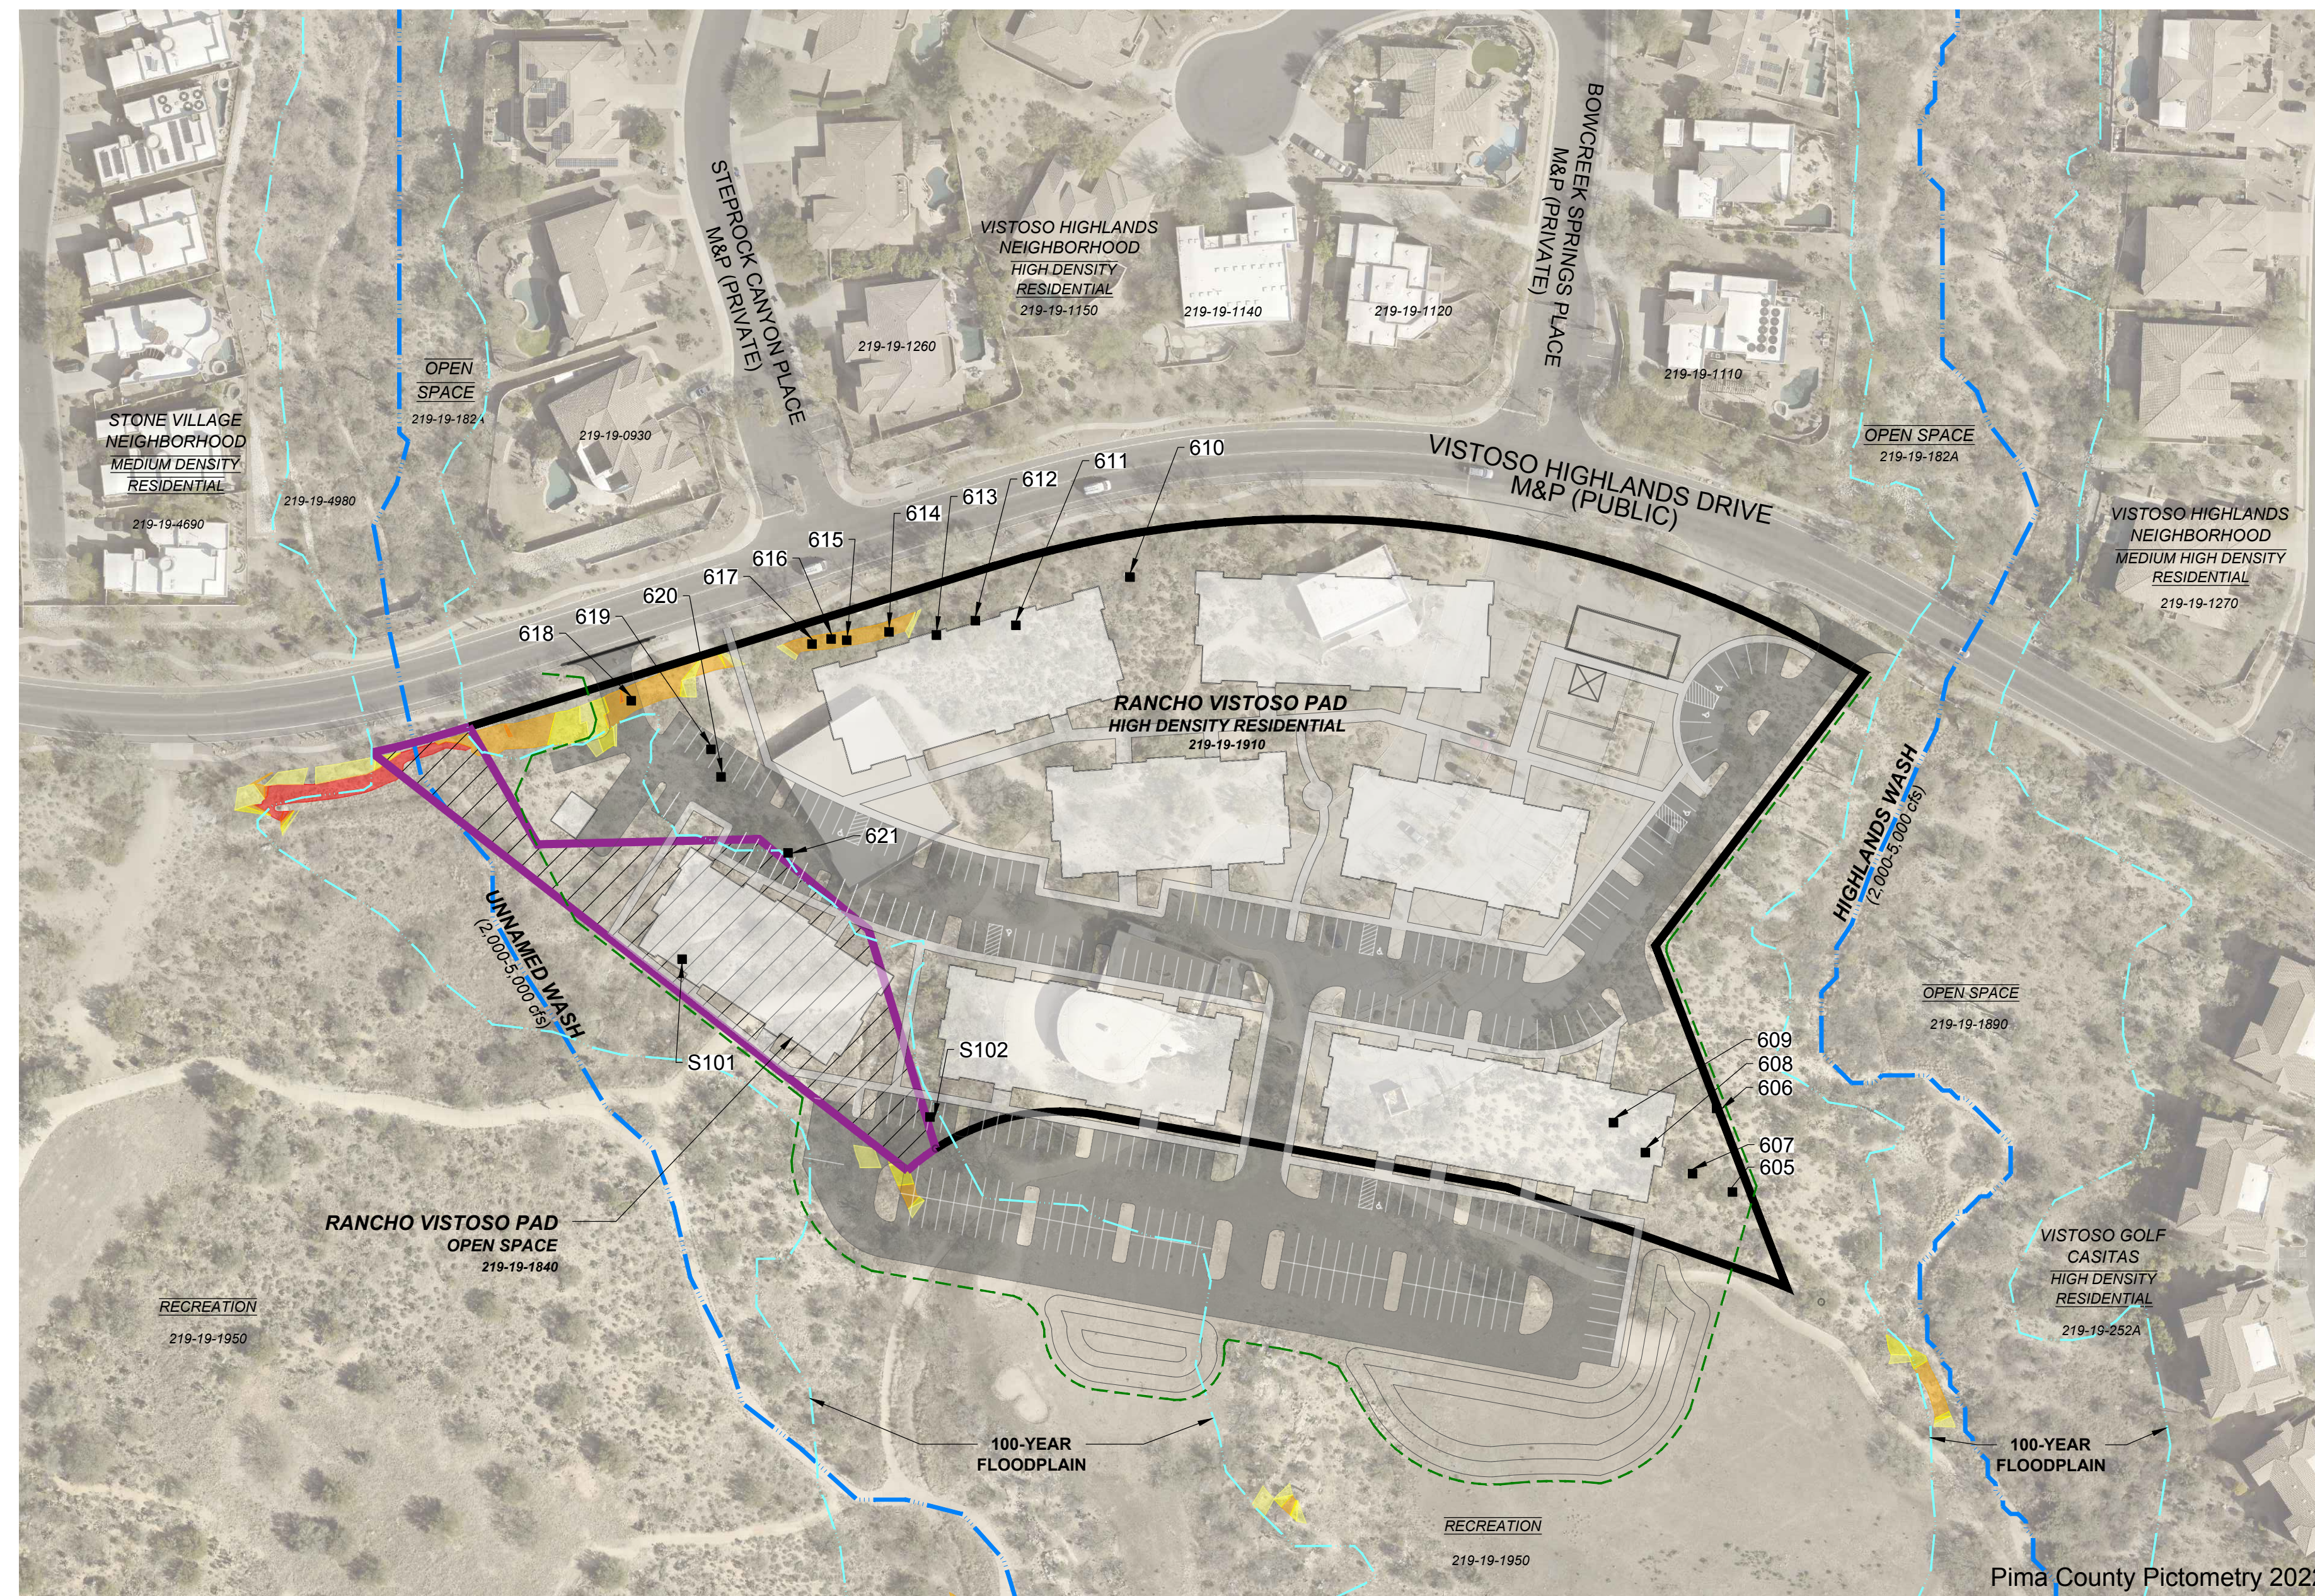
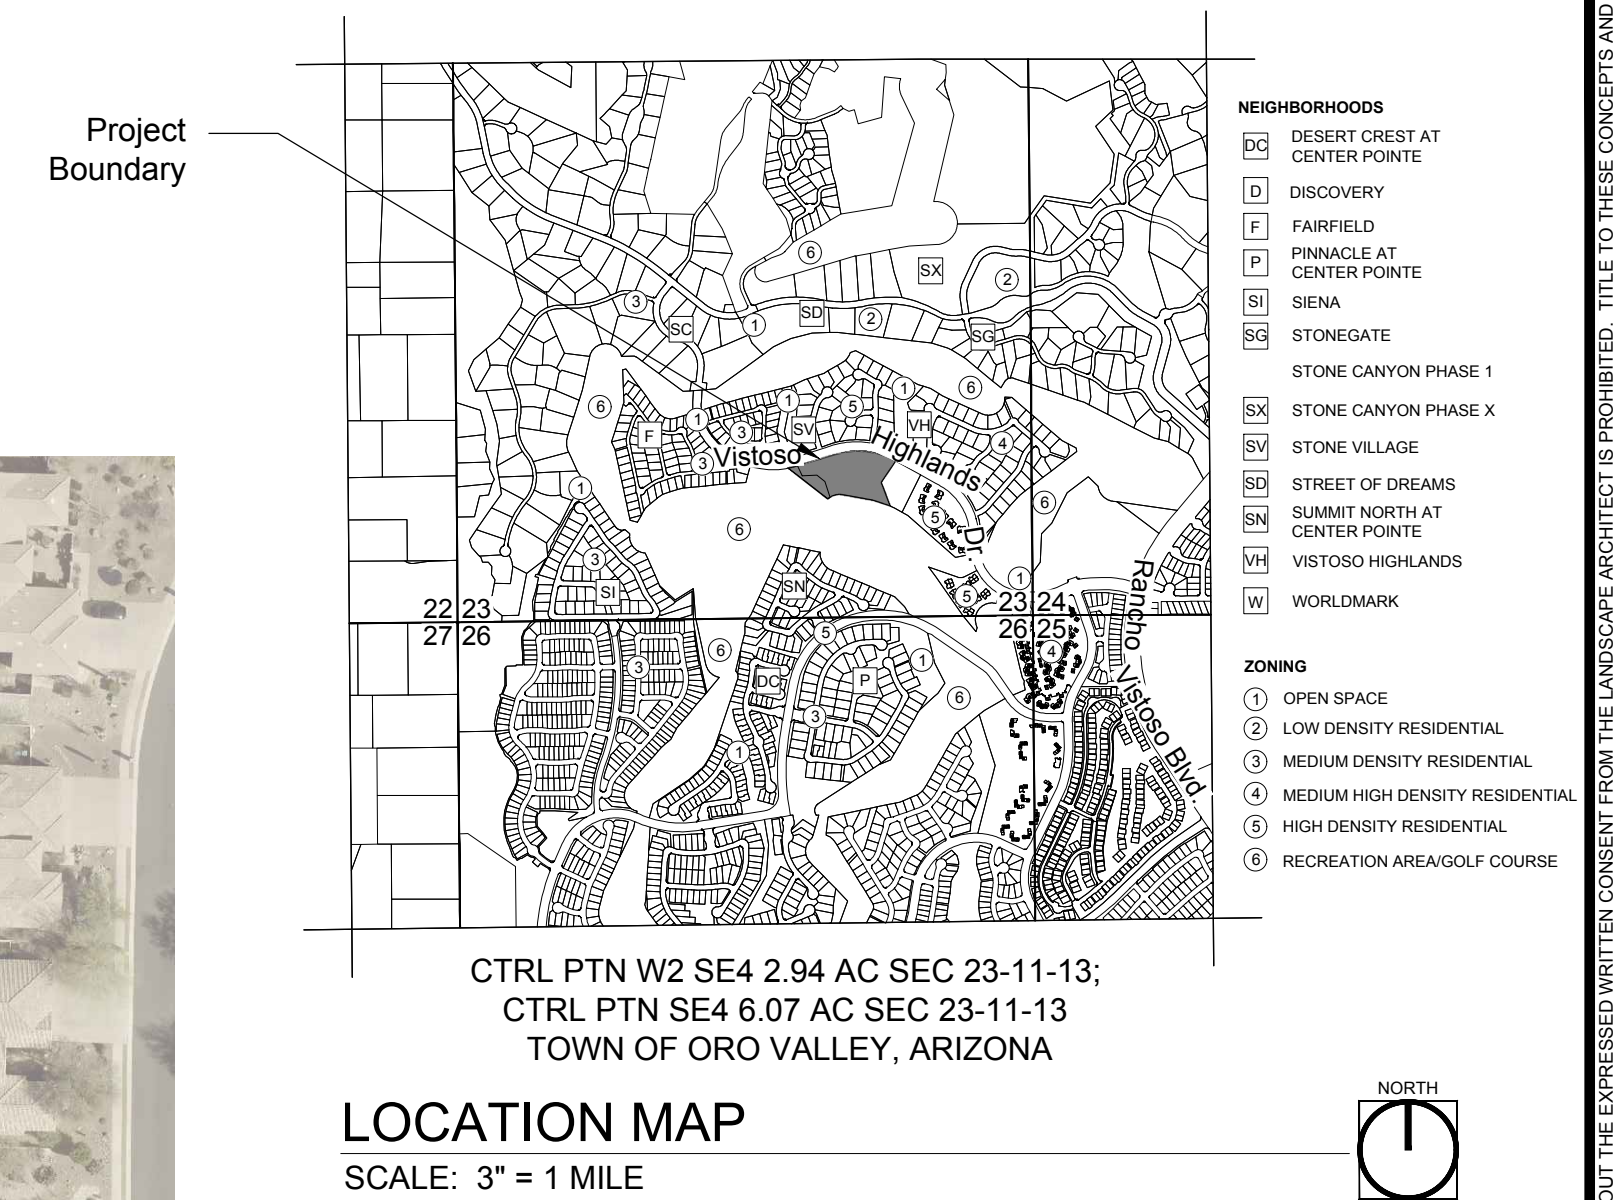
The extents of this SRI include APNs: 219-19-1910; APN 219-19-1840; and APN 219-19-1950.
2.

There are no Distinct Native Plant Stands on-site.
3.

This aerial photo is less than two years old.
4.

The site features a combination of constructed and native landscape. Areas of constructed landscape are excluded from this inventory.
5.

The significant species are identified on the map.
