# Preliminary Geotechnical Evaluation Rancho Vistoso Parcel 5-R Planned Area Development Amendment Oro Valley, Arizona

September 6, 2023 | Project No. 607834001

In accordance with our proposal dated July 28, 2023, and your authorization, we have performed a preliminary geotechnical evaluation for the design and construction of Rancho Vistoso Parcel 5-R Planned Area Development (PAD) Amendment in Oro Valley, Arizona (Figure 1). The purpose of our evaluation was to assess the subsurface conditions at the project site in order to provide preliminary geotechnical recommendations for design and construction. This report presents the results of our evaluation and our geotechnical preliminary conclusions and recommendations regarding the proposed construction.

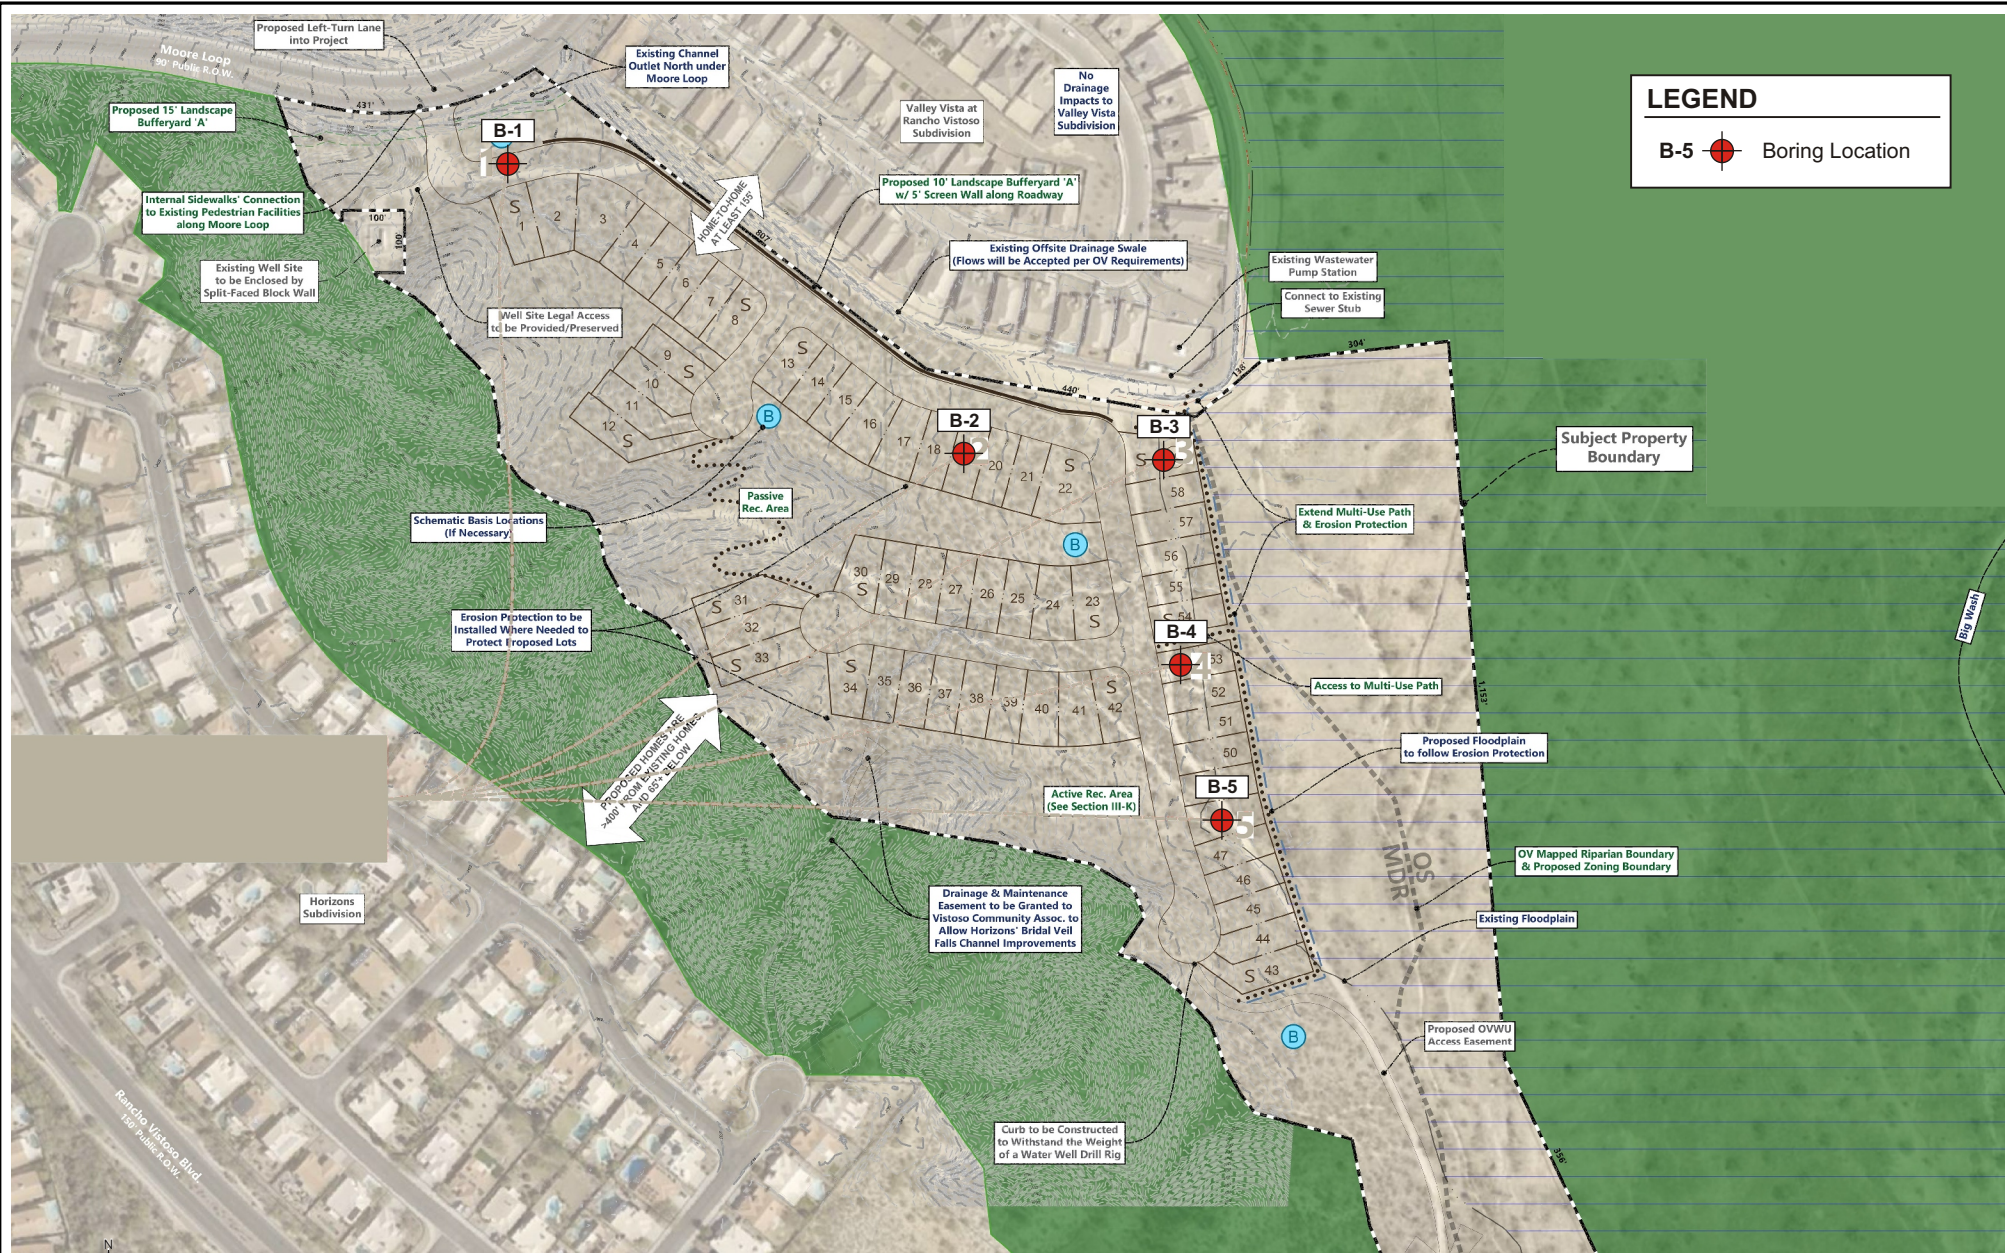
**LEGEND**
