PROJECT: Rancho Vistoso Parcel 5-R Proposed Rezoning
January 2026 Project Update and Hearing Request

May 13, 2025 | Project No. 607834001

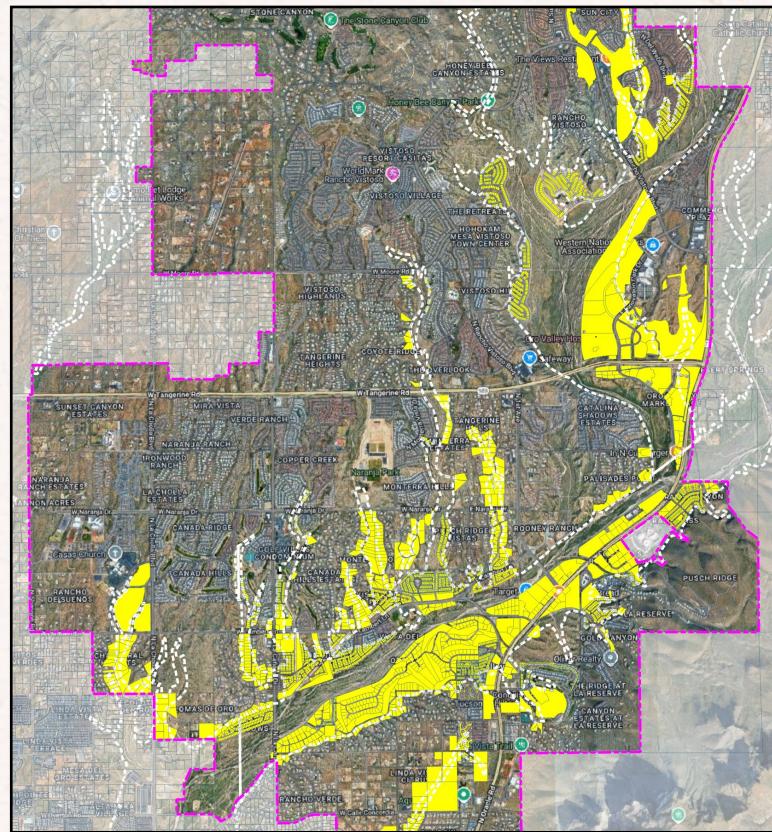
**Properties in Oro Valley
With Soils Similar to
Vistoso 5-R & Valley Vista:**

- Thousands of homes and businesses in Oro Valley have existed over this type of soil for decades, without significant problems. Notable businesses, institutions, and neighborhoods include the Oro Valley Hospital, Honeywell, Oro Valley Marketplace, Steam Pump Ranch, Basis School, the Rooney Ranch Shopping Center, San Dorado, Securaplane, the Oro Valley Country Club, Tranquillo, Alterra, portions of the Villages of La Canada and La reserve, and others.

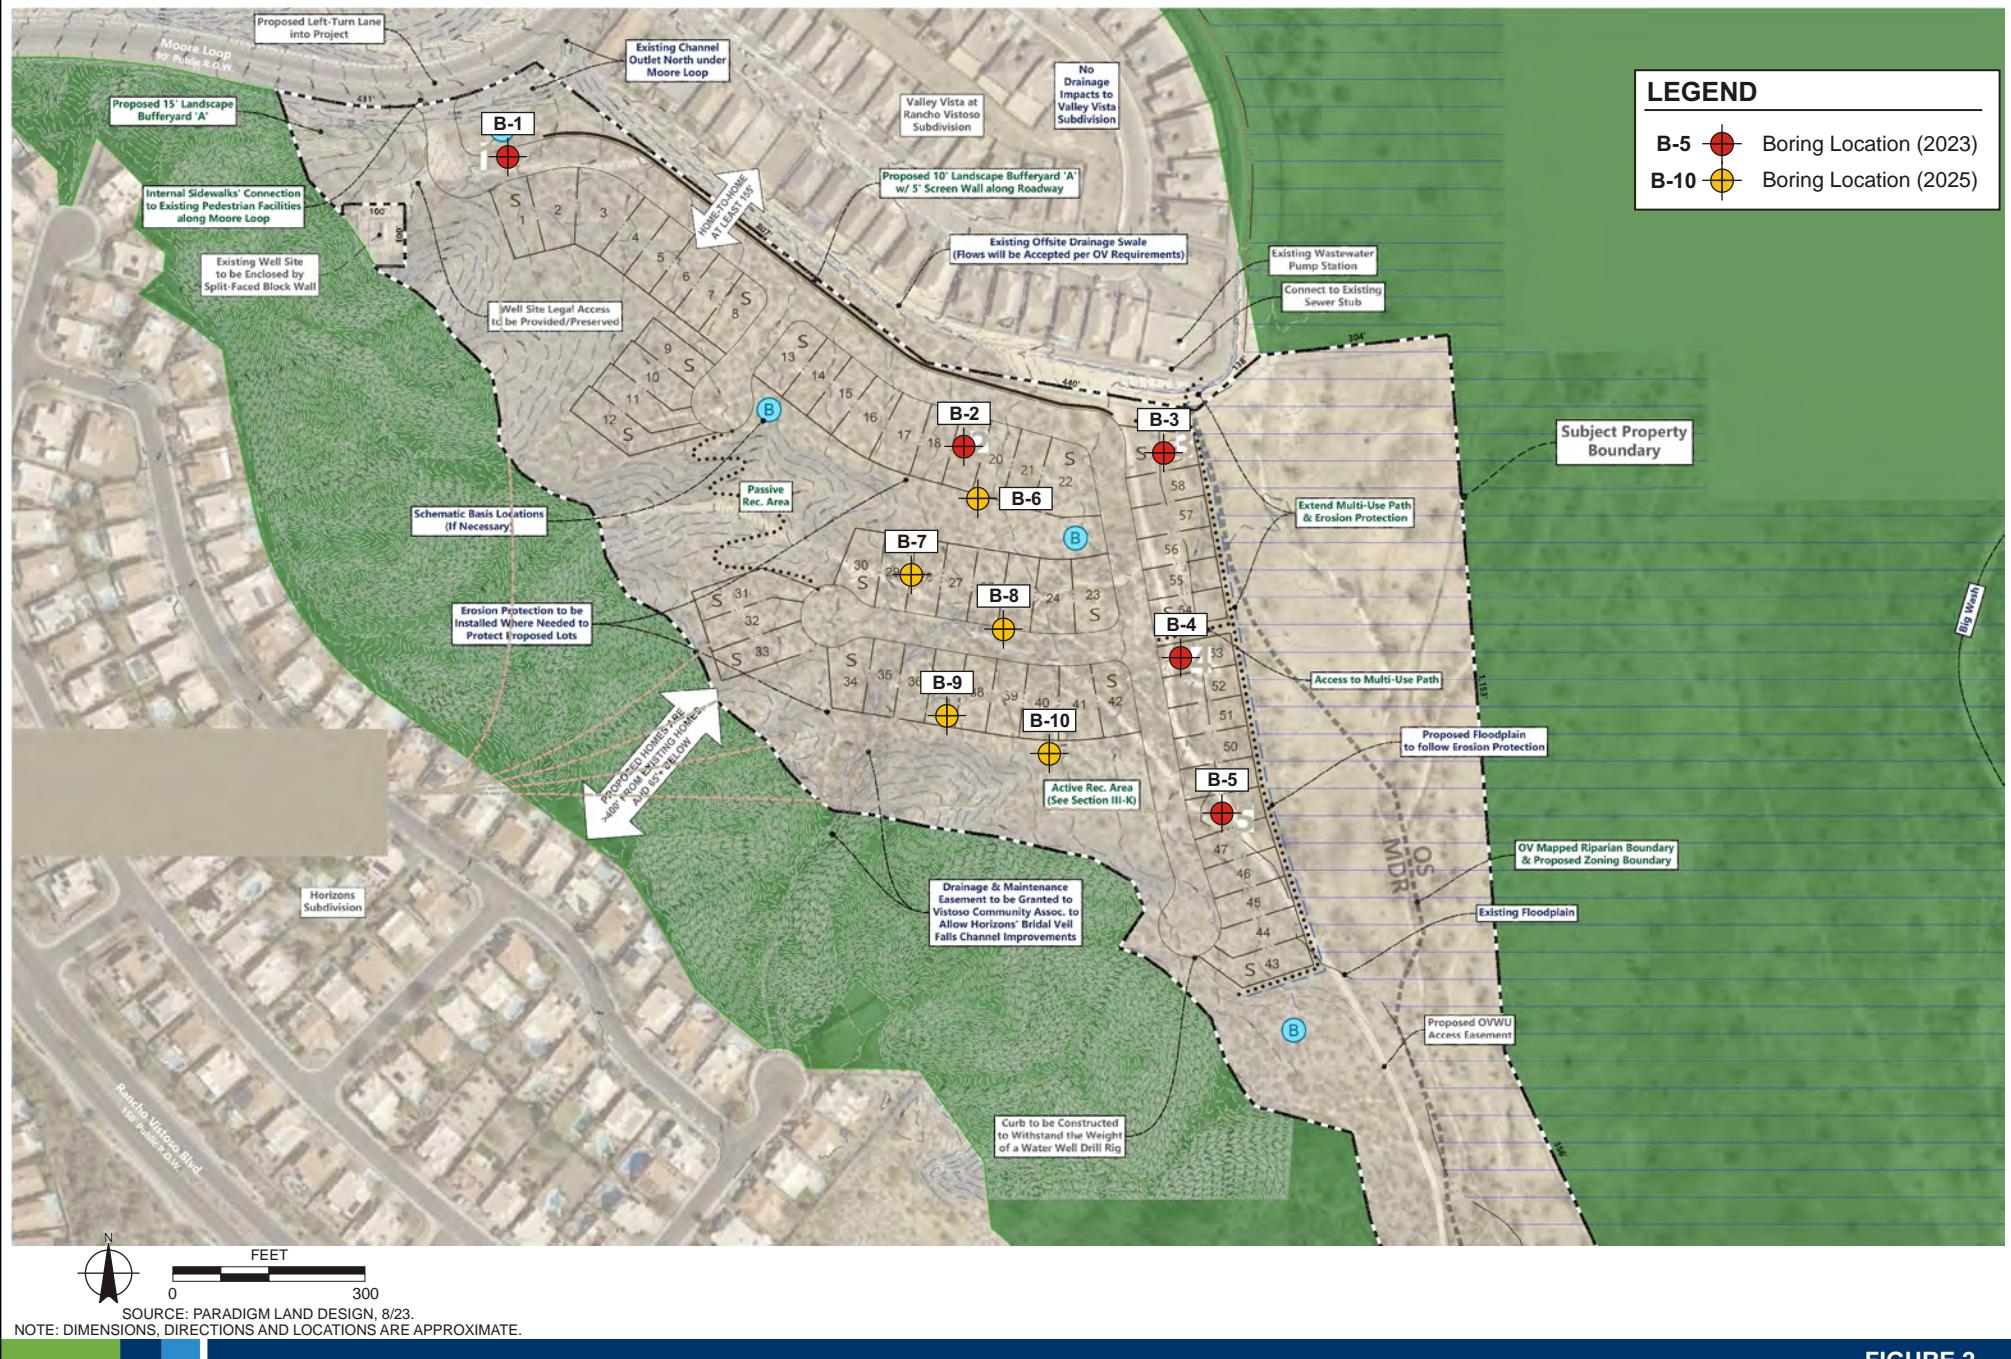
FIGURE 2

BORING LOCATIONS

On August 24 and 25, 2023, and January 27, 2025, Ninyo & Moore conducted a subsurface exploration at the site in order to evaluate the subsurface conditions and to collect soil samples for laboratory testing. Our evaluation consisted of drilling, logging, and sampling of 10 exploratory borings using a CME 75 truck mounted drill rig equipped with HSAs (Figure 2). The borings extended to approximate depths of 34 to 50 feet bgs. Bulk and relatively undisturbed soil samples were collected at selected depth intervals in our borings.

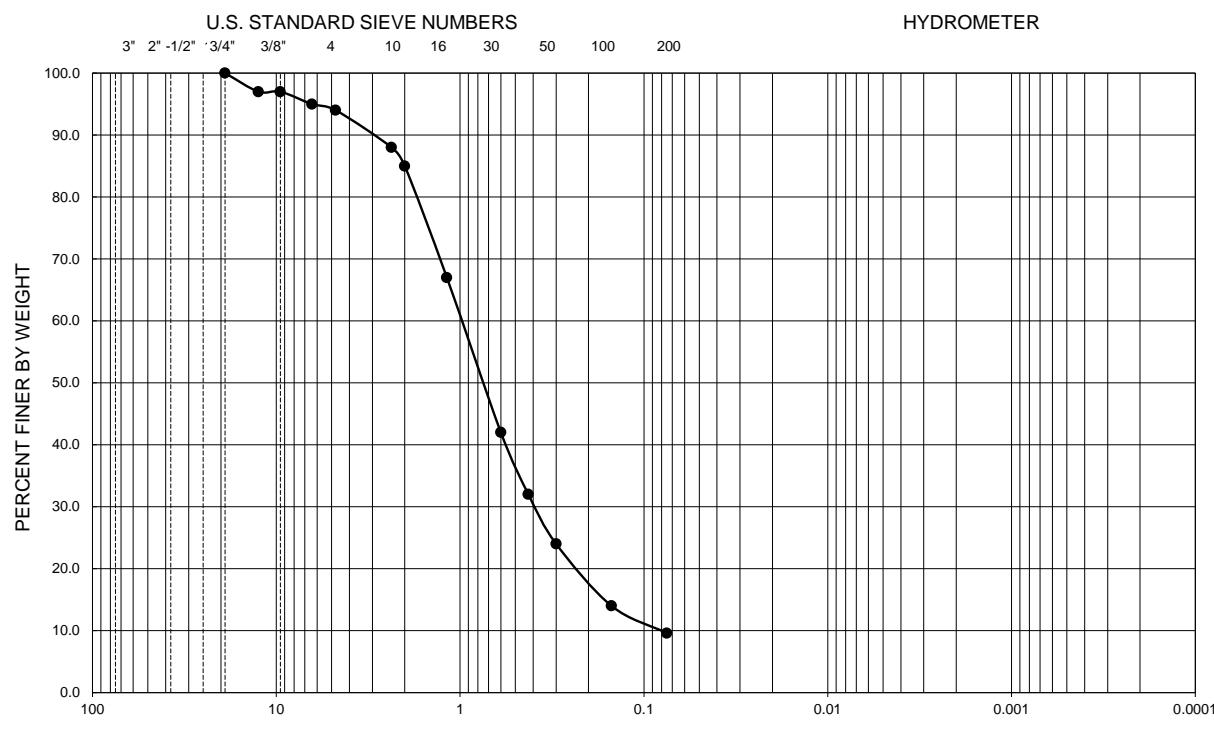
Symbol	Sample Location	Depth (ft)	Liquid Limit	Plastic Limit	Plasticity Index	D ₁₀	D ₃₀	D ₆₀	C _u	C _c	Passing No. 200 (percent)	USCS
●	B-1	0.0-5.0	--	--	NP	0.079	0.396	0.98	12.4	2.0	9.6	SW-SM

PERFORMED IN GENERAL ACCORDANCE WITH ASTM C136 / D422

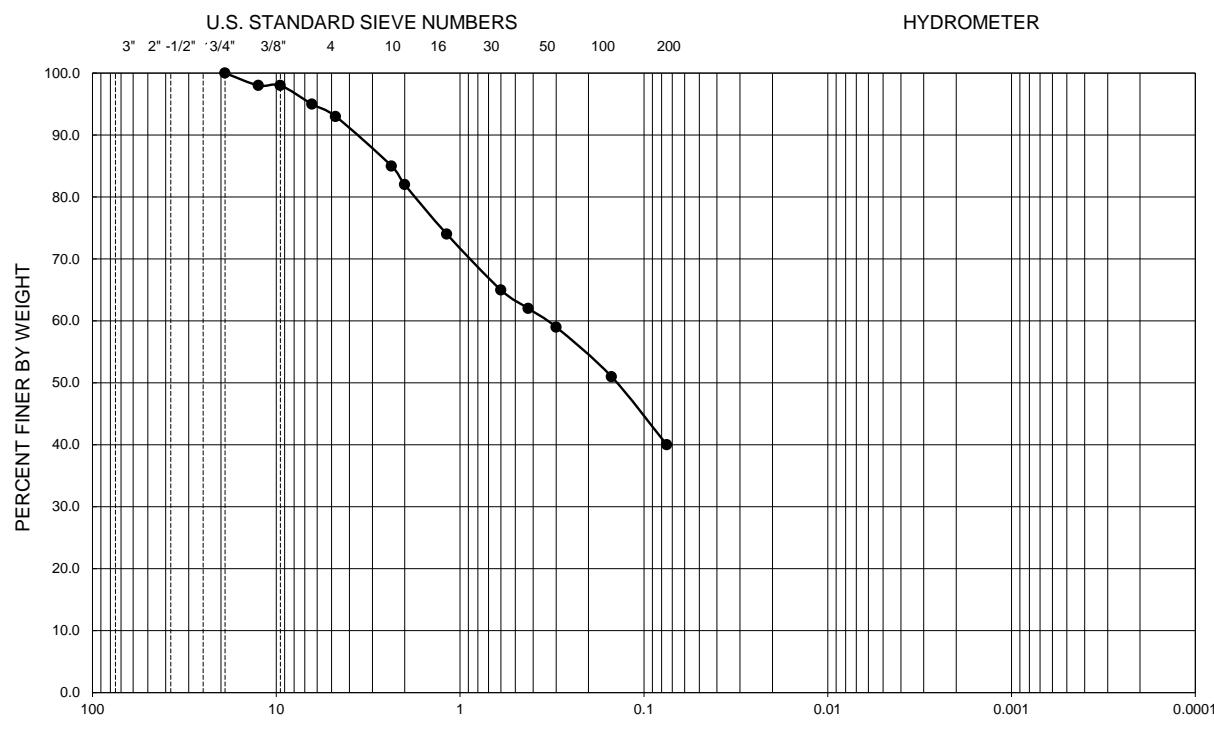
Symbol	Sample Location	Depth (ft)	Liquid Limit	Plastic Limit	Plasticity Index	D ₁₀	D ₃₀	D ₆₀	C _u	C _c	Passing No. 200 (percent)	USCS
●	B-3	0.0-5.0	--	--	NP	--	--	0.34	--	--	40.0	SM

PERFORMED IN GENERAL ACCORDANCE WITH ASTM C136 / D422

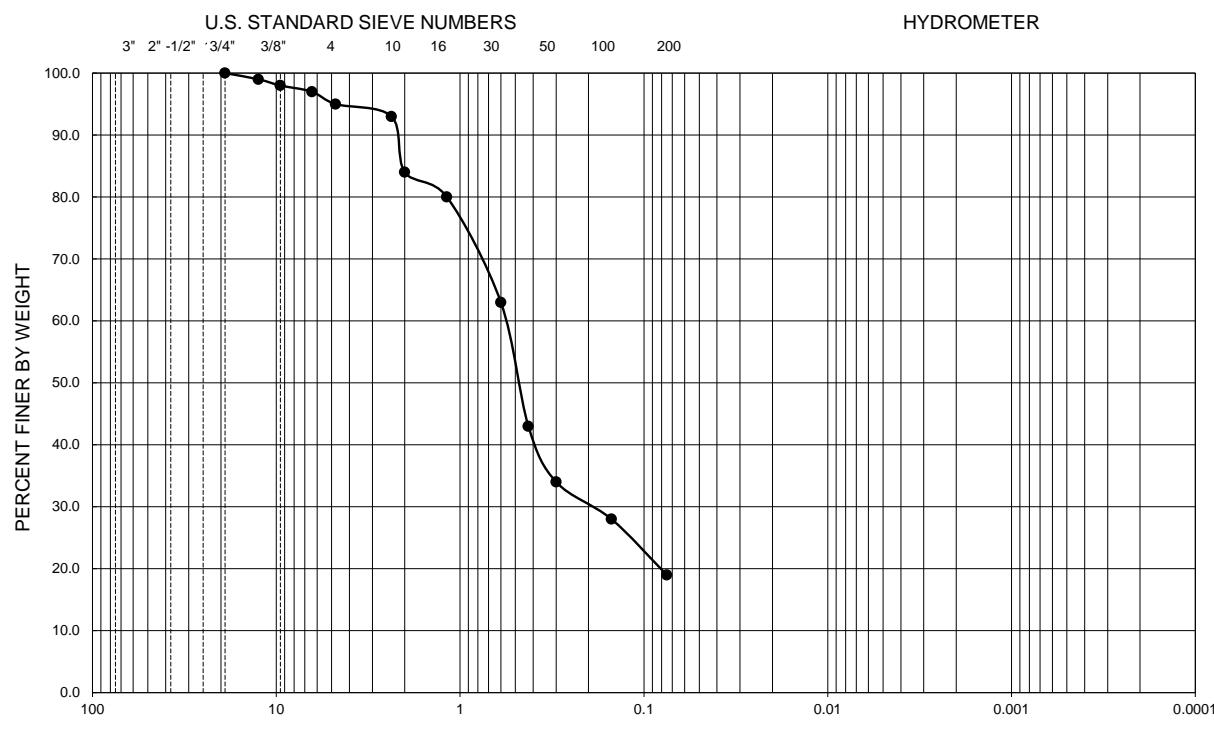
Symbol	Sample Location	Depth (ft)	Liquid Limit	Plastic Limit	Plasticity Index	D ₁₀	D ₃₀	D ₆₀	C _u	C _c	Passing No. 200 (percent)	USCS
●	B-3	18.0-25.0	--	--	NP	--	0.342	1.07	--	--	14.0	SM

PERFORMED IN GENERAL ACCORDANCE WITH ASTM C136 / D422

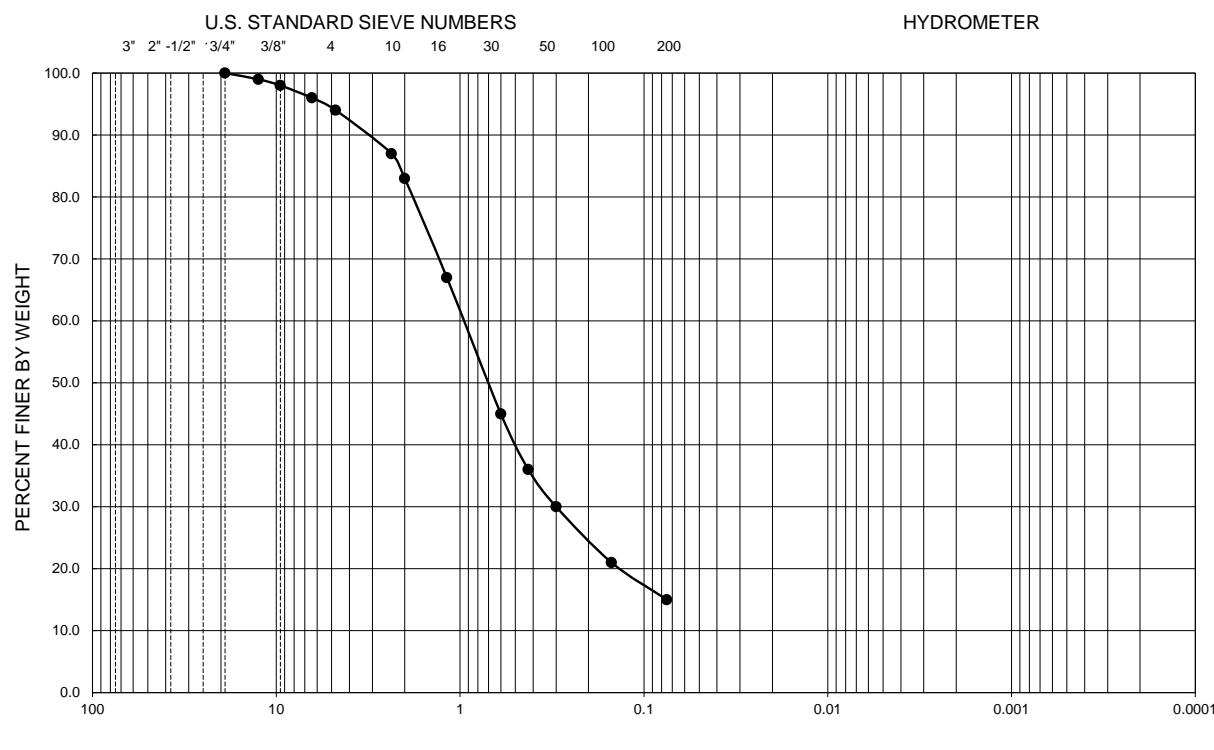
Symbol	Sample Location	Depth (ft)	Liquid Limit	Plastic Limit	Plasticity Index	D ₁₀	D ₃₀	D ₆₀	C _u	C _c	Passing No. 200 (percent)	USCS
●	B-4	0.0-5.0	--	--	NP	--	0.305	0.95	--	--	15.0	SM

PERFORMED IN GENERAL ACCORDANCE WITH ASTM C136 / D422

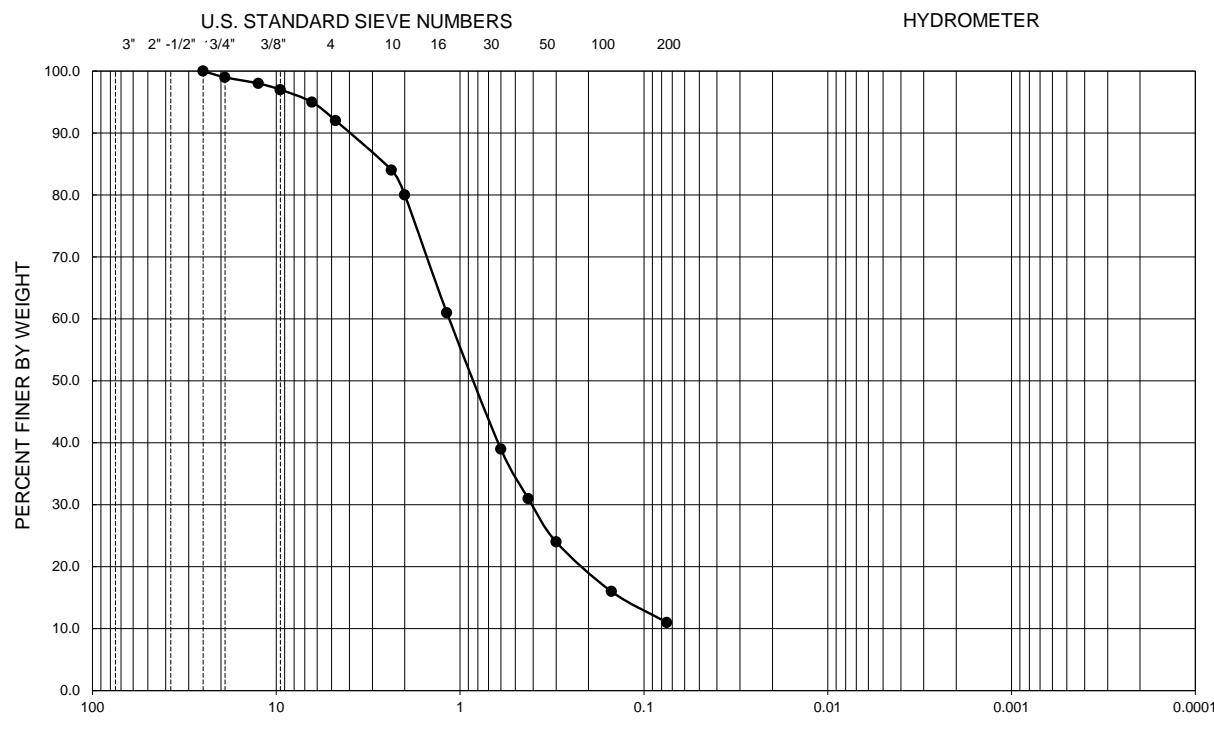
Symbol	Sample Location	Depth (ft)	Liquid Limit	Plastic Limit	Plasticity Index	D_{10}	D_{30}	D_{60}	C_u	C_c	Passing No. 200 (percent)	USCS
●	B-6	0.0-5.0	--	--	NP	--	0.411	1.16	--	--	11.0	SP-SM

PERFORMED IN GENERAL ACCORDANCE WITH ASTM C136 / D422

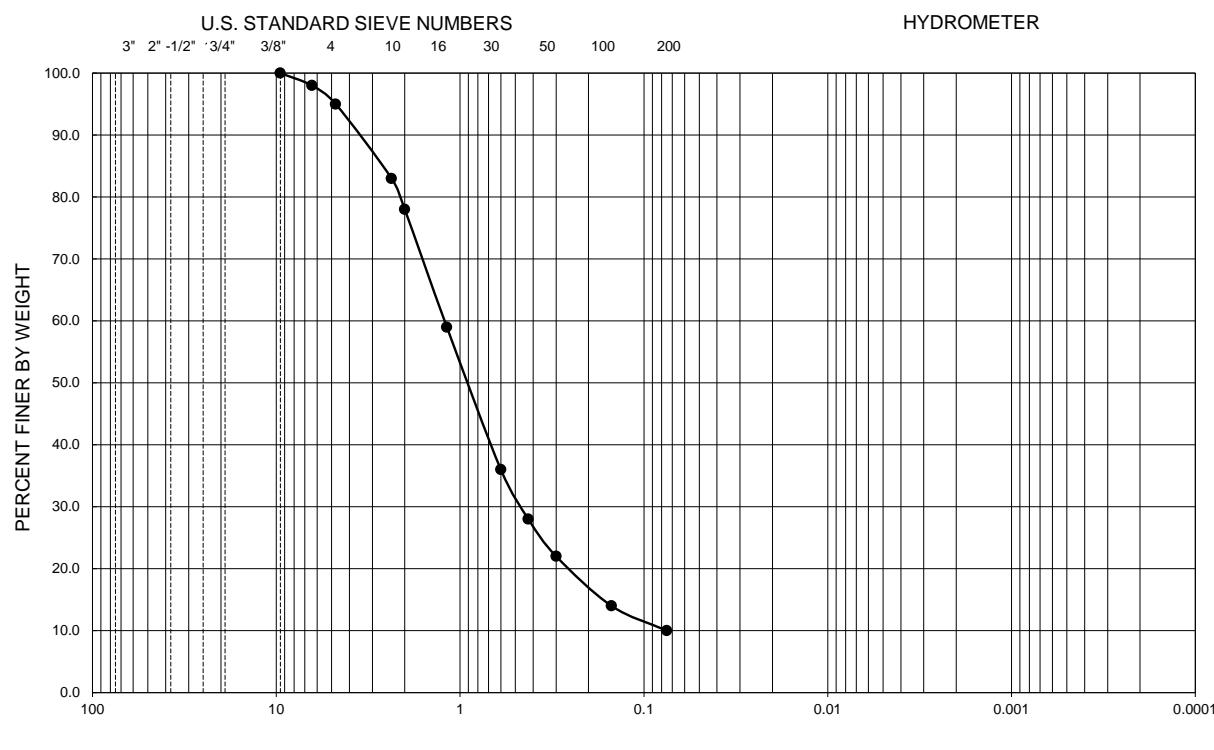
Symbol	Sample Location	Depth (ft)	Liquid Limit	Plastic Limit	Plasticity Index	D ₁₀	D ₃₀	D ₆₀	C _u	C _c	Passing No. 200 (percent)	USCS
●	B-7	0.0-5.0	--	--	NP	0.074	0.466	1.23	16.6	2.4	10.0	SW-SM

PERFORMED IN GENERAL ACCORDANCE WITH ASTM C136 / D422

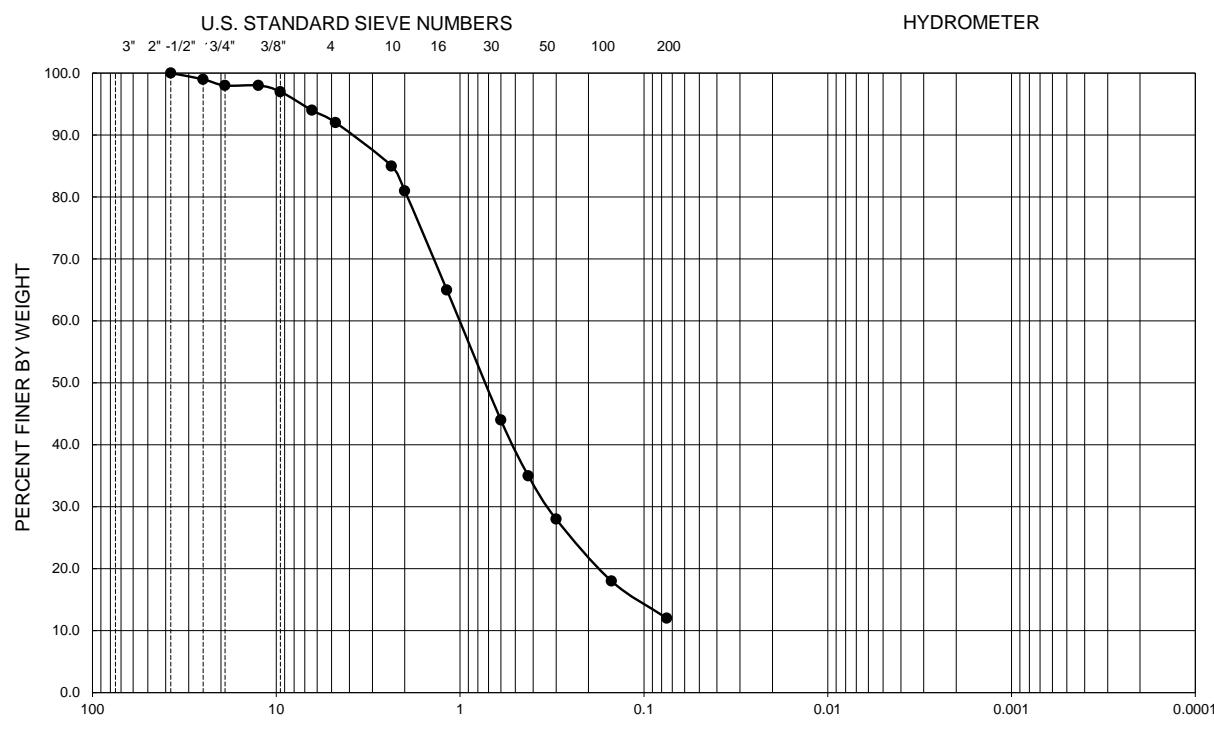
Symbol	Sample Location	Depth (ft)	Liquid Limit	Plastic Limit	Plasticity Index	D ₁₀	D ₃₀	D ₆₀	C _u	C _c	Passing No. 200 (percent)	USCS
●	B-8	0.0-5.0	--	--	NP	--	0.337	1.01	--	--	12.0	SM

PERFORMED IN GENERAL ACCORDANCE WITH ASTM C136 / D422

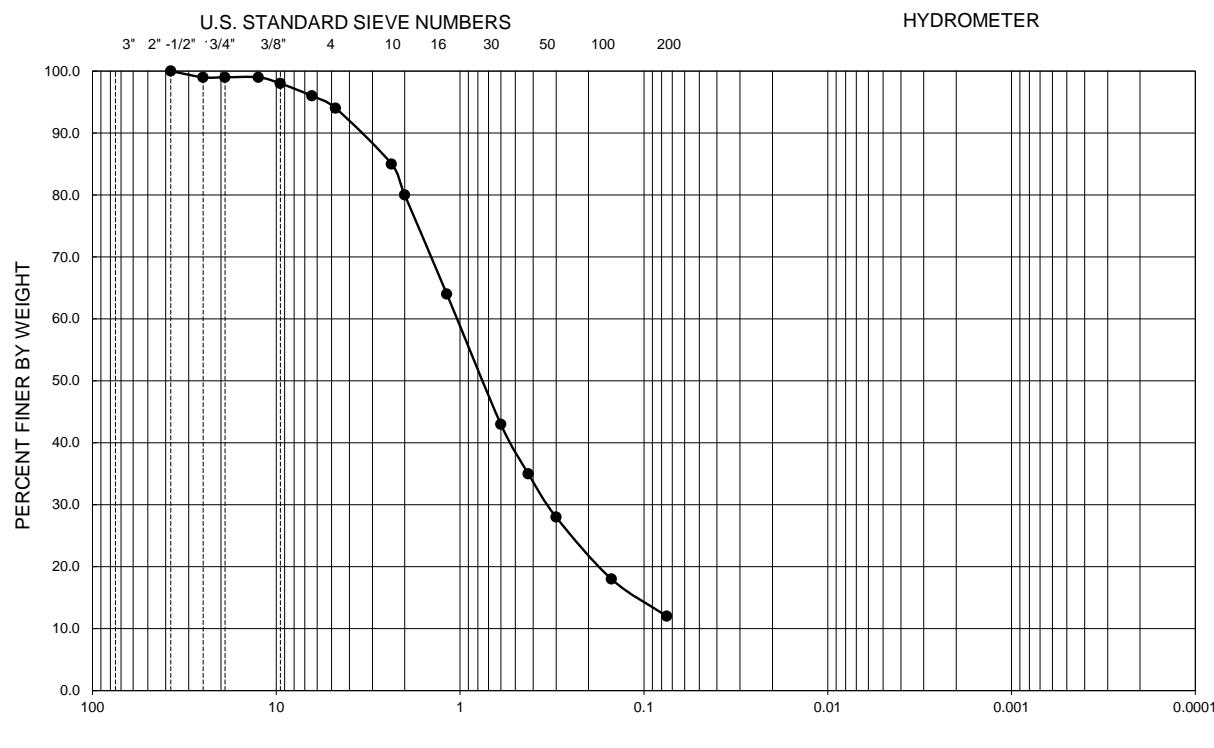
Symbol	Sample Location	Depth (ft)	Liquid Limit	Plastic Limit	Plasticity Index	D ₁₀	D ₃₀	D ₆₀	C _u	C _c	Passing No. 200 (percent)	USCS
●	B-9	0.0-5.0	--	--	NP	--	0.337	1.04	--	--	12.0	SP-SM

PERFORMED IN GENERAL ACCORDANCE WITH ASTM C136 / D422

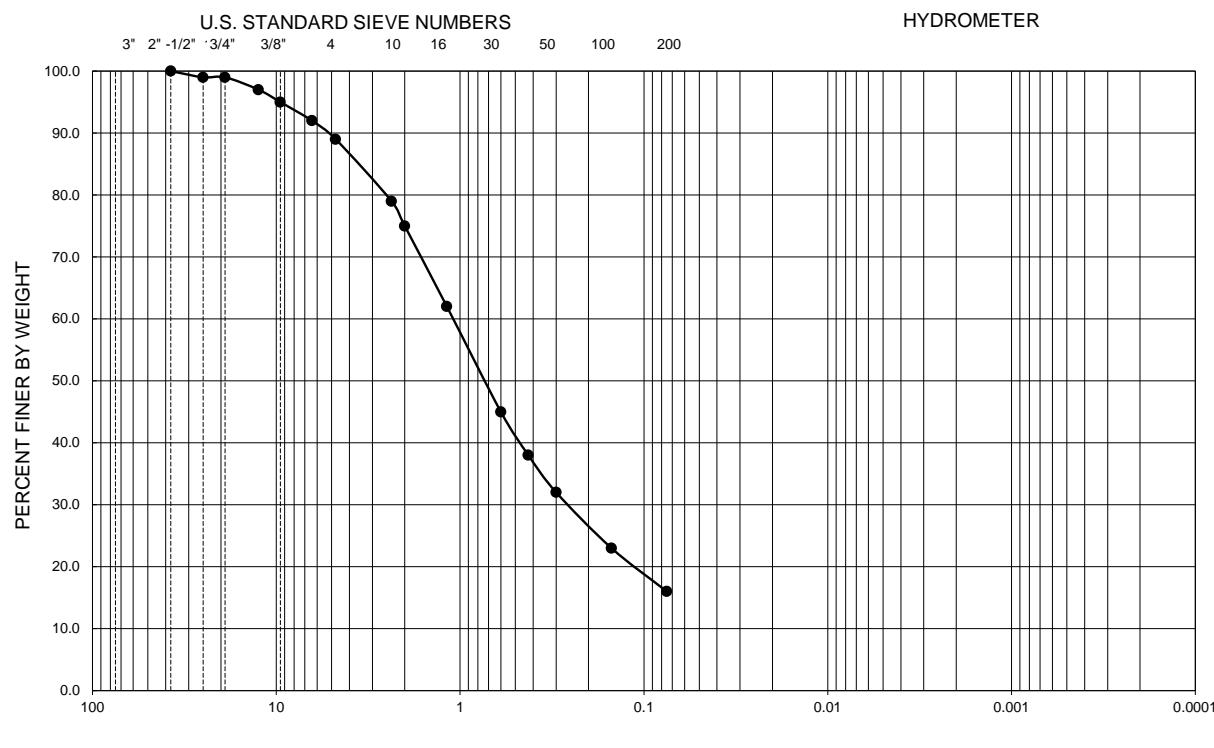
Symbol	Sample Location	Depth (ft)	Liquid Limit	Plastic Limit	Plasticity Index	D_{10}	D_{30}	D_{60}	C_u	C_c	Passing No. 200 (percent)	USCS
●	B-10	0.0-5.0	23	17	6	--	0.260	1.10	--	--	16.0	SC-SM

PERFORMED IN GENERAL ACCORDANCE WITH ASTM C136 / D422

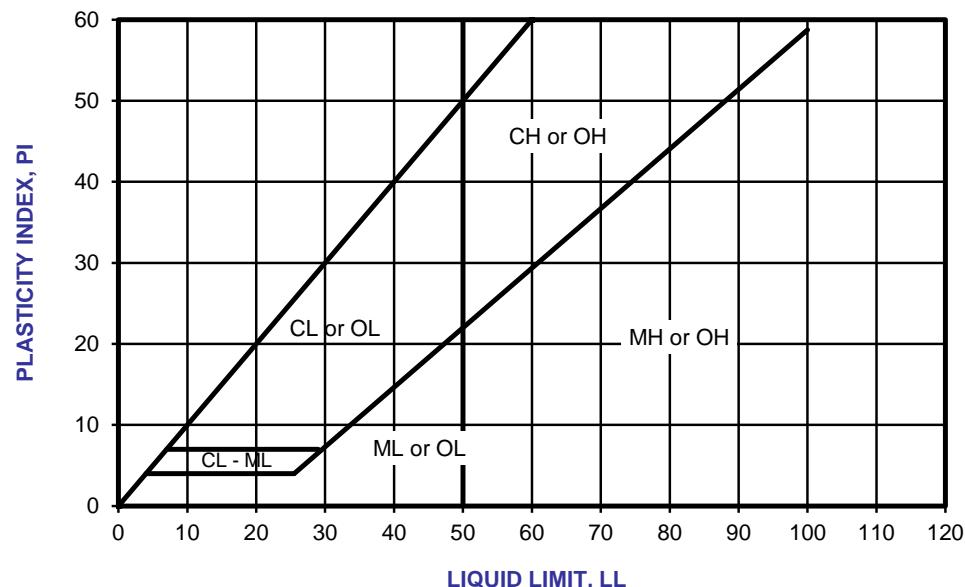
FIGURE B-14

SYMBOL	LOCATION	DEPTH (ft)	LIQUID LIMIT	PLASTIC LIMIT	PLASTICITY INDEX	USCS CLASSIFICATION (Fraction Finer Than No. 40 Sieve)	USCS
●	B-1	0.0-5.0	--	--	NP	ML	SW-SM
■	B-1	8.5-10.0	--	--	NP	ML	SW-SM
◆	B-2	0.0-5.0	--	--	NP	ML	SM
○	B-3	0.0-5.0	--	--	NP	ML	SM
□	B-3	18.0-25.0	--	--	NP	ML	SM
△	B-4	0.0-5.0	--	--	NP	ML	SM
✗	B-5	0.0-5.0	--	--	NP	ML	SM
+	B-5	13.5-15.0	--	--	NP	ML	SM

PERFORMED IN GENERAL ACCORDANCE WITH ASTM D 4318

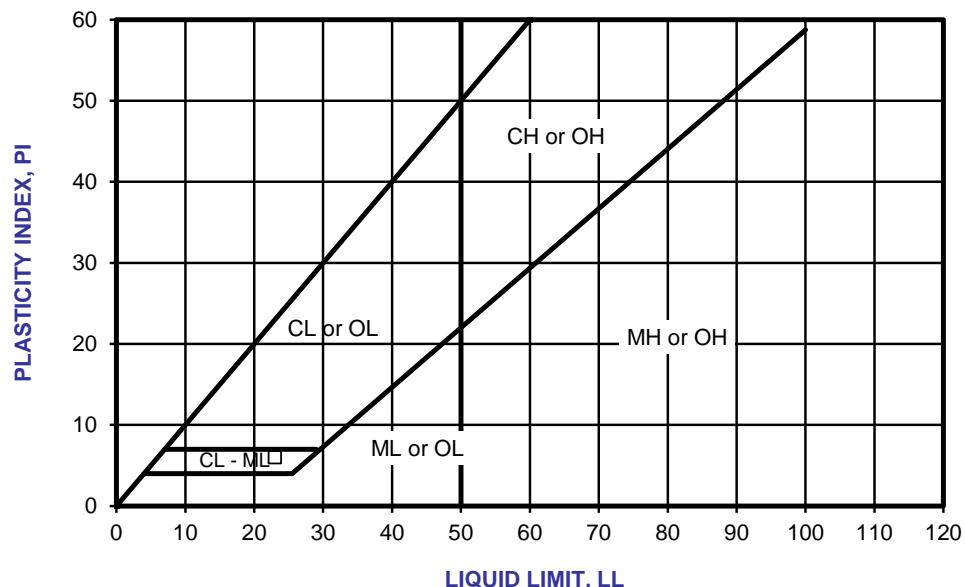
FIGURE B-15

SYMBOL	LOCATION	DEPTH (ft)	LIQUID LIMIT	PLASTIC LIMIT	PLASTICITY INDEX	USCS CLASSIFICATION (Fraction Finer Than No. 40 Sieve)	USCS
●	B-6	0.0-5.0	--	--	NP	ML	SP-SM
■	B-7	0.0-5.0	--	--	NP	ML	SW-SM
◆	B-8	0.0-5.0	--	--	NP	ML	SM
○	B-9	0.0-5.0	--	--	NP	ML	SP-SM
□	B-10	0.0-5.0	23	17	6	CL-ML	SC-SM

PERFORMED IN GENERAL ACCORDANCE WITH ASTM D 4318

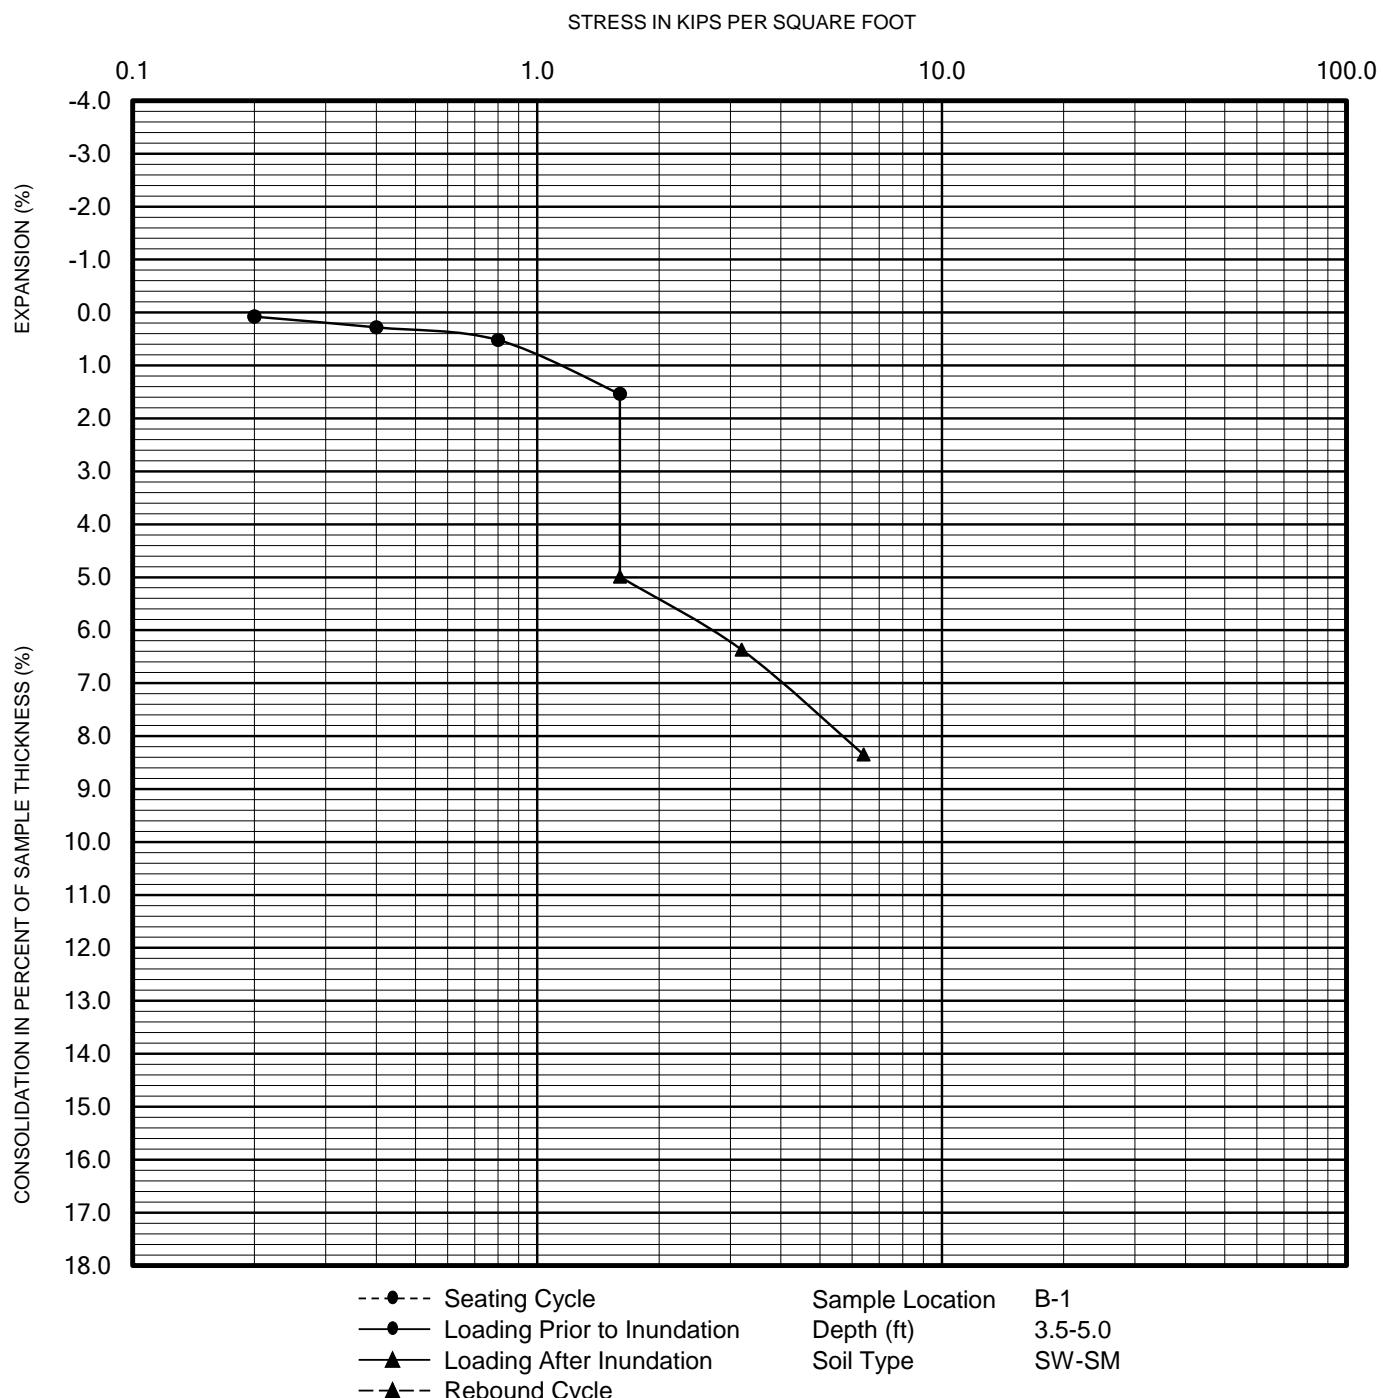
PERFORMED IN GENERAL ACCORDANCE WITH ASTM D 2435

FIGURE B-16
CONSOLIDATION TEST RESULTS

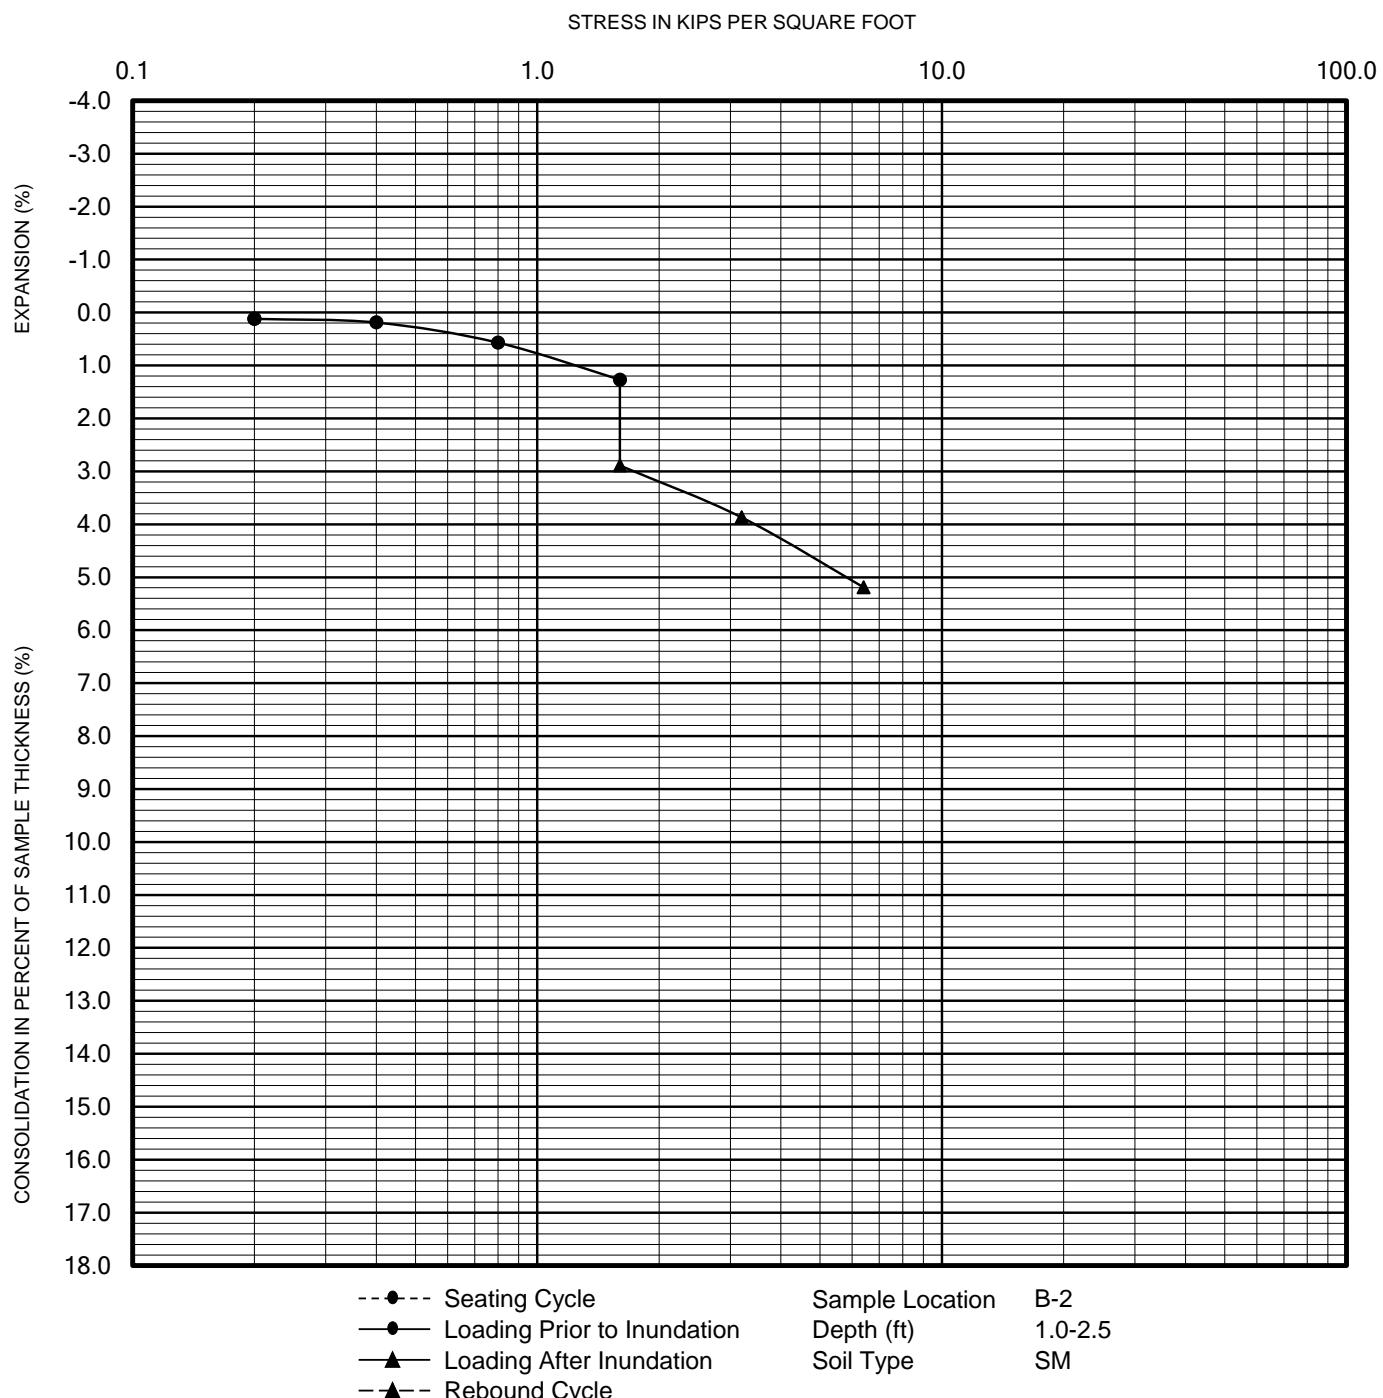
PERFORMED IN GENERAL ACCORDANCE WITH ASTM D 2435

FIGURE B-17
CONSOLIDATION TEST RESULTS

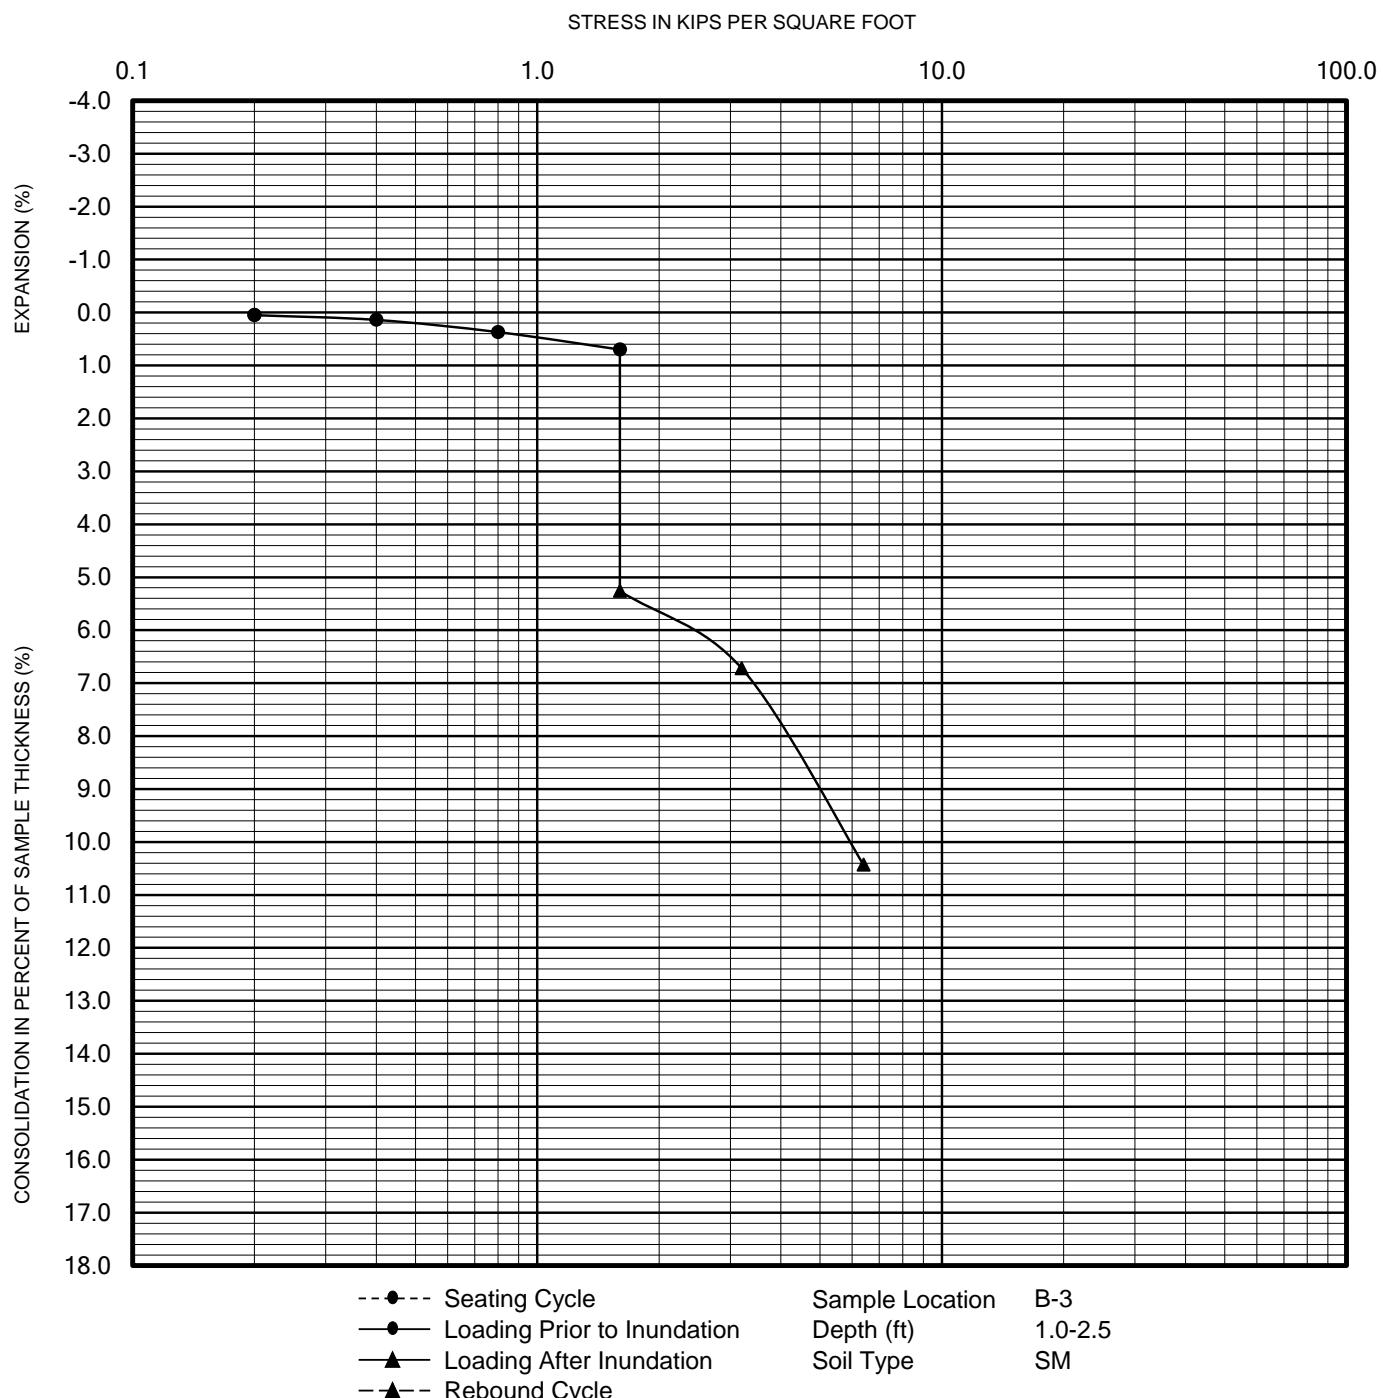
PERFORMED IN GENERAL ACCORDANCE WITH ASTM D 2435

FIGURE B-18
CONSOLIDATION TEST RESULTS

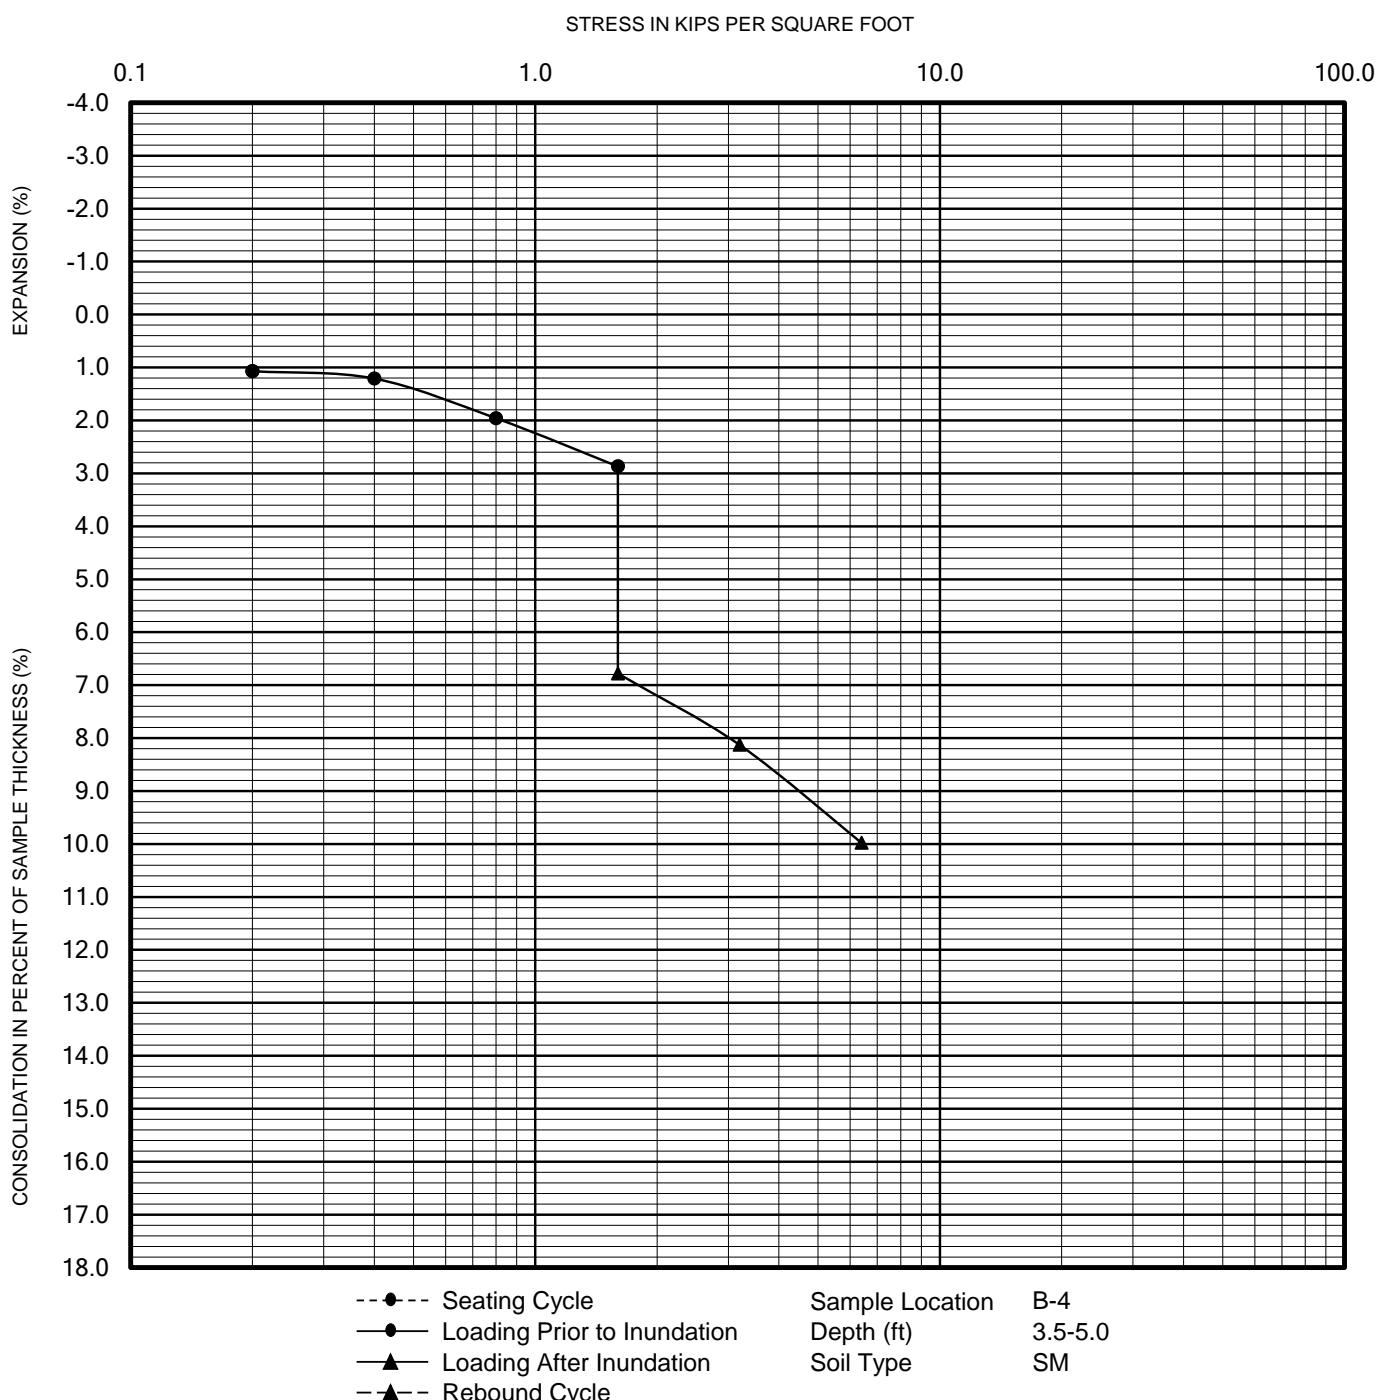
PERFORMED IN GENERAL ACCORDANCE WITH ASTM D 2435

FIGURE B-20 CONSOLIDATION TEST RESULTS
