PROJECT: Rancho Vistoso Parcel 5-R Proposed Rezoning
January 2026 Project Update and Hearing Request

May 13, 2025 | Project No. 607834001

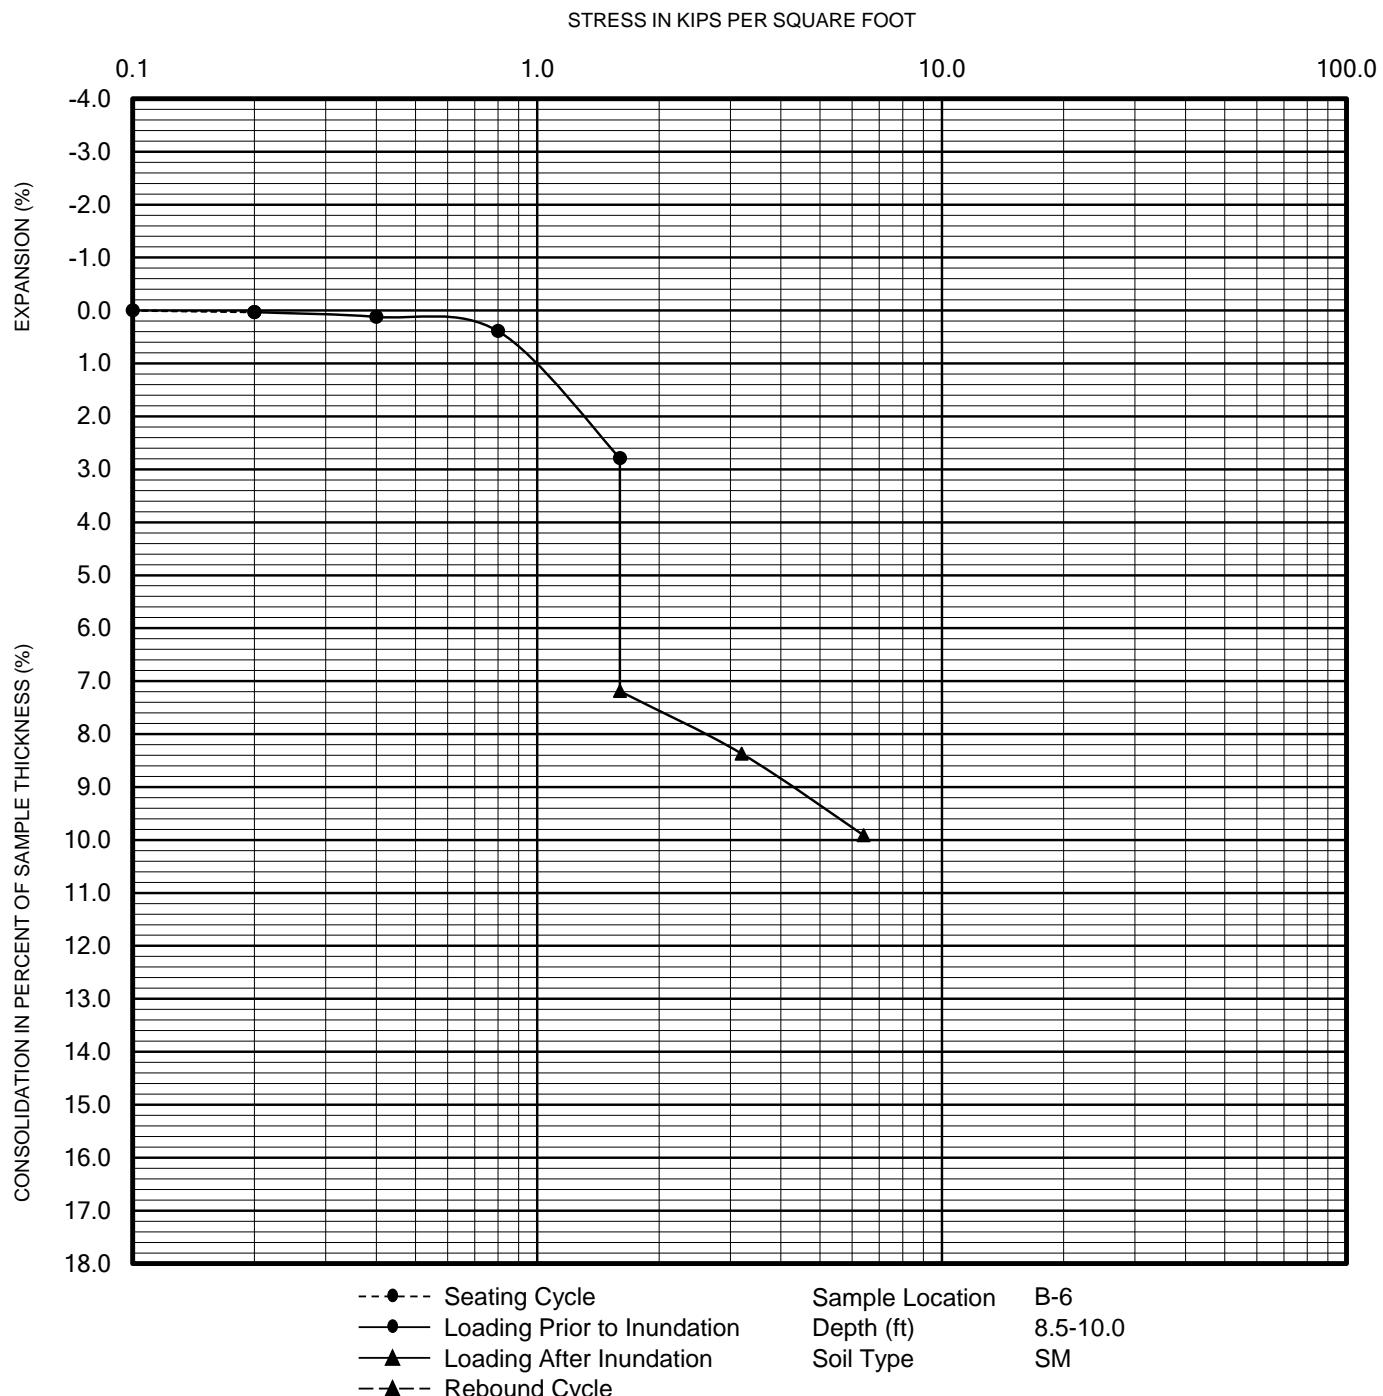
FIGURE B-22
CONSOLIDATION TEST RESULTS

PERFORMED IN GENERAL ACCORDANCE WITH ASTM D 2435

Consolidation test was performed on selected relatively undisturbed soil samples in general accordance with ASTM D2435. The samples were inundated during testing to represent adverse field conditions. The percent of consolidation for each load cycle was recorded as a ratio of the amount of vertical compression to the original height of the samples. The results of the tests are summarized on Figures B-16 through B-27.

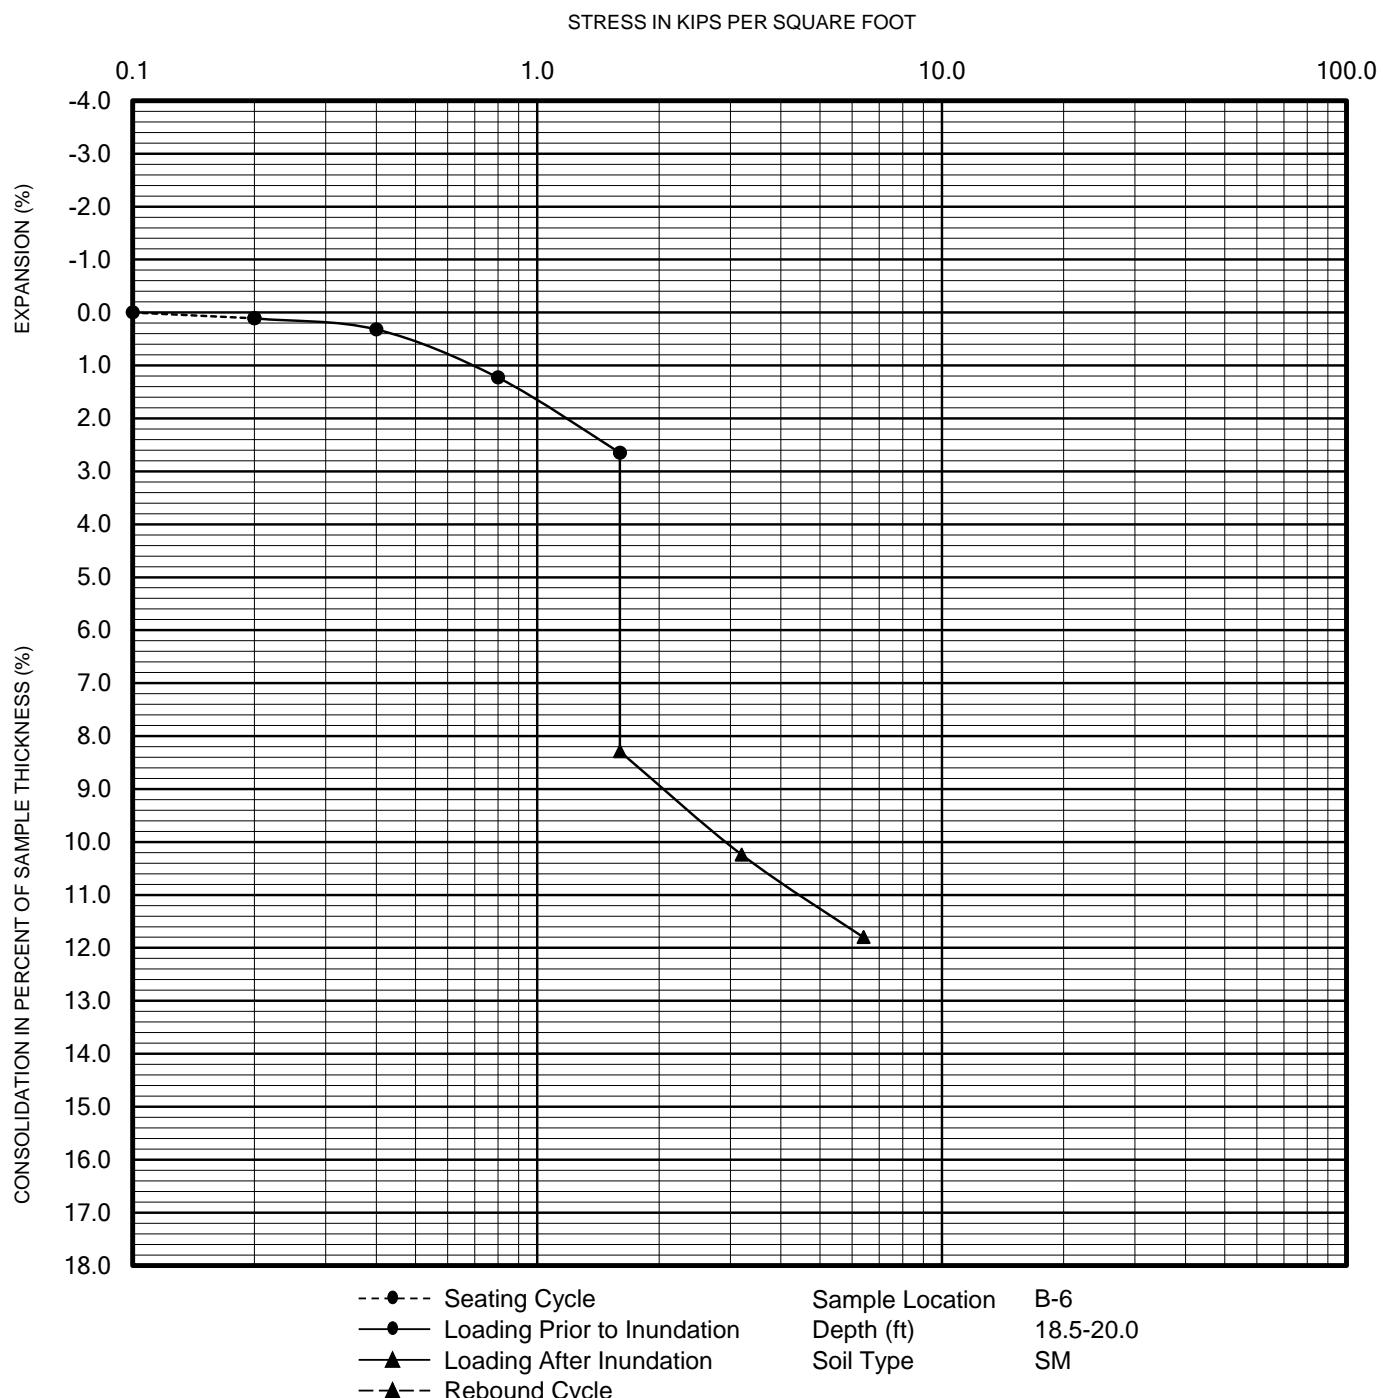
PERFORMED IN GENERAL ACCORDANCE WITH ASTM D 2435

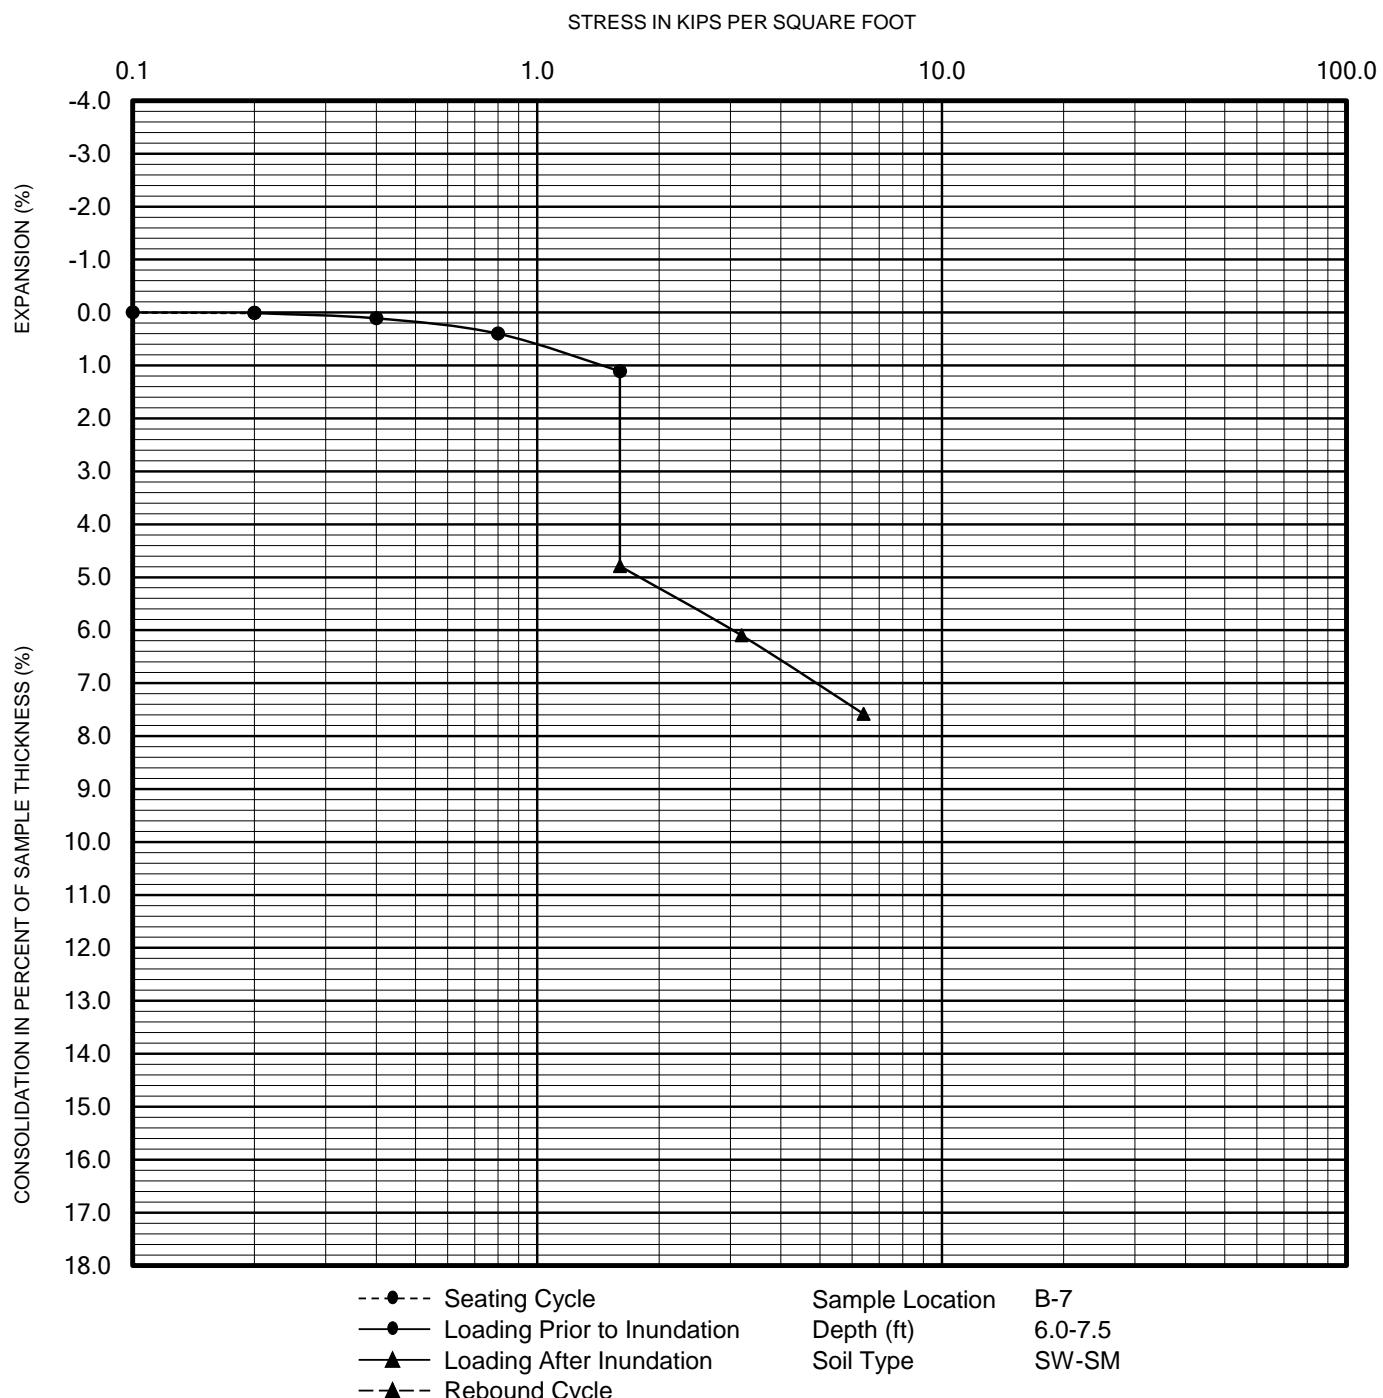
FIGURE B-24
CONSOLIDATION TEST RESULTS

PERFORMED IN GENERAL ACCORDANCE WITH ASTM D 2435

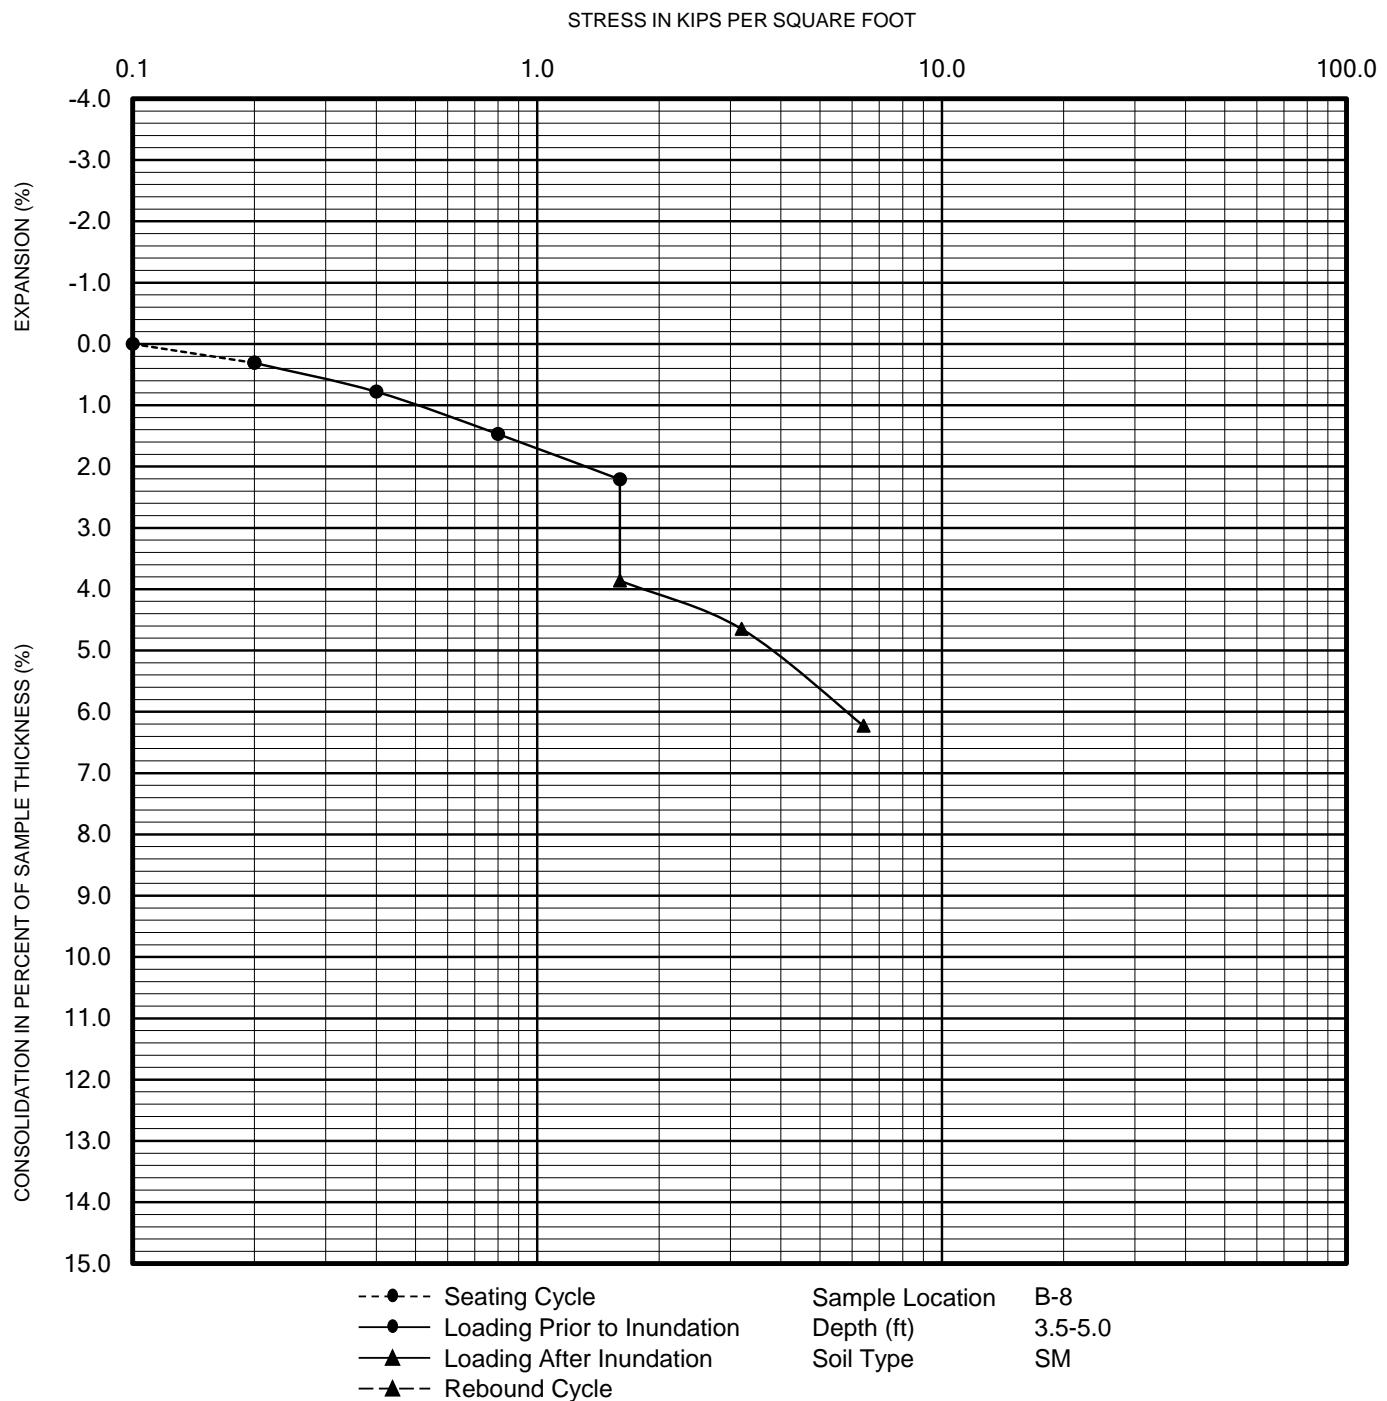
PERFORMED IN GENERAL ACCORDANCE WITH ASTM D 2435

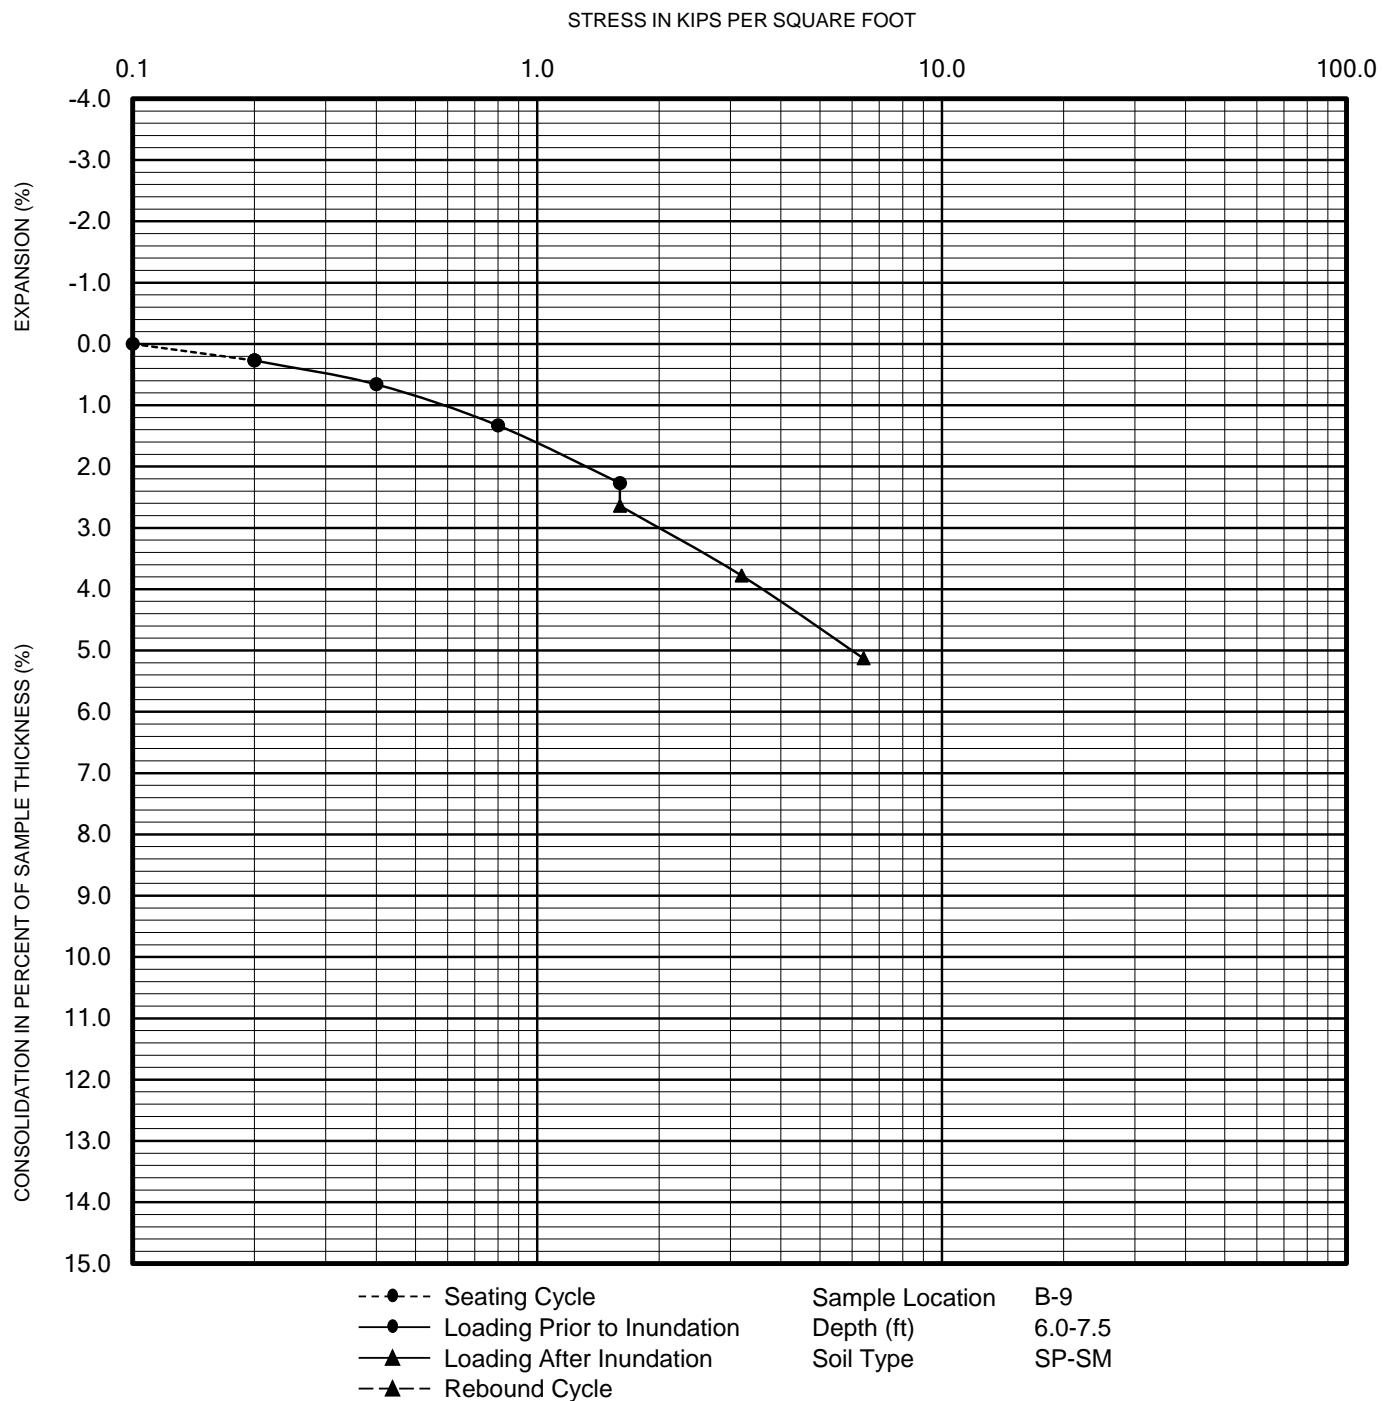
FIGURE B-26
CONSOLIDATION TEST RESULTS

PERFORMED IN GENERAL ACCORDANCE WITH ASTM D 2435

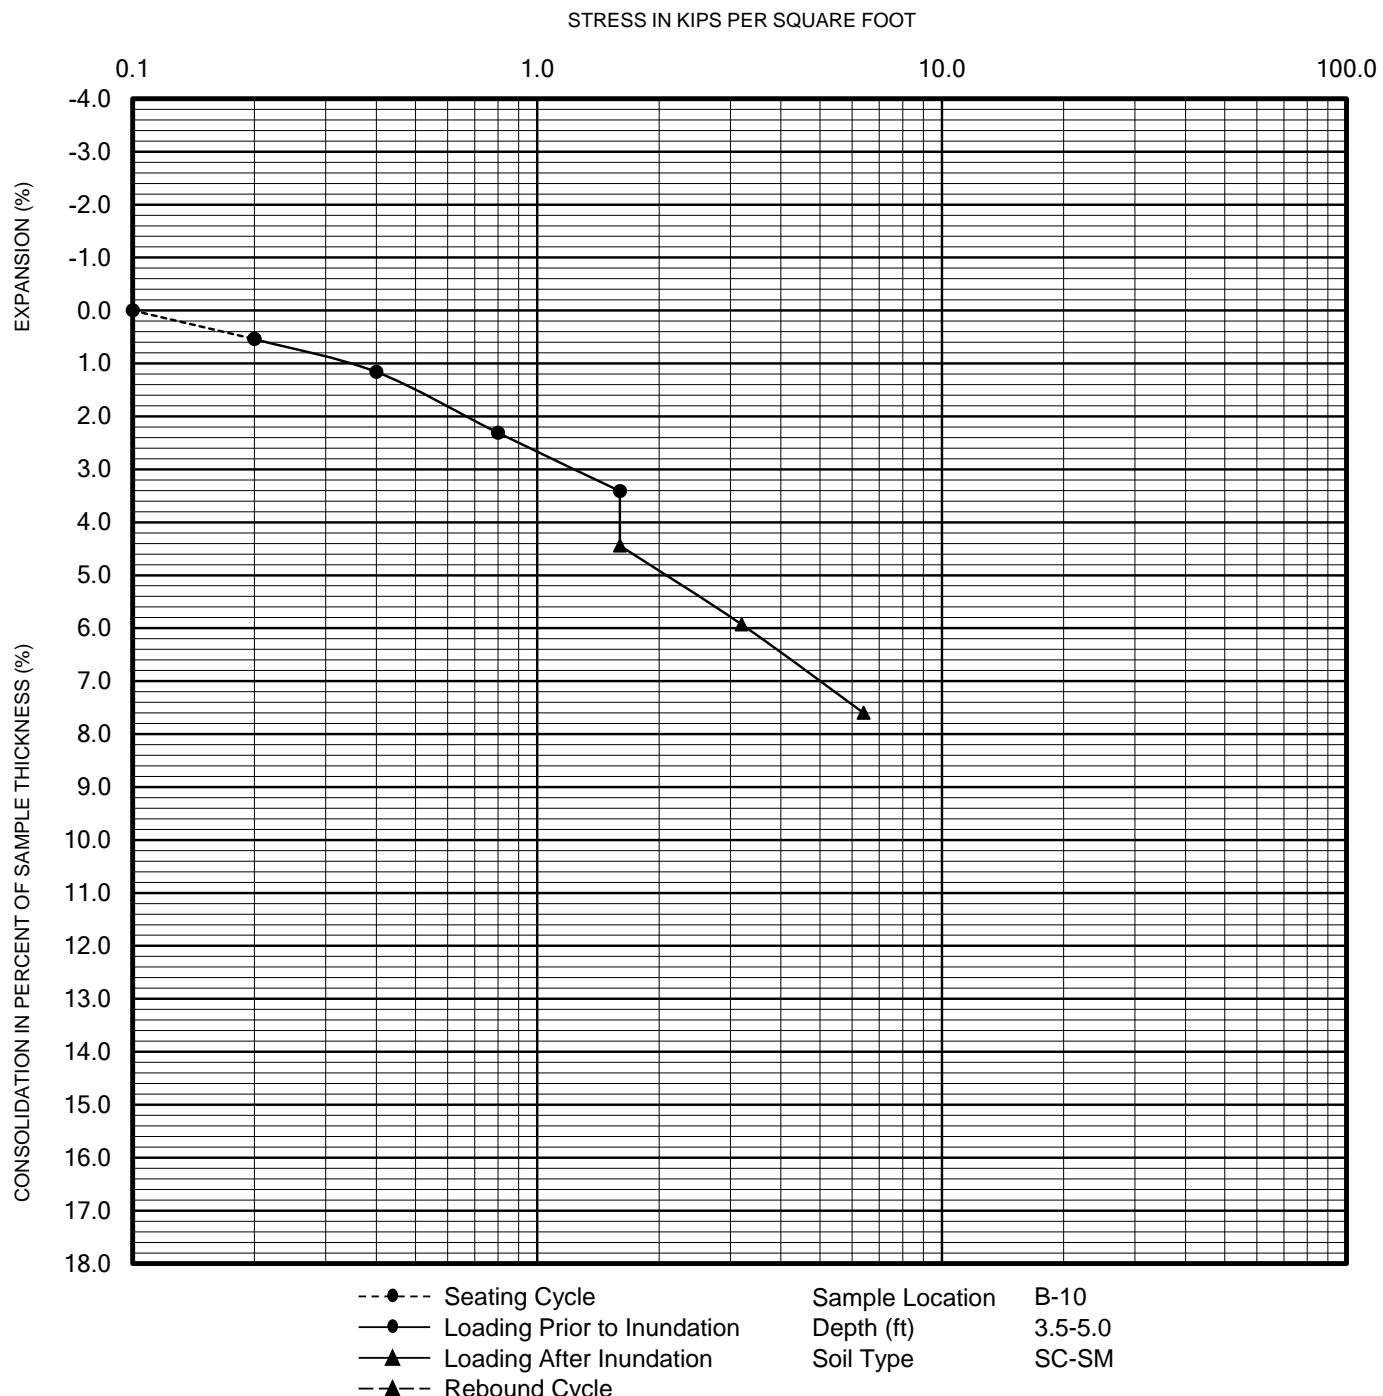
FIGURE B-27
CONSOLIDATION TEST RESULTS

PERFORMED IN GENERAL ACCORDANCE WITH ASTM D 2435
