August 22, 2023 Project No. 606630015

Subject: Geotechnical Services Valley Vista Sewer and Pump Station Evaluation Oro Valley, Arizona

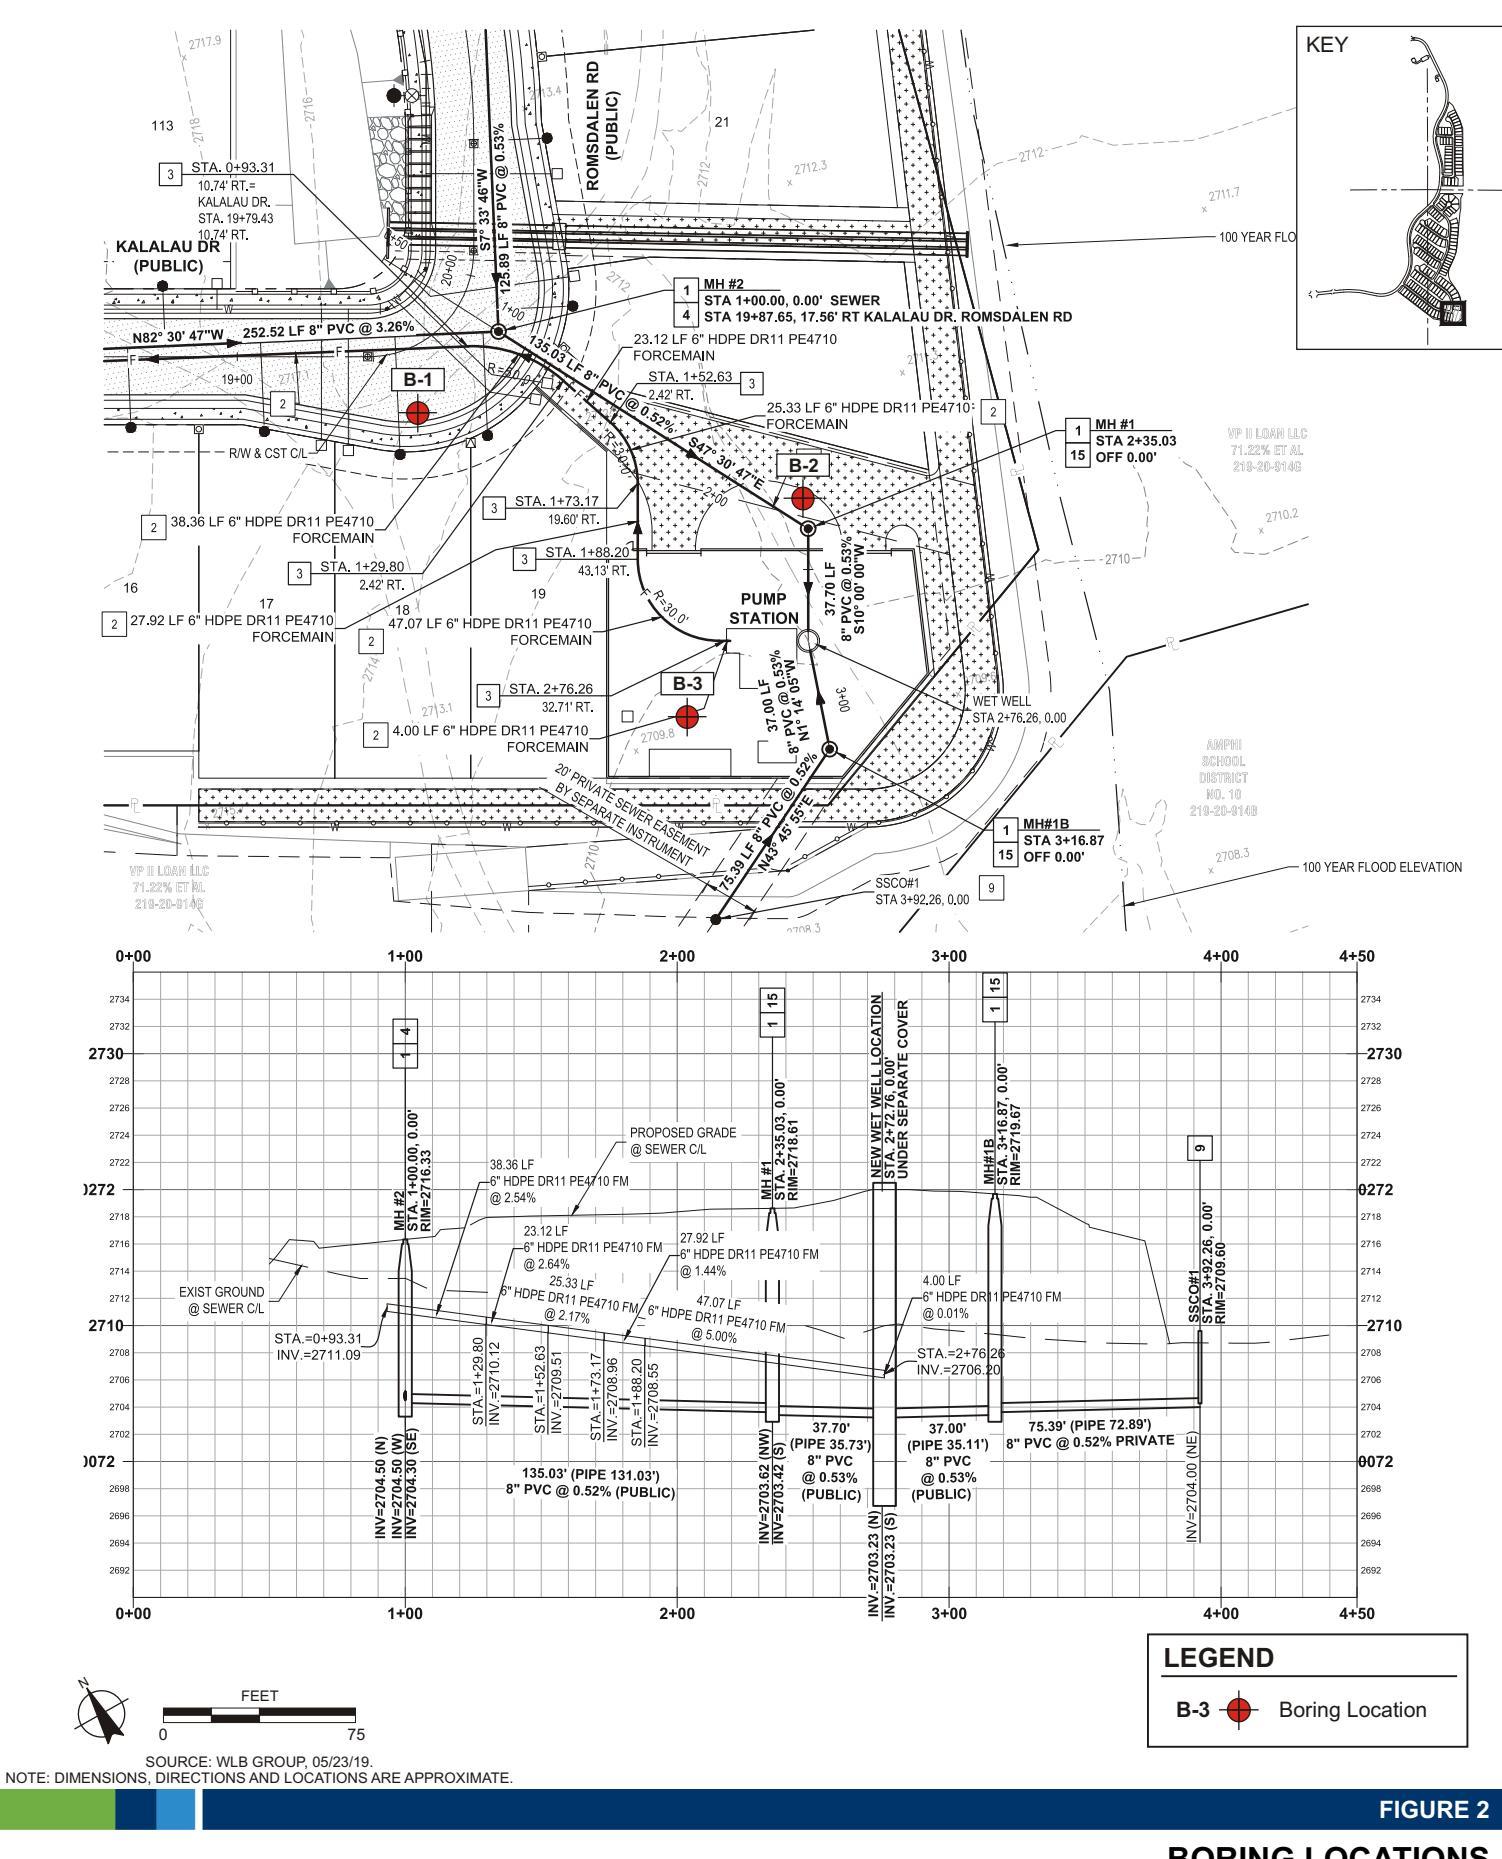
## **BORING LOCATIONS**

On July 14 and August 9, 2023, Ninyo & Moore conducted a geotechnical exploration in order to evaluate the subgrade conditions. Our evaluation consisted of drilling, logging, and sampling three exploratory borings denoted as B-1 through B-3, using a CME 75 truck mounted drill rig equipped

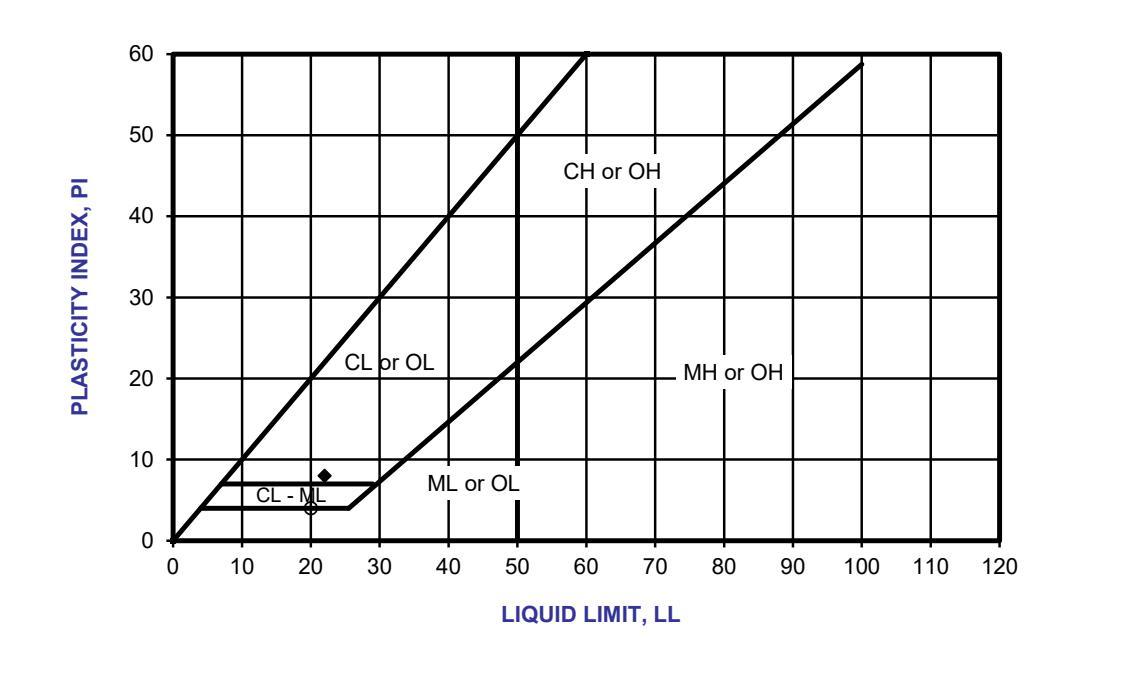
#### FIGURE B-8

PERFORMED IN GENERAL ACCORDANCE WITH ASTM D 4318

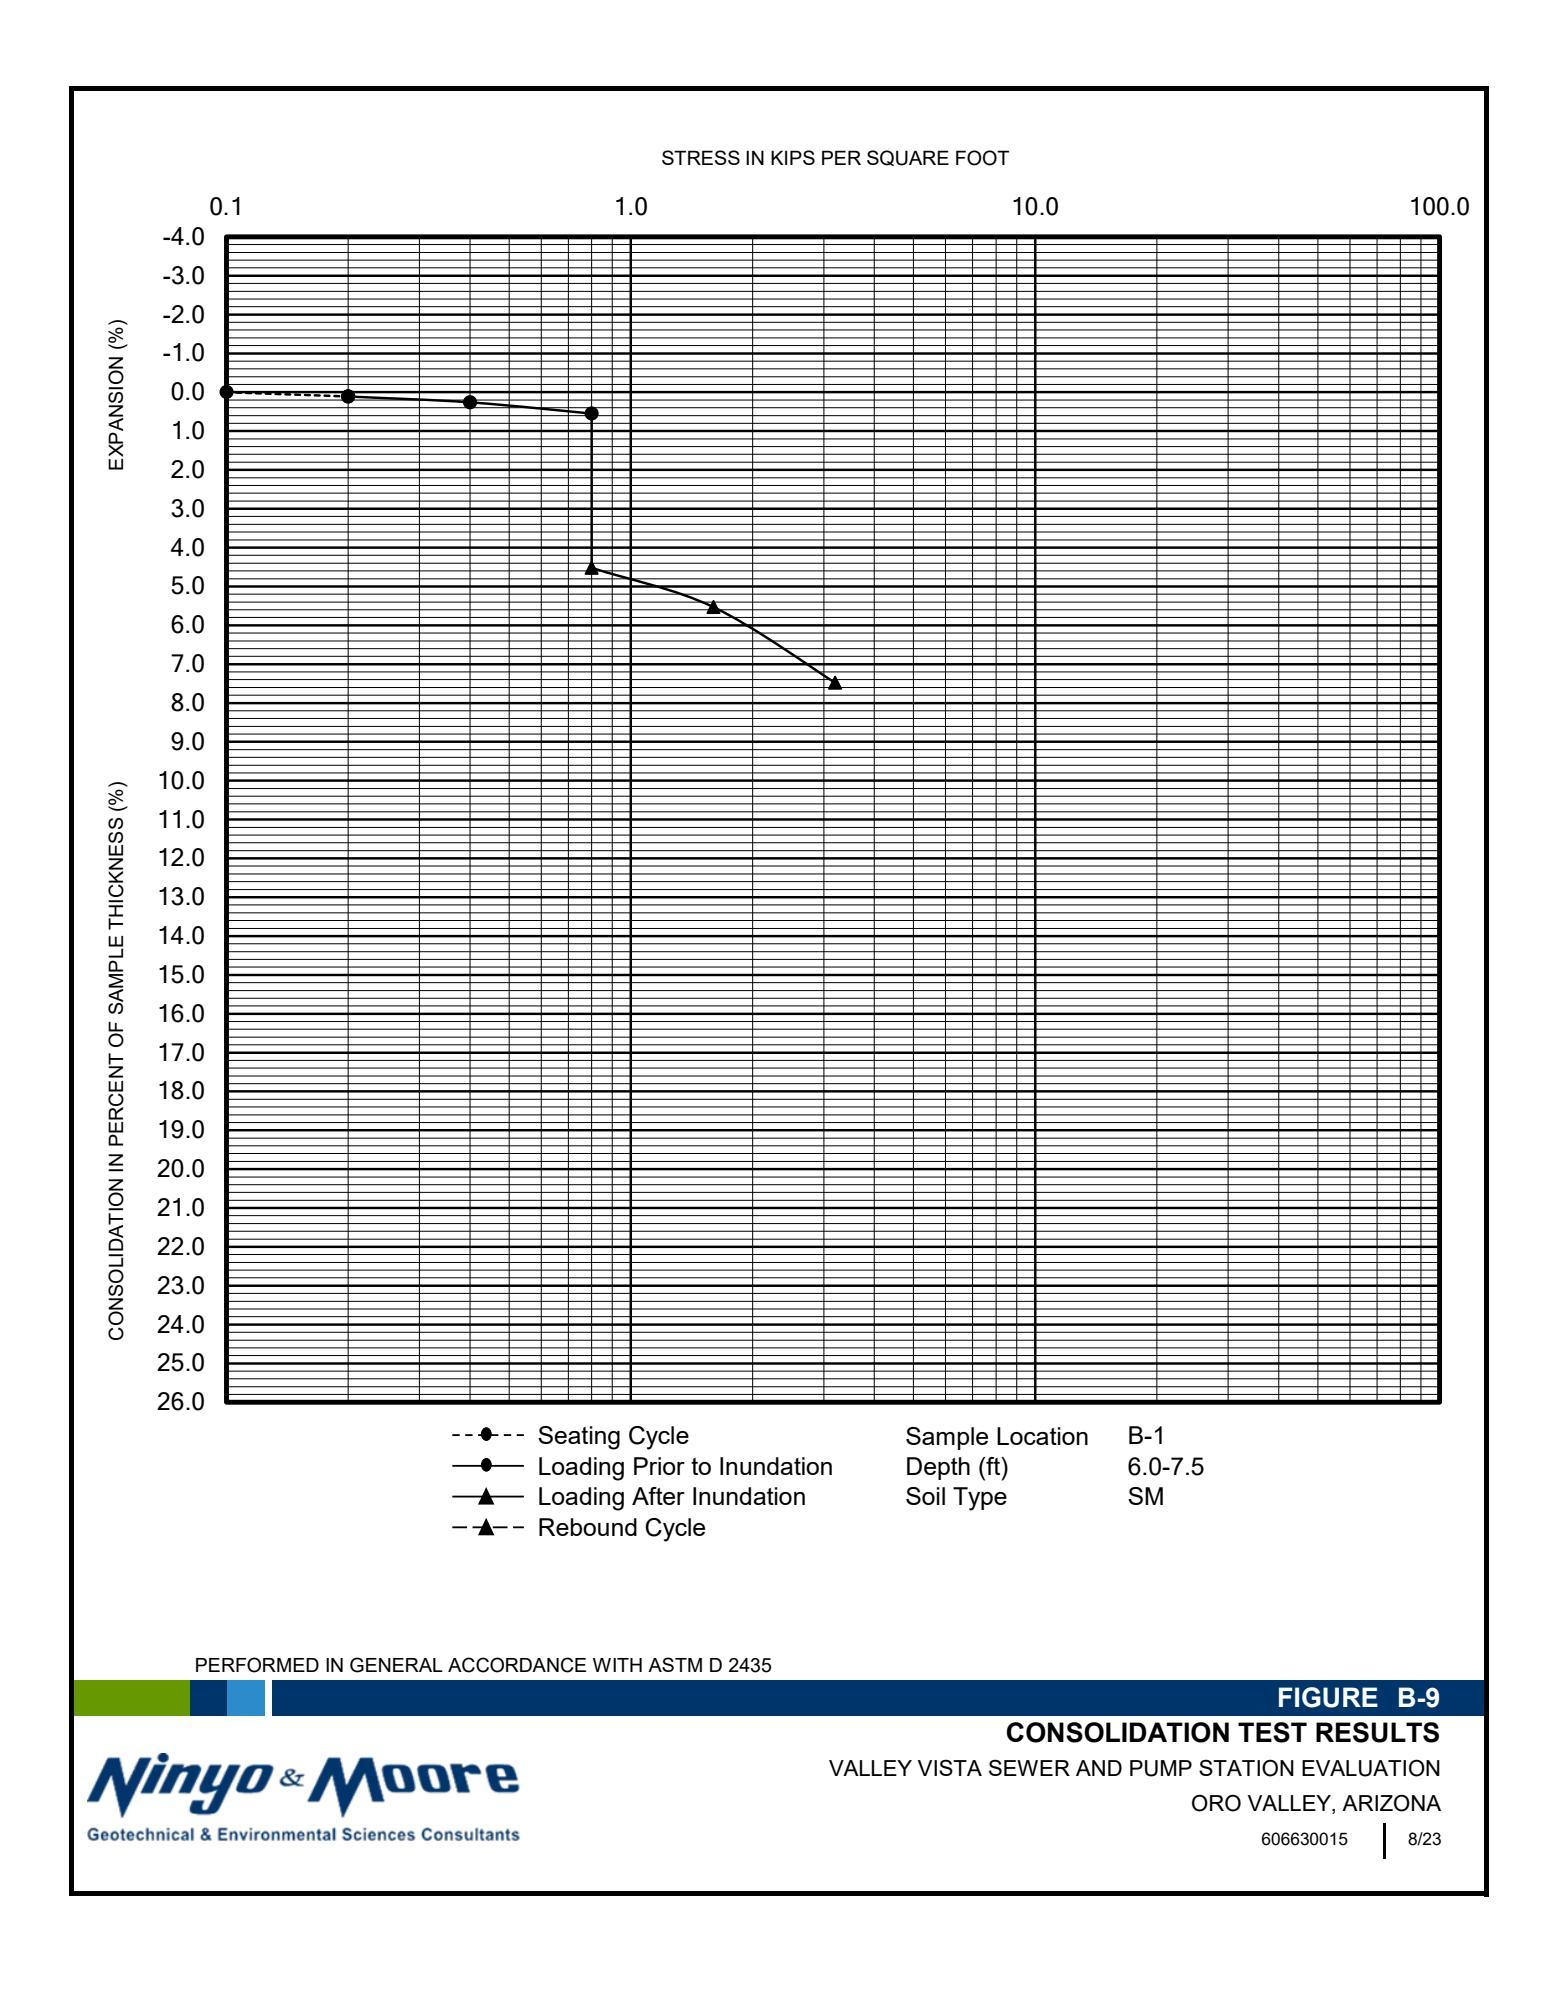
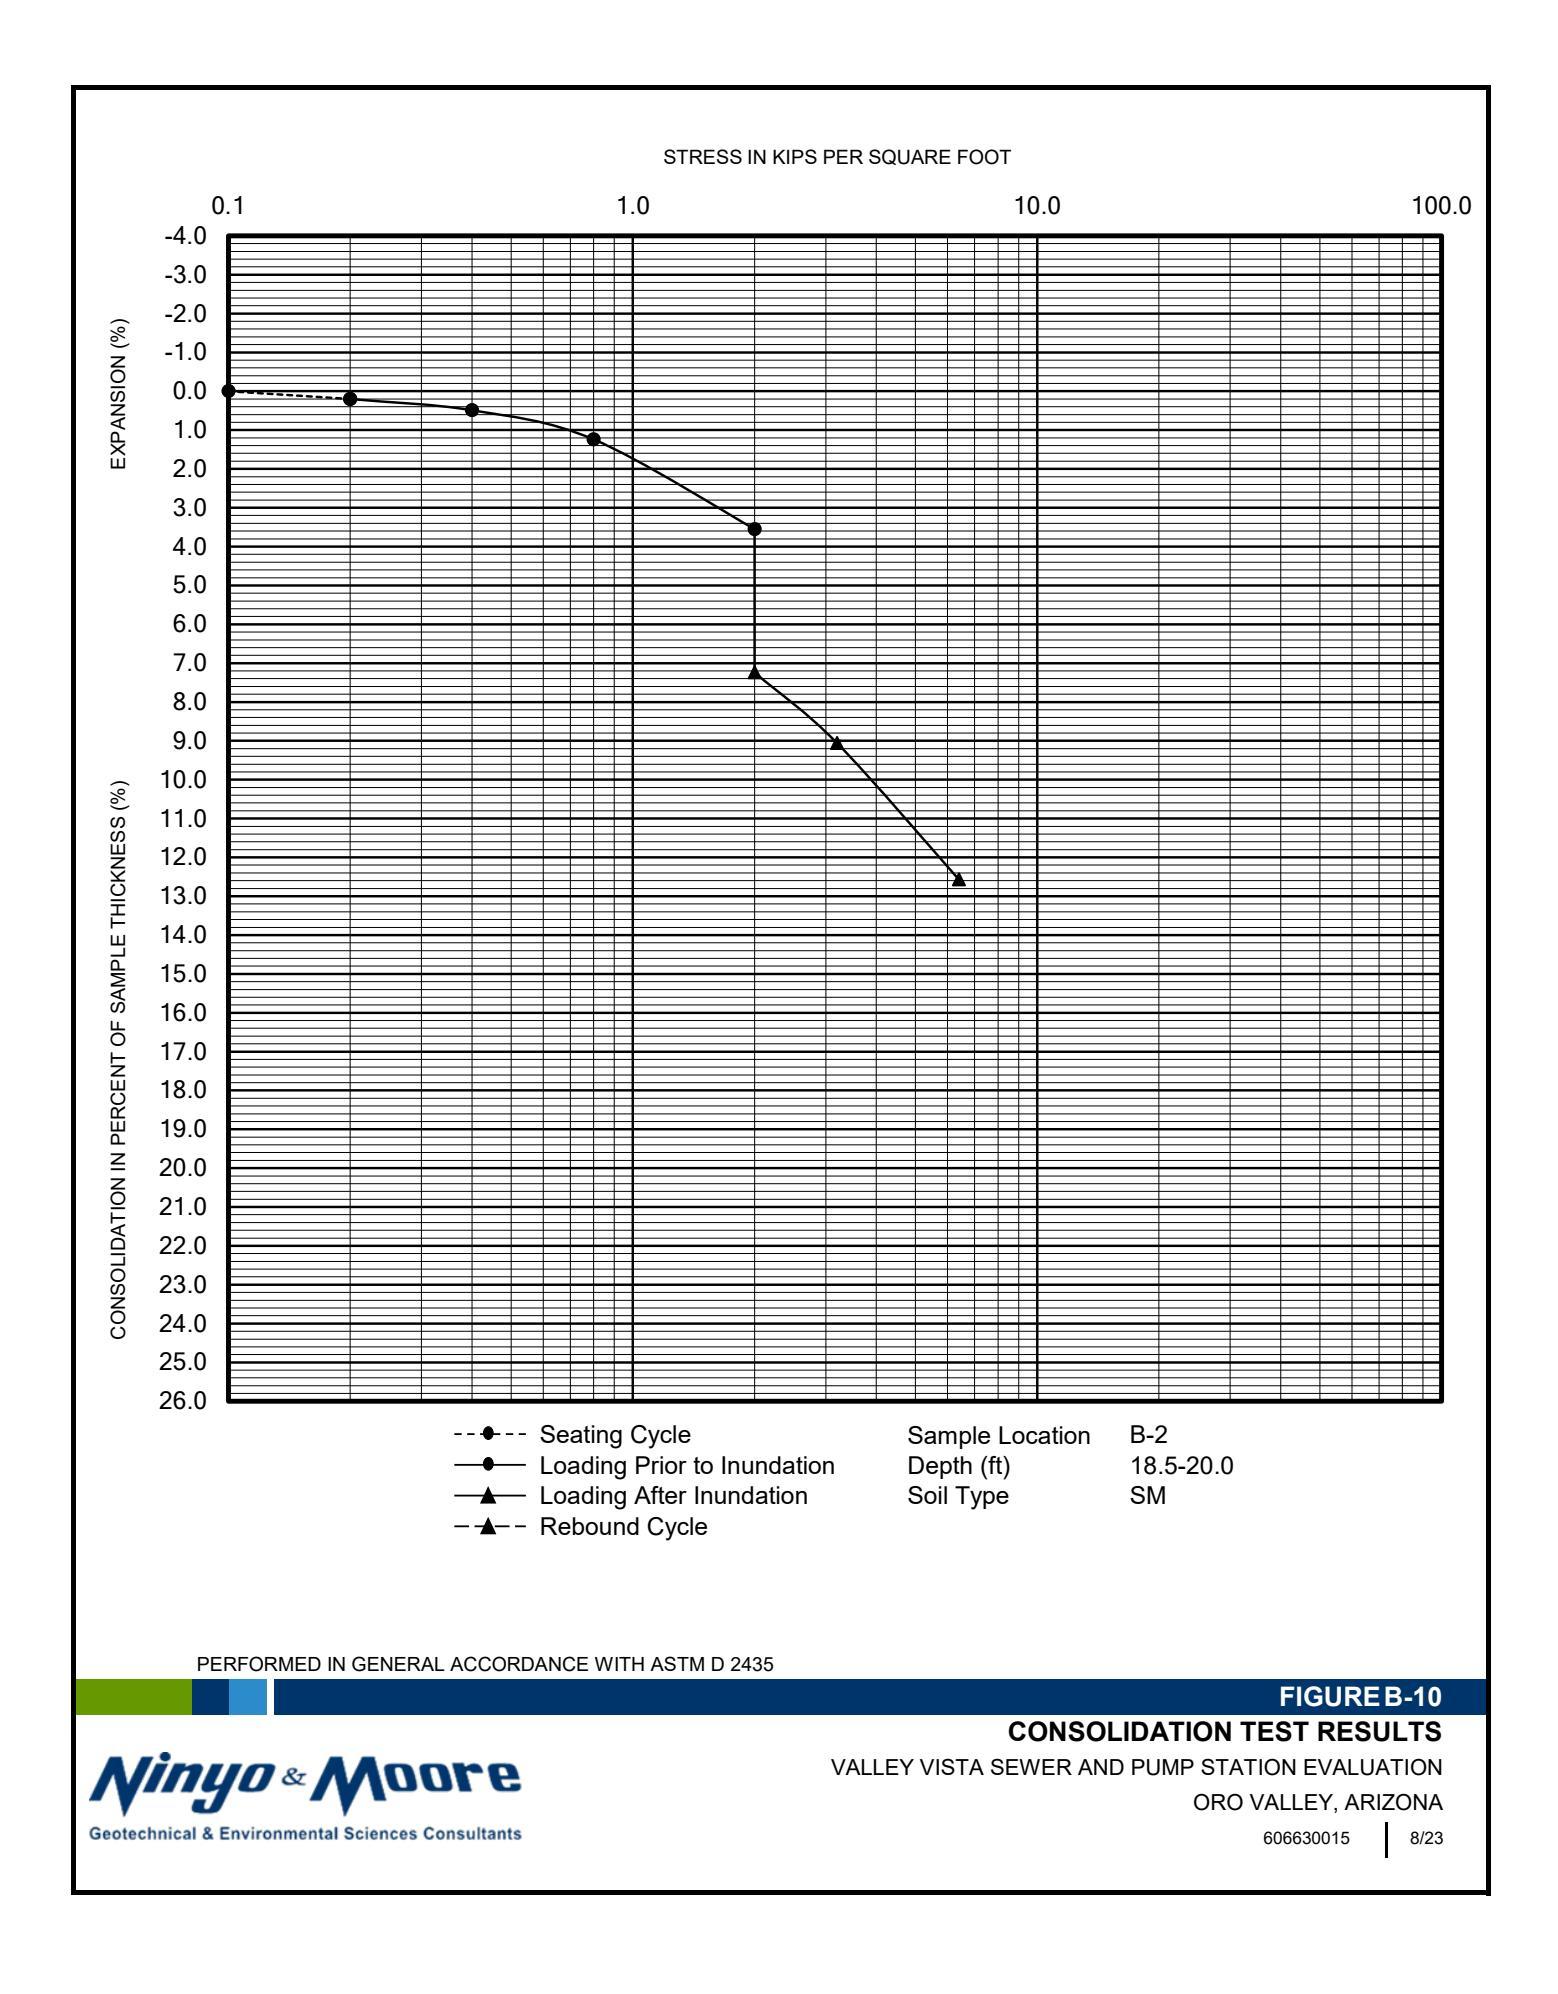
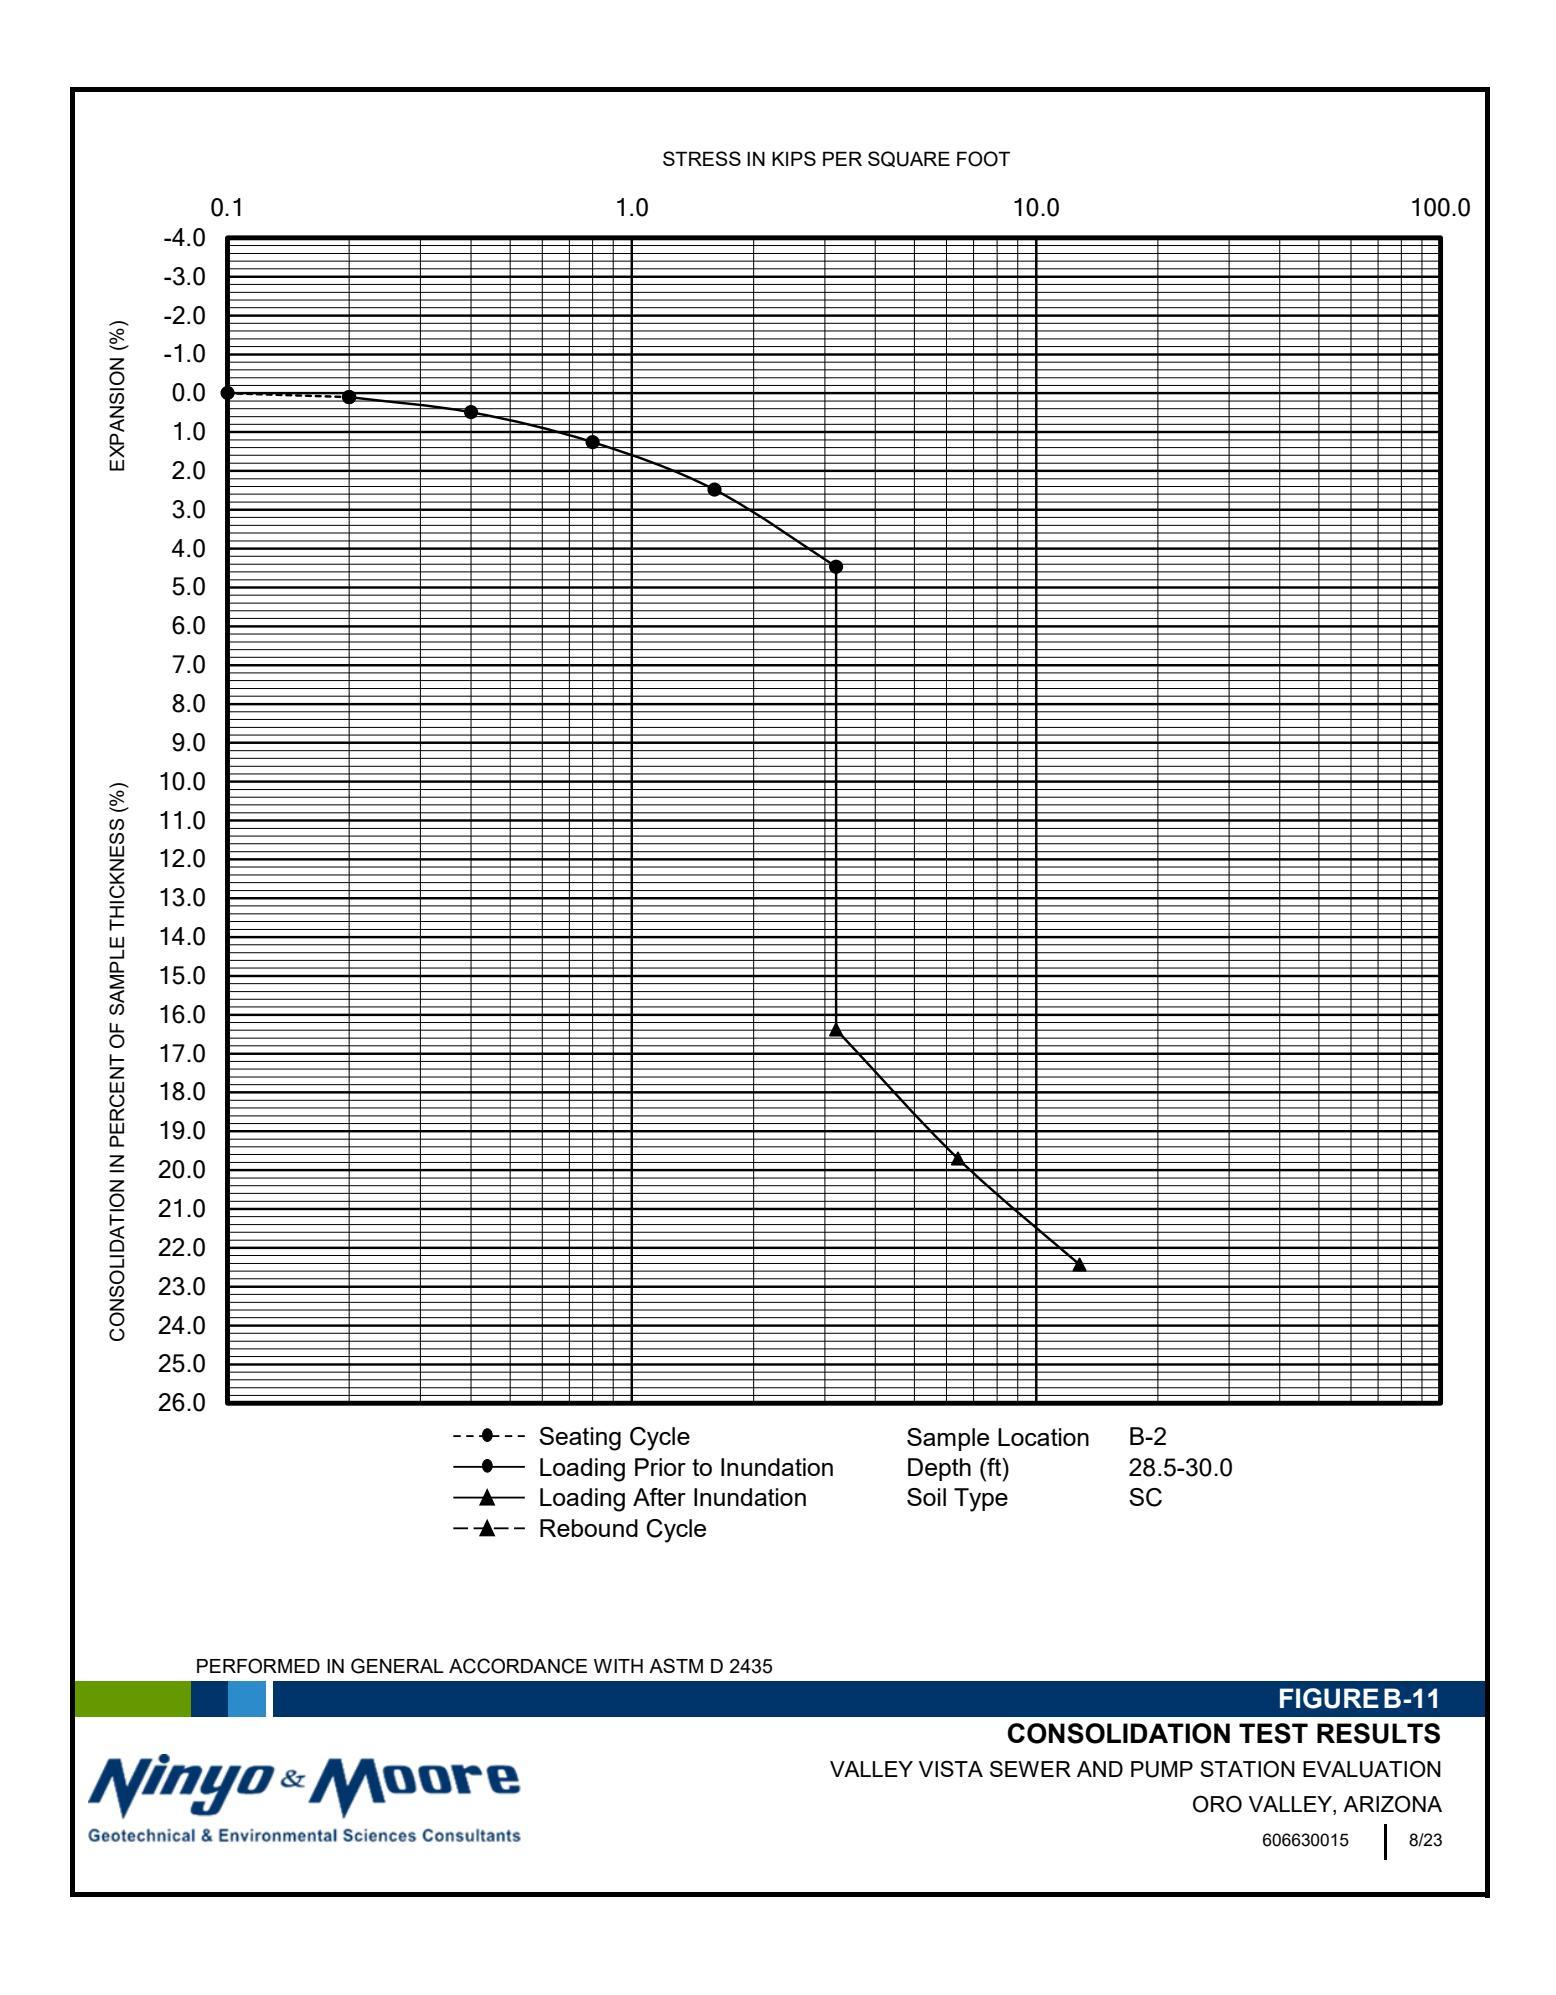
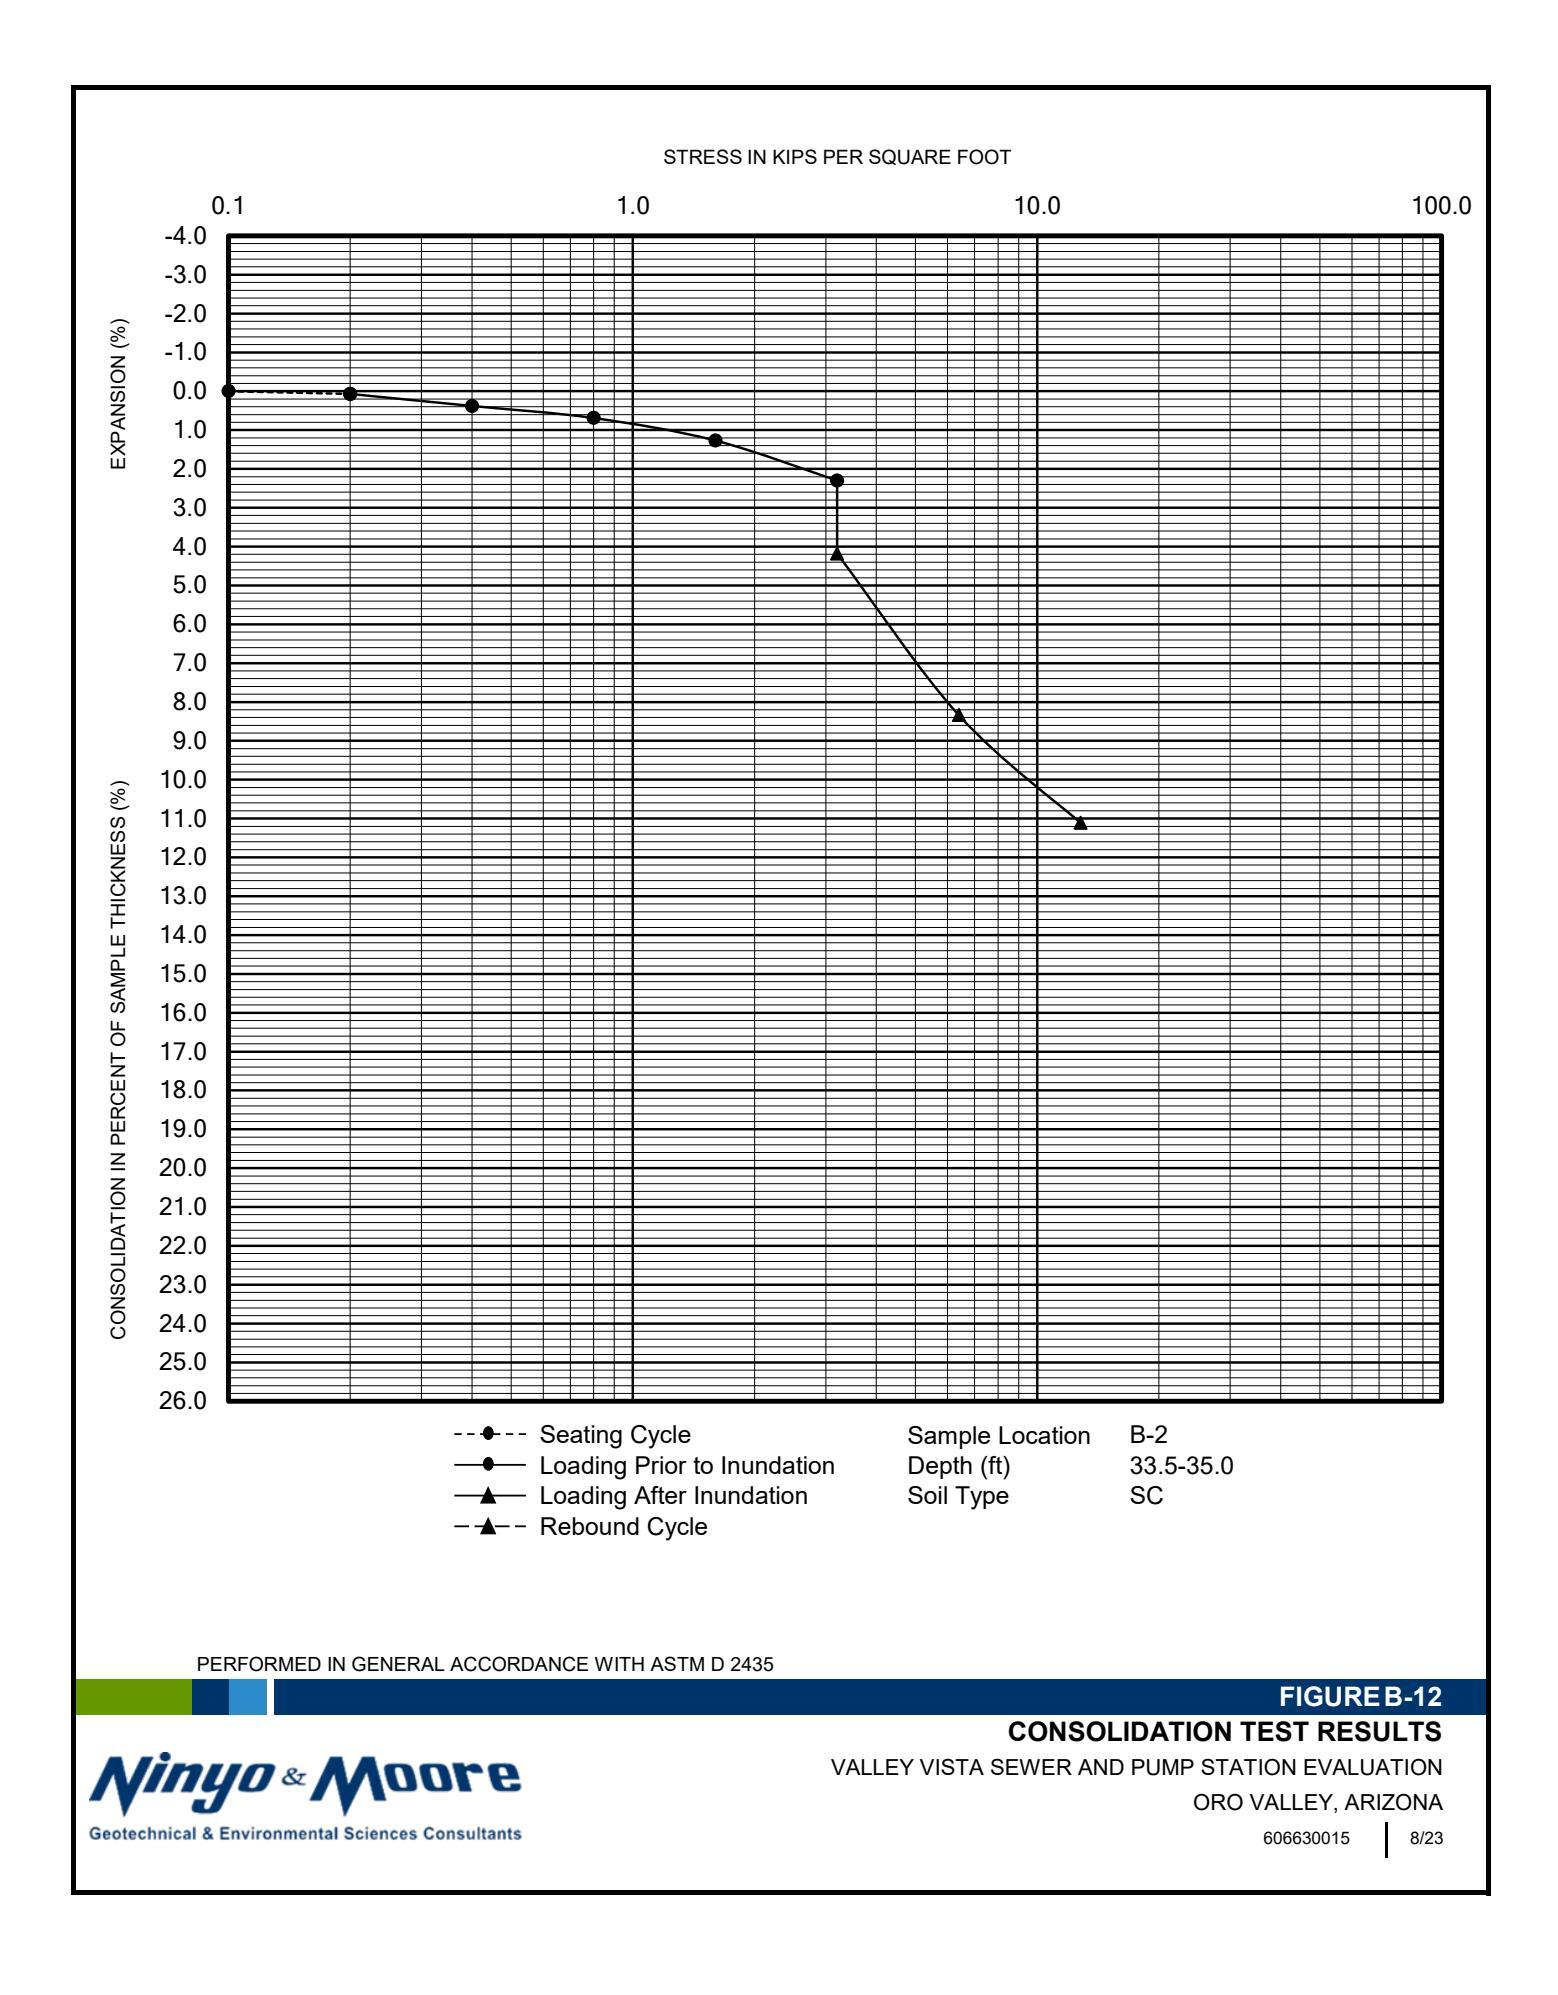
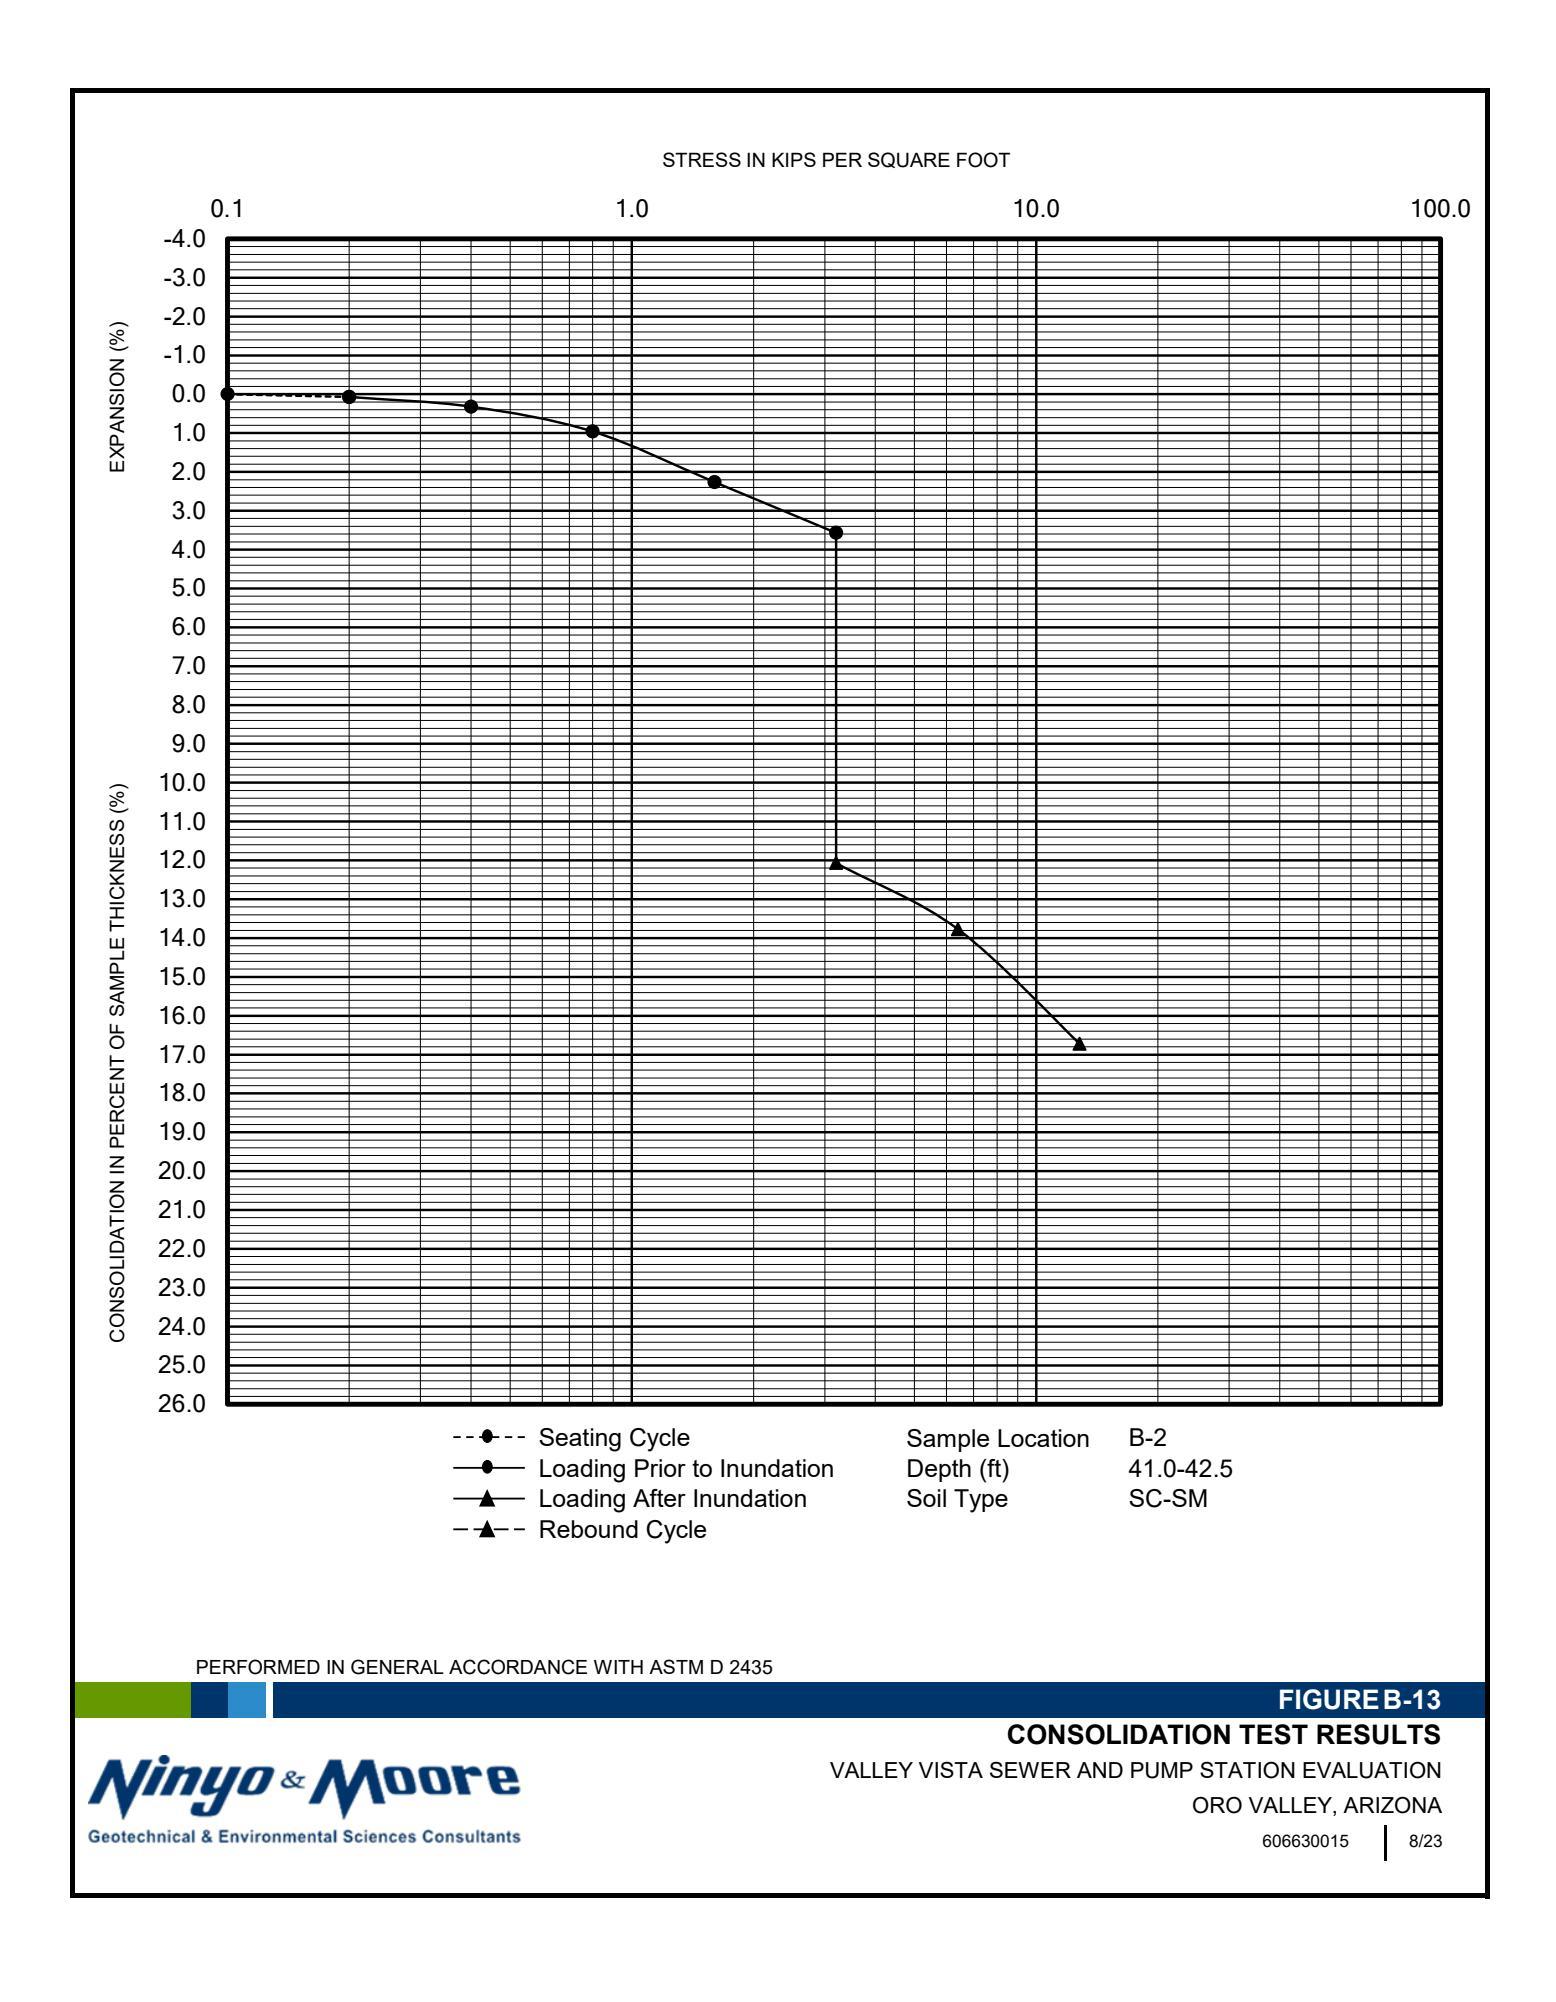
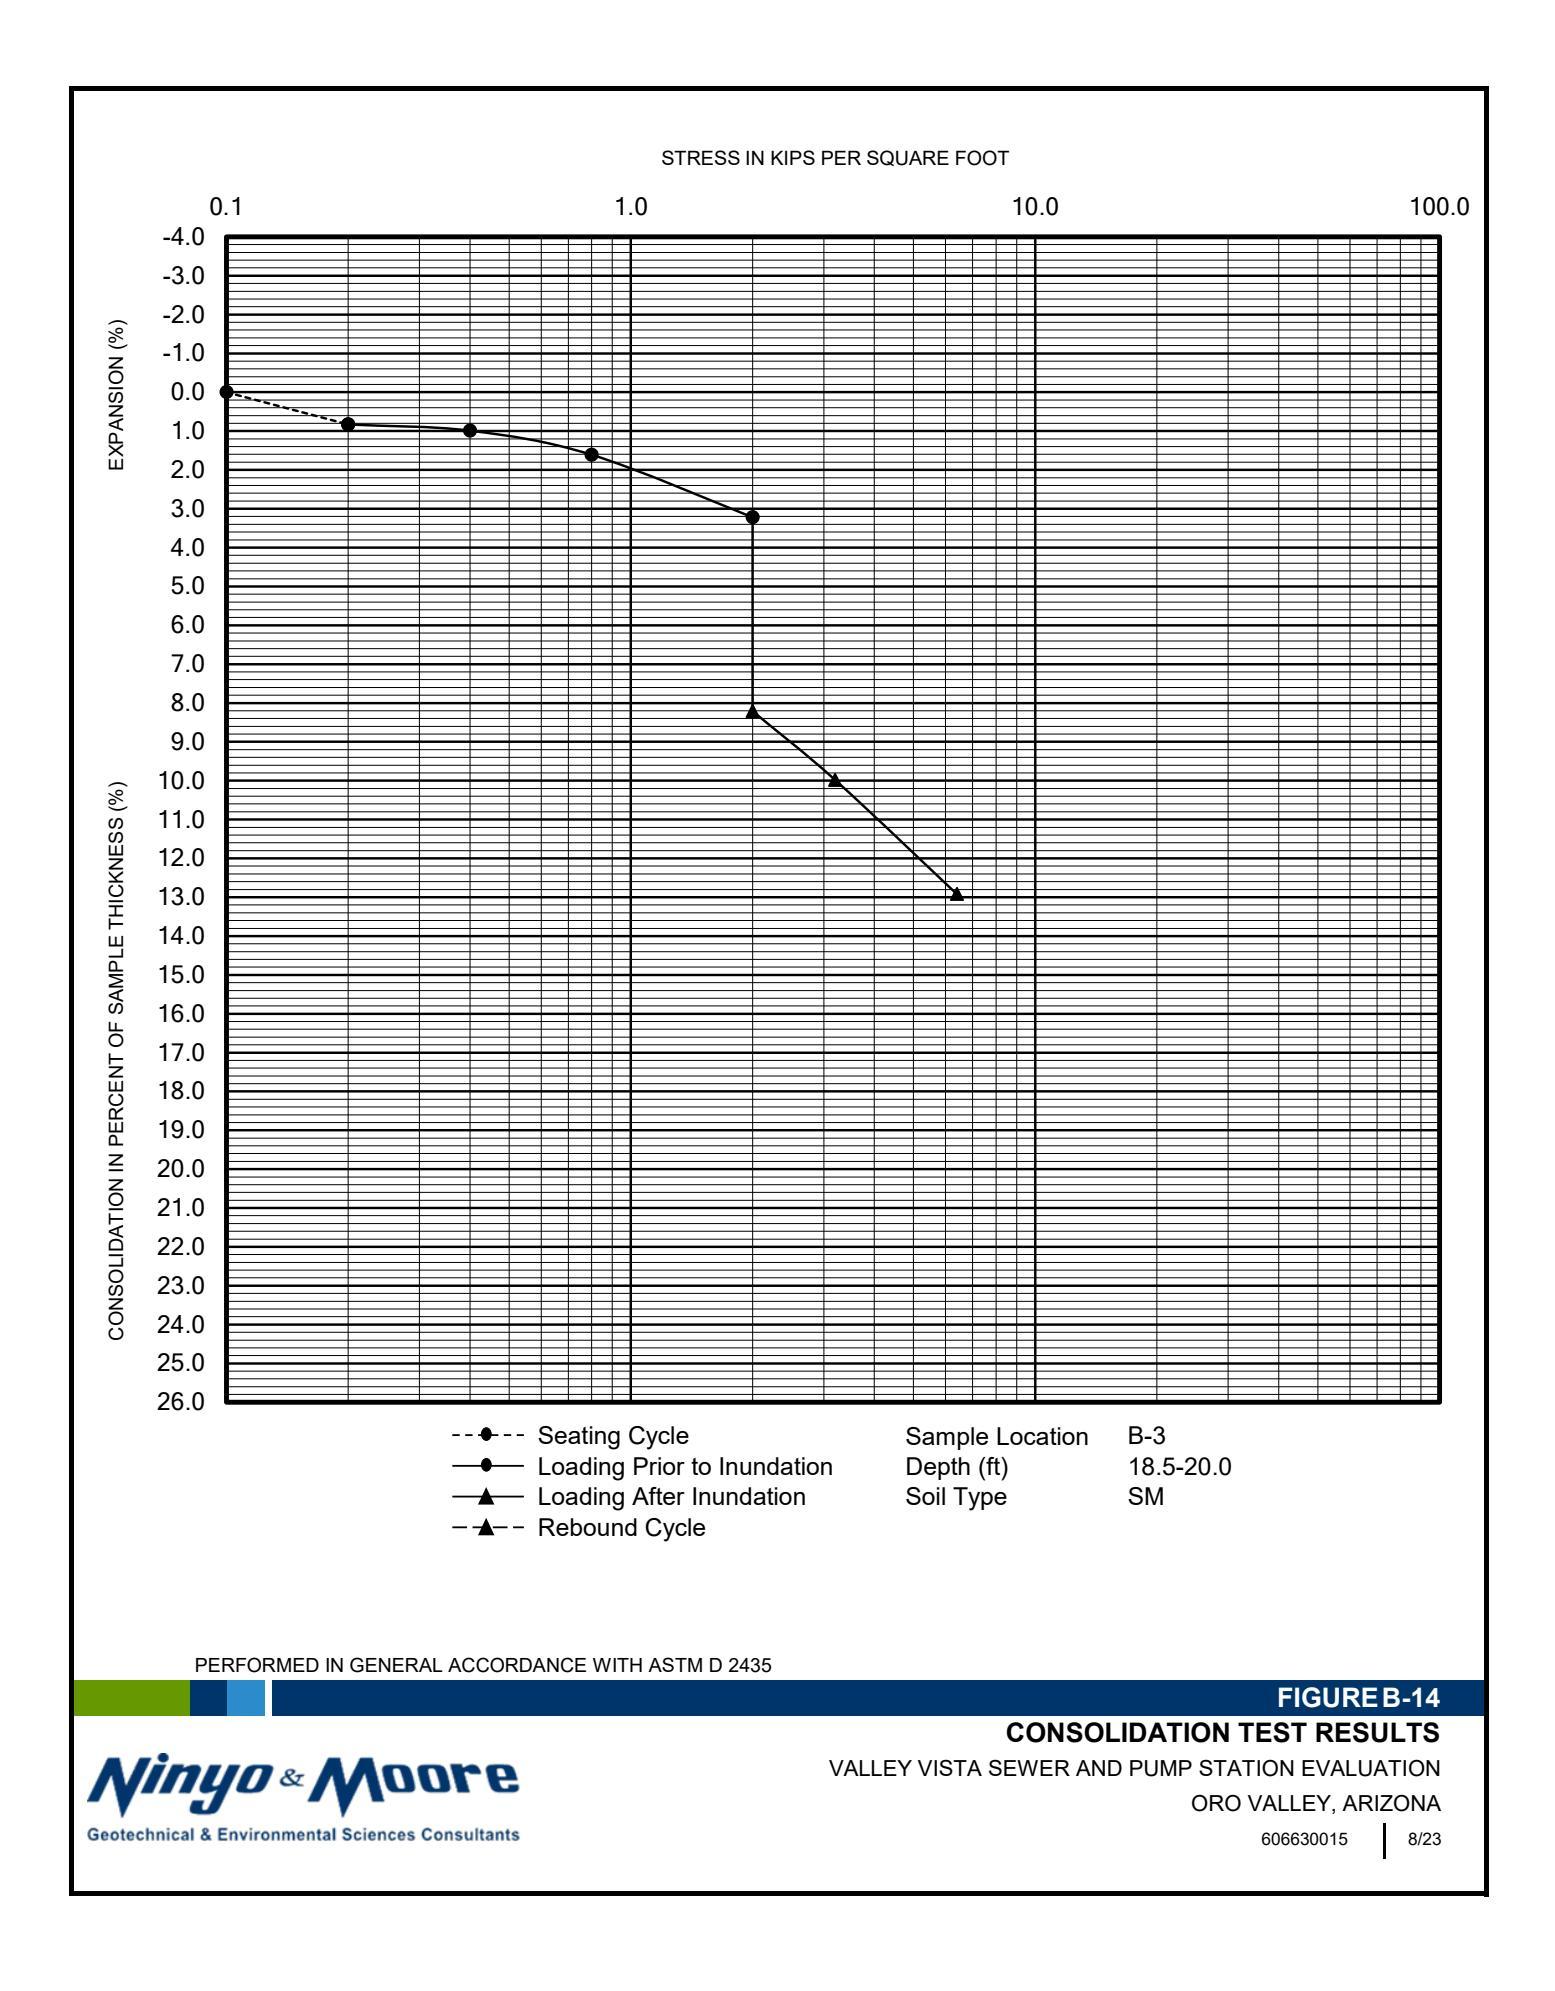
Consolidation (collapse potential) tests were performed on selected relatively undisturbed soil sample in general accordance with ASTM D 2435. The samples were inundated during testing to represent adverse field conditions. The percent of consolidation for each load cycle was recorded as a ratio of the amount of vertical compression to the original height of the samples. The results of the tests are summarized on Figures B-9 through B-14.

As mentioned above, both fill and native alluvial soils were encountered in our borings and generally consisted of silty and clayey sands. The in-situ moisture contents estimated for the ring samples for the fill soils varied between 3.7 and 8.5 (with one result being 17.1 percent and close to saturation) and generally increased with depth. The alluvium soils showed moistures varying widely between 1.2 and 14.9 percent. However, in borings B-2 and B-3, the in situ moisture contents and the degrees of saturation were significantly higher than in our boring B-1. The alluvium soils showed significantly lower moisture contents and saturation levels below an approximate depth of 20 to 25 feet bgs. The fill soils relative compaction was estimated to be approximately 96 to 100 percent of the maximum dry density as evaluated in accordance with ASTM D698. The results of our consolidation tests indicate moderate collapse potential upon saturation (approximately 4 to 5 percent) of the fill soils and severe collapse potential (approximately 2 to 12 percent) of the alluvial deposits.
