August 22, 2023 Project No. 606630015

Subject: Geotechnical Services Valley Vista Sewer and Pump Station Evaluation Oro Valley, Arizona

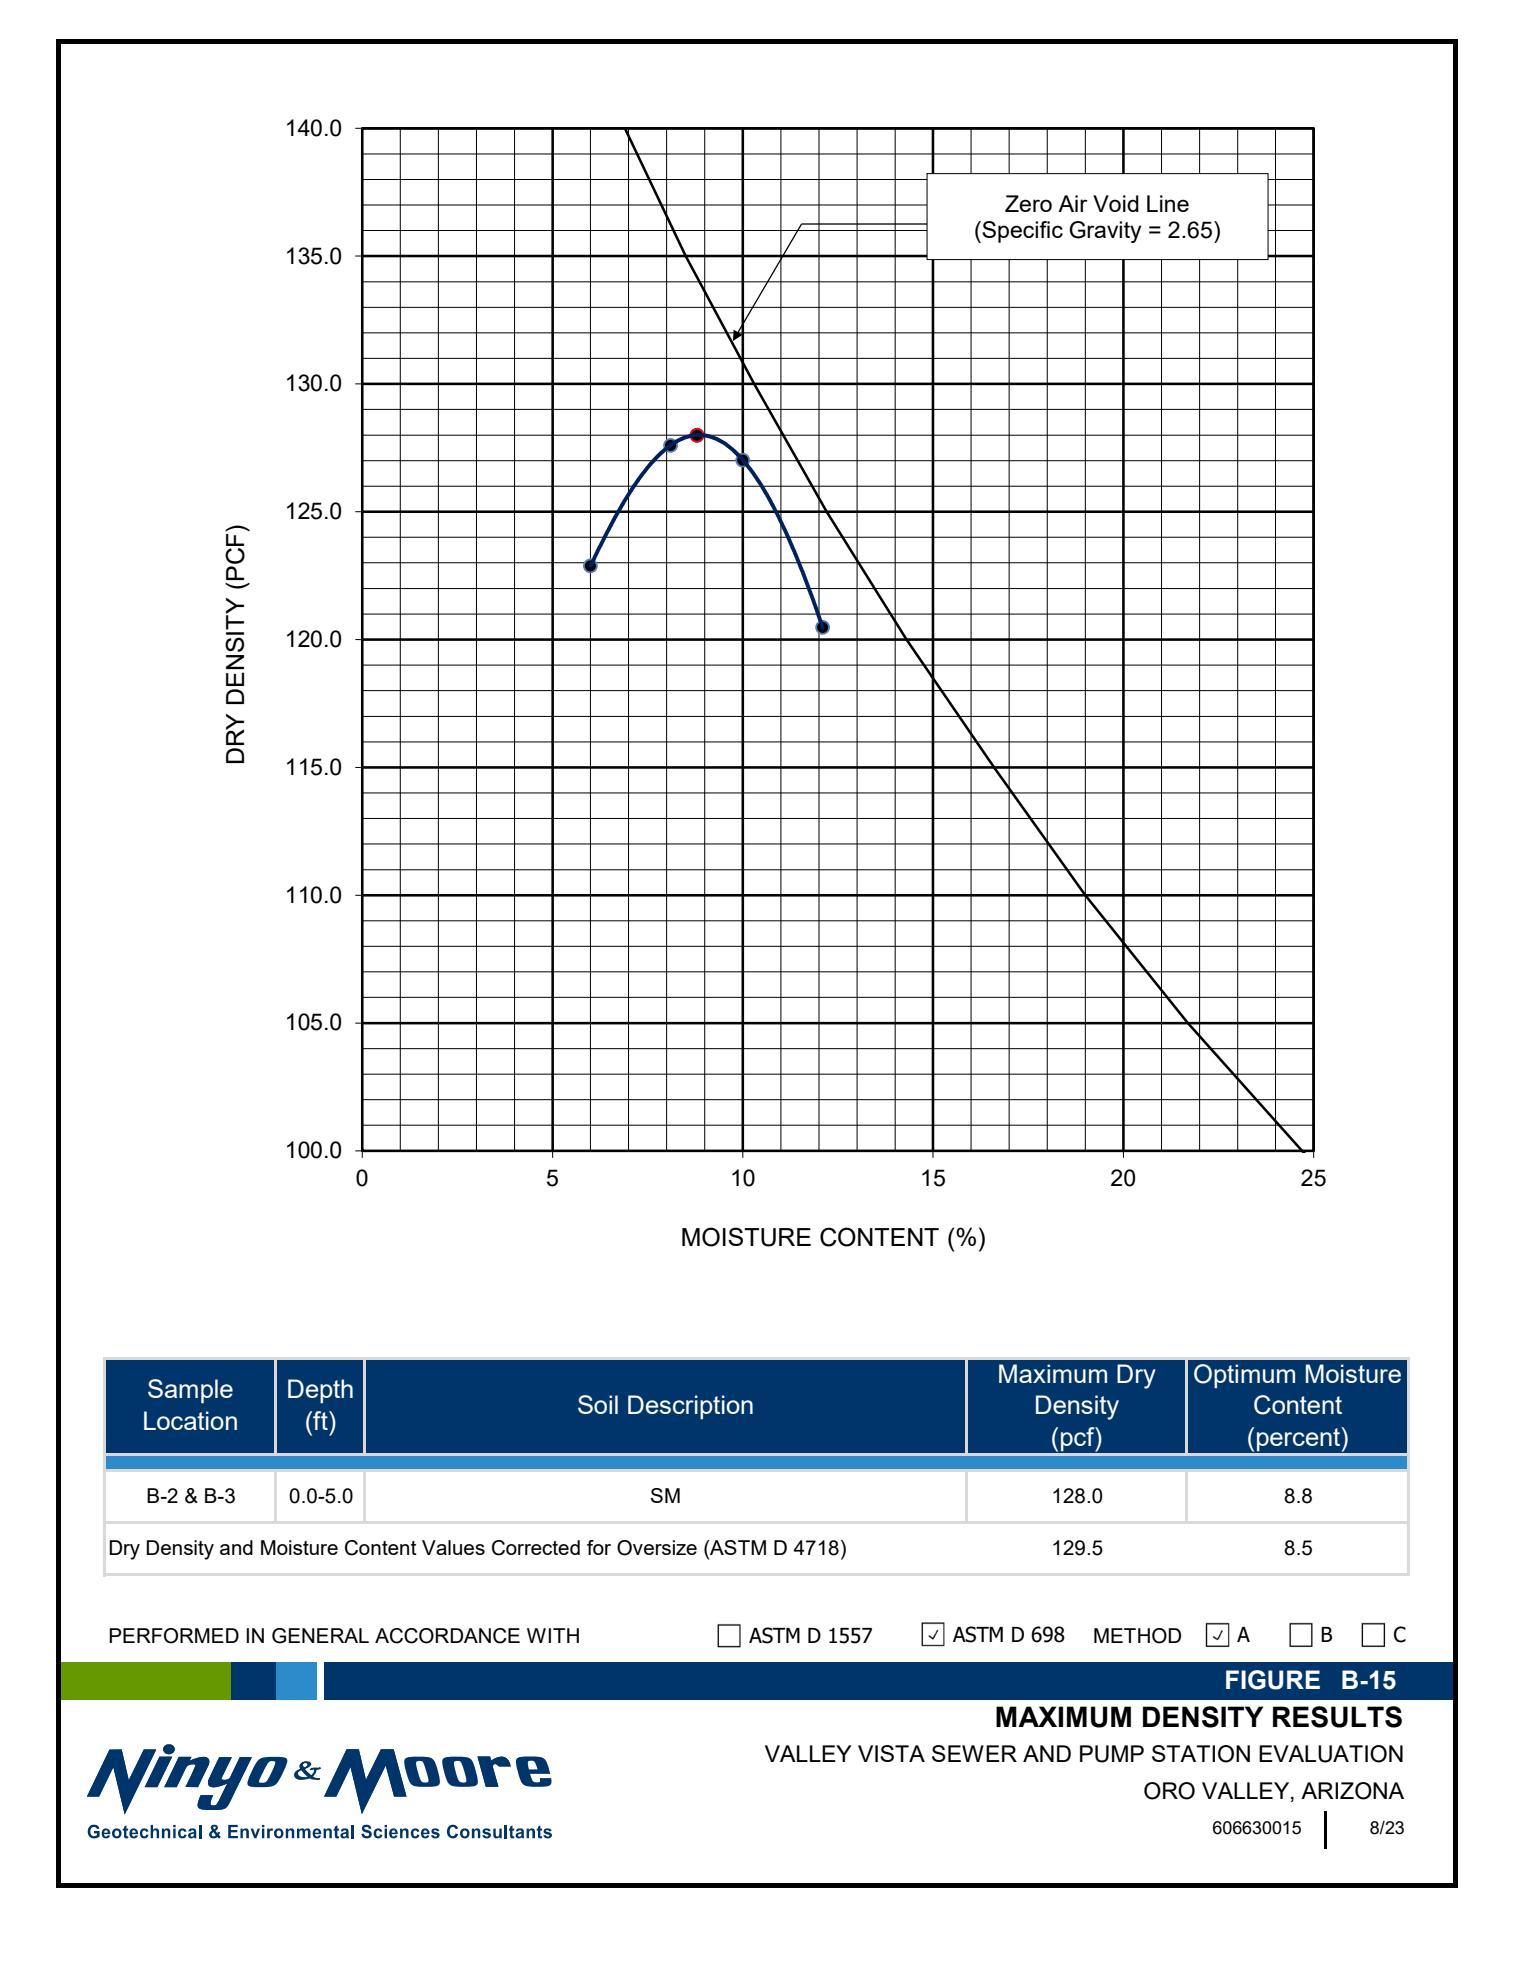
The maximum dry density and optimum moisture content of a selected representative soil sample was evaluated in general accordance with ASTM D 698. The results of these test are summarized on Figure B-15.
