Geotechnical Investigation

Rancho Vistoso Valley Vista – Lot 19 Residence

780 East Kalalau Drive Oro Valley, Arizona ProTeX Job No.: 12804

Re: Geotechnical Investigation - Forensics

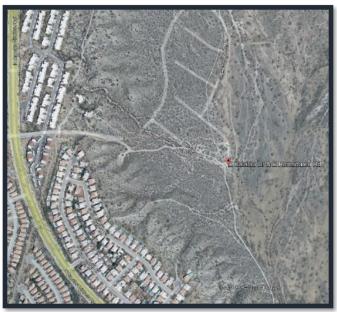
Figure 1: March, 2011, showing the historical pattern of the existing waterway into Big Wash

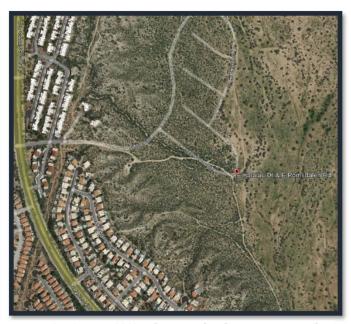
Figure 2: August, 2018, showing abundant vegetation along waterway, before the construction of the residential community

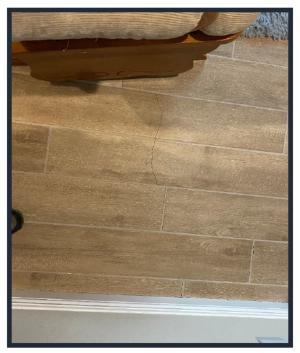
Figure 3: Lot 19, evidence of slab cracking reflecting on the tiles inside the existing home

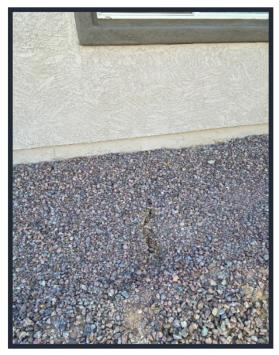
Figure 4: Lot 19, cracks observed in the soil on the west side of house

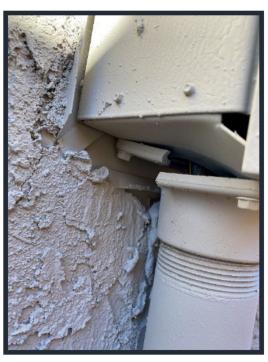
Figure 5: Lot 19, outside utility piping has separated from the base of electric box on the east side of house

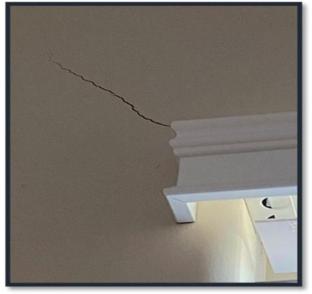
Figure 6: Lot 19 Cracks in the drywall at top edge of the window in Bedroom 2

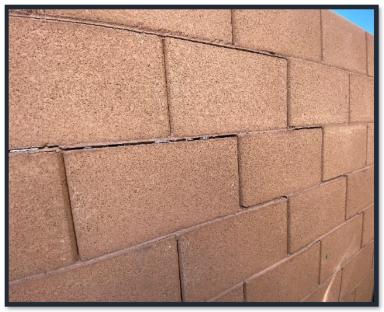
The privacy wall system on the east side of the lot consists of a single wall that borders the Pump/Booster station, located immediately east of the residential lot. Vertical and stair-step separation cracks, measuring up to approximately ½ inch or more were observed in this wall. Wall separations at control joints measured between 1" to 1 3/8" from the bottom to the top of the wall. The accompanying pictures show some of the cracks noted in the privacy walls.

Figure 1: Lot 19 Stair-step separation of individual blocks in the wall

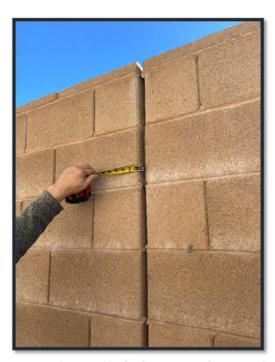
Figure 3: Lot 19 displacement and westward deflection observed in the east wall
